**Airworthiness Directives; Eurocopter France Helicopters**

**ACTION:** Notice of proposed rulemaking (NPRM).

**Eurocopter France:** Docket No. FAA-2012-0631; Directorate Identifier 2011-SW-021-AD.

This AD applies to Eurocopter France Model AS350B, AS350BA, AS350B1, AS350B2, AS350B3, AS350C, AS350D, AS350D1, AS355E, AS355F, AS355F1, AS355F2, AS355N, and AS355NP helicopters with an Aerazur emergency flotation gear attachment bracket, part number 158172, 158173, 158288, or 158289, installed, certificated in any category.

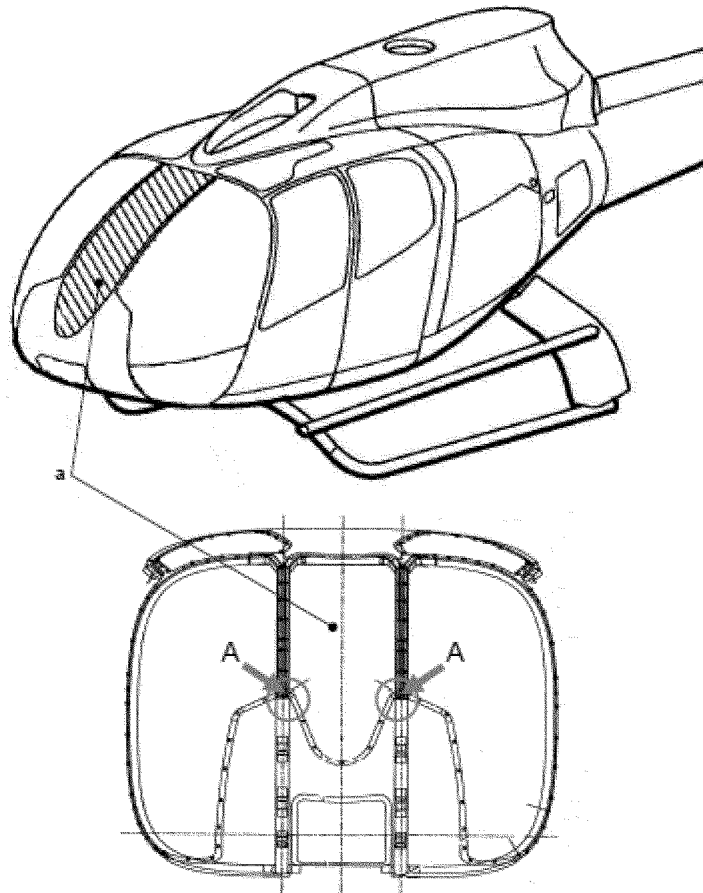
**Figure 1**

(2) If there is a crack or if a pilot indicates that the center windscreen distorted during flight, before further flight, replace the center windscreen with an airworthy center windscreen, P/N 350A25-9045-20, in accordance with the Accomplishment Instructions, paragraphs 2.B.2.b. through 2.B.2.b.4. of Eurocopter Service Bulletin No. 56-003, Revision 0, dated November 16, 2010.

(3) Within 12 months, replace the center windscreen with an airworthy center windscreen, P/N 350A25-9045-20, in accordance with the instructions contained in paragraph (d)(2) of this AD.

(4) Replacing the center windscreen with center windscreen, P/N 350A25-9045-20, constitutes terminating action for the requirements of this AD.

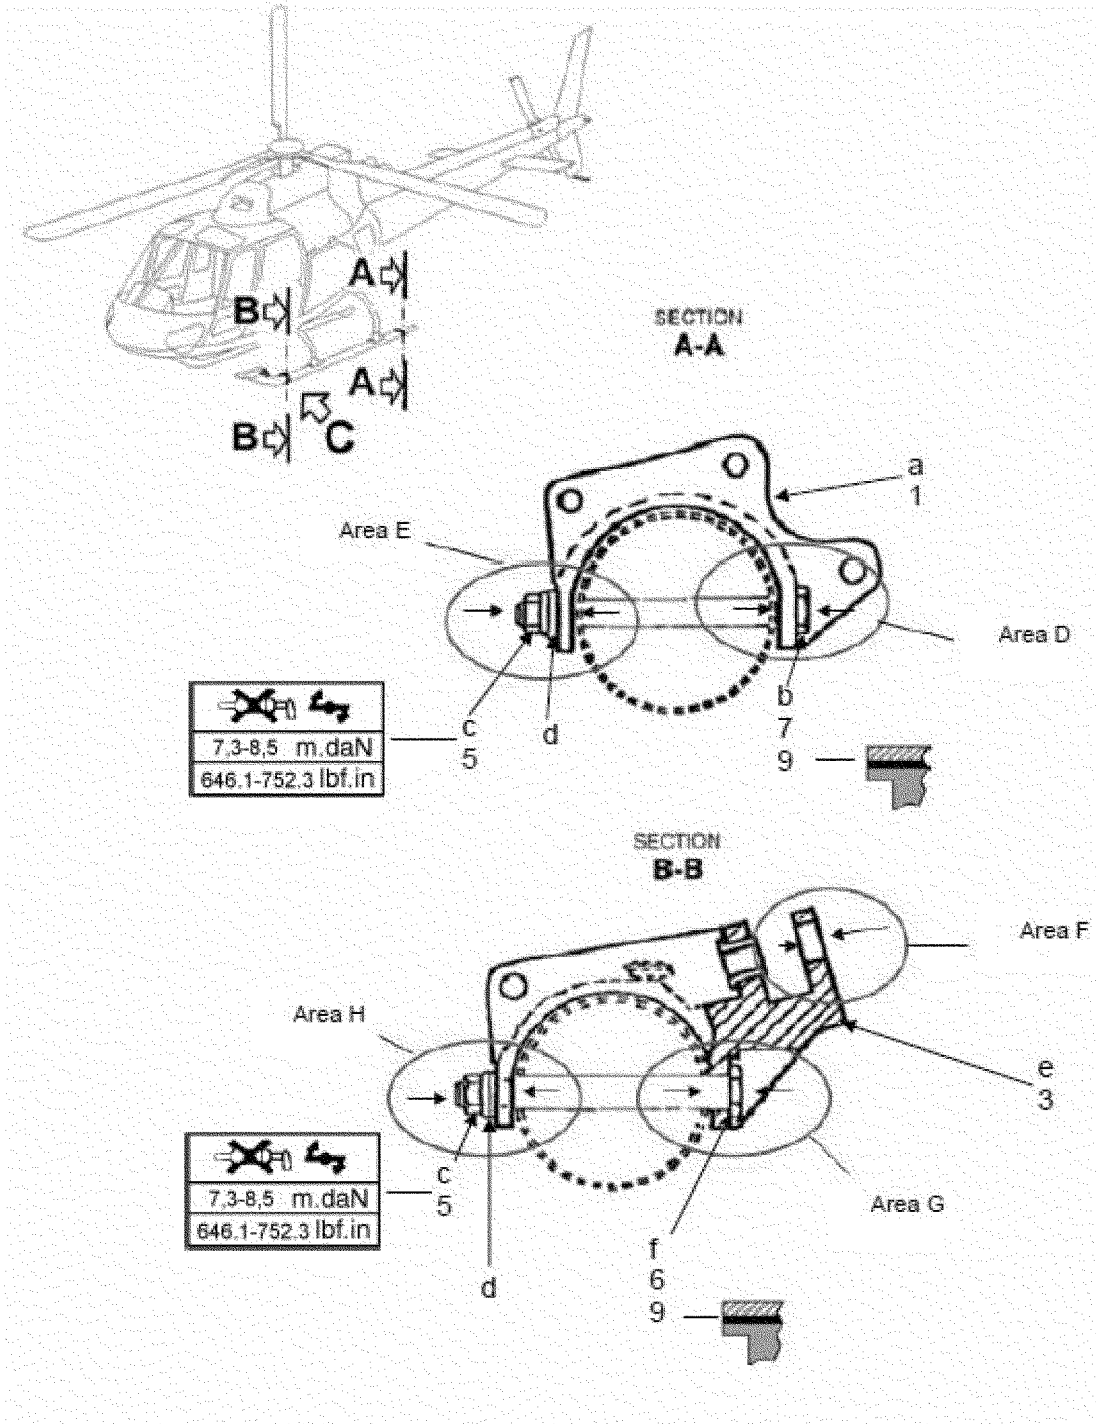
Figure 1. Emergency Flotation Gear Attachment Brackets

This AD defines the unsafe condition as a crack in an attachment bracket of the emergency flotation gear. This condition could result in failure of the emergency flotation system and loss of float stability in the event of a water landing.

- (1) Using a 5x or higher power magnifying glass, visually inspect the front emergency flotation gear attachment bracket (Figure 1 of this AD, section B-B, item (e)) in Areas F, G, and H; and the rear emergency flotation gear attachment bracket (Figure 1 of this AD, section A-A, item (a)) in Areas D and E for a crack.

(2) If there is a crack, replace the cracked emergency flotation gear attachment bracket with an airworthy emergency flotation gear attachment bracket prior to reinstallation of the emergency flotation equipment.
