[Docket No. FAA-2012-0716; Directorate Identifier 2012-SW-011-AD; Amendment 39-17121; AD 2012-14-07]

#### Airworthiness Directives; Bell Helicopter Textron Canada Helicopters

**SUMMARY:** We are adopting an airworthiness directive (AD) superseding an existing airworthiness directive for Bell Helicopter Textron Canada (Bell) Model 407 and 427 helicopters. The existing AD requires inspecting certain hydraulic servo actuators (servo) to determine whether the shaft turns independently of the nut or the clevis assembly, and additional actions based upon the inspection's outcome. The AD also requires reidentifying the servo. Since we issued

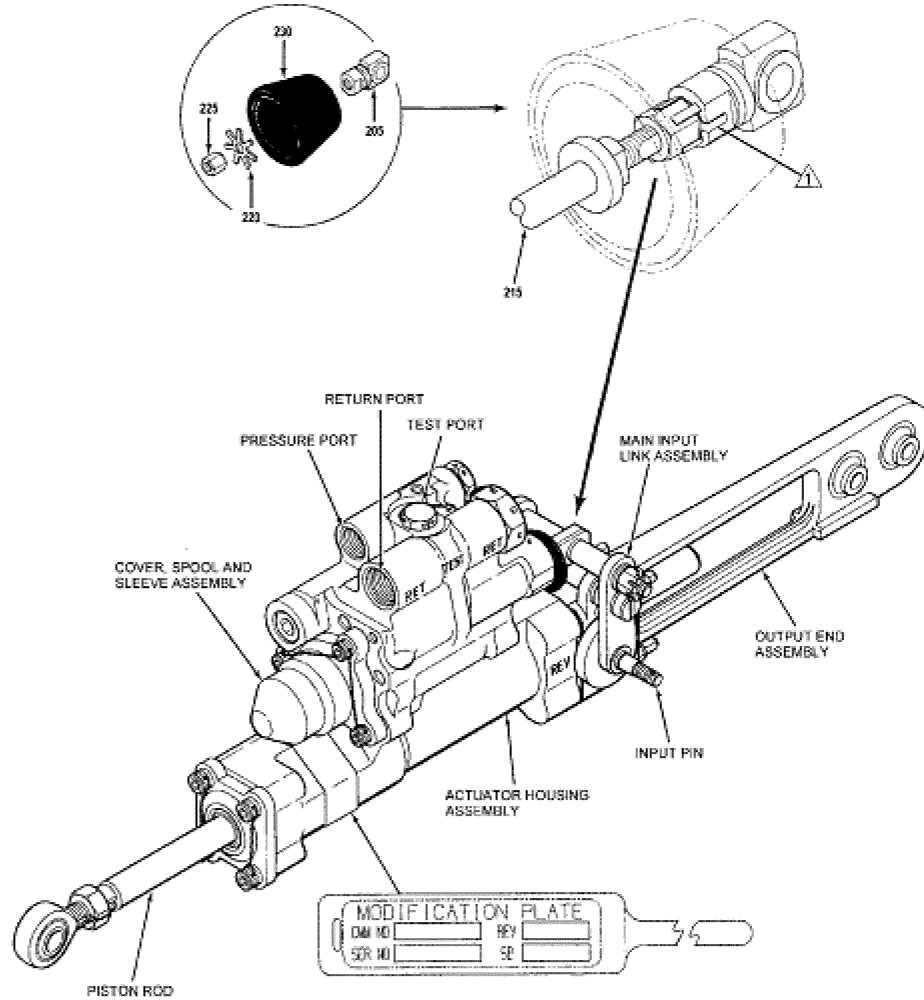
This AD defines the unsafe condition as a loose or misaligned part in the servo that

**ACCEPTABLE CONDITION**  
 A MINIMUM OF ONE TAB SHALL BE IN LINE AND BENT FLUSH WITH THE NUT FLAT SURFACE AND A MINIMUM OF ONE TAB SHALL BE IN LINE AND BENT FLUSH WITH THE CLEVIS ASSEMBLY FLAT SURFACE

least one tab of the lock washer is bent flush against a flat surface of the nut and if at least one tab of the lock washer is bent flush against a flat surface of the clevis assembly.

(i) Retract the boot depicted as 230 in Figure 1 to Paragraph (f) of this AD.

(ii) Applying only hand pressure, determine whether the nut, the shaft, or the clevis assembly, depicted as items 225, 215 and 205, respectively, in Figure 1 to Paragraph (f) of this AD, turn independently.

If the shaft turns independently of the nut or clevis assembly, before further flight, replace the servo with an airworthy servo.

(iv) If at least one lock washer tab is not aligned and bent flush with a nut flat surface and at least one lock washer tab is not aligned and bent flush with a flat surface of the clevis assembly, before further flight, replace the servo with an airworthy servo.

(v) If any tab of the lock washer is not bent flush against either a flat surface of the nut or clevis assembly, bend the tab flush against a flat surface.
