**[Docket No. FAA-2012-0739; Directorate Identifier 2012-SW-044-AD; Amendment 39-17125; AD 2012-14-11]**

#### **Airworthiness Directives; Various Restricted Category Helicopters**

**2012-14-11 Various Restricted Category Helicopters:** Amendment 39-17125; Docket No. FAA-2012-0739; Directorate Identifier 2012-SW-044-AD.

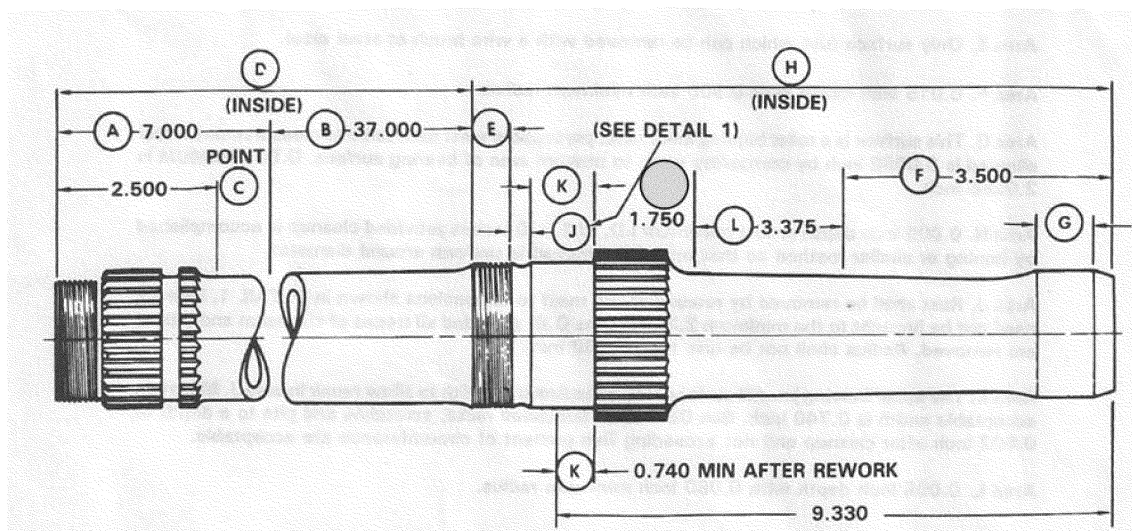
**Figure 1 to Paragraph (e)**

AFE reported two failures of a mast on an OH-58A+ and an OH-58C helicopter used in agricultural spraying operations. Investigation revealed that the mast failures were caused by fatigue cracking, which initiated from corrosion pitting found in the threaded section of the mast approximately 45 inches from

- (1) Within 30 days, unless accomplished previously within the last 12 months:
  - (i) Overhaul the main rotor mast assembly and magnetic particle inspect the mast; mast bearing nut; plate, mast and seal; and bearing liner for a crack.
  - (ii) Fluorescent penetrant inspect the locking plate for a crack.
  - (iii) Using a 10X or higher magnifying glass, inspect the threaded area of the mast

as shown in area E of figure 1 to paragraph (e) of this AD for pitting, corrosion, or a

crack. Remove any surface rust with a wire brush or steel wool.

(2) If there is a crack, pitting, or corrosion, before further flight, replace the mast with an airworthy mast.
