[Docket No. FAA-2012-0704; Directorate Identifier 2012-SW-040-AD; Amendment 39-17113; AD 2012-13-11]

Airworthiness Directives; Eurocopter Deutschland GmbH Helicopters

SUMMARY: We are adopting a new airworthiness directive (AD) for Eurocopter Deutschland GmbH (ECD) Model MBB-BK 117 (all versions) and BO-105LS A-3 helicopters. This AD requires inspecting the tail rotor pitch link spherical bearing for proper swaging. This AD is prompted by a report of a tail rotor pitch link with a spherical bearing that had migrated out of the bearing bore. The actions specified by this AD are intended to prevent failure of the tail rotor pitch link and subsequent loss of control of the helicopter.

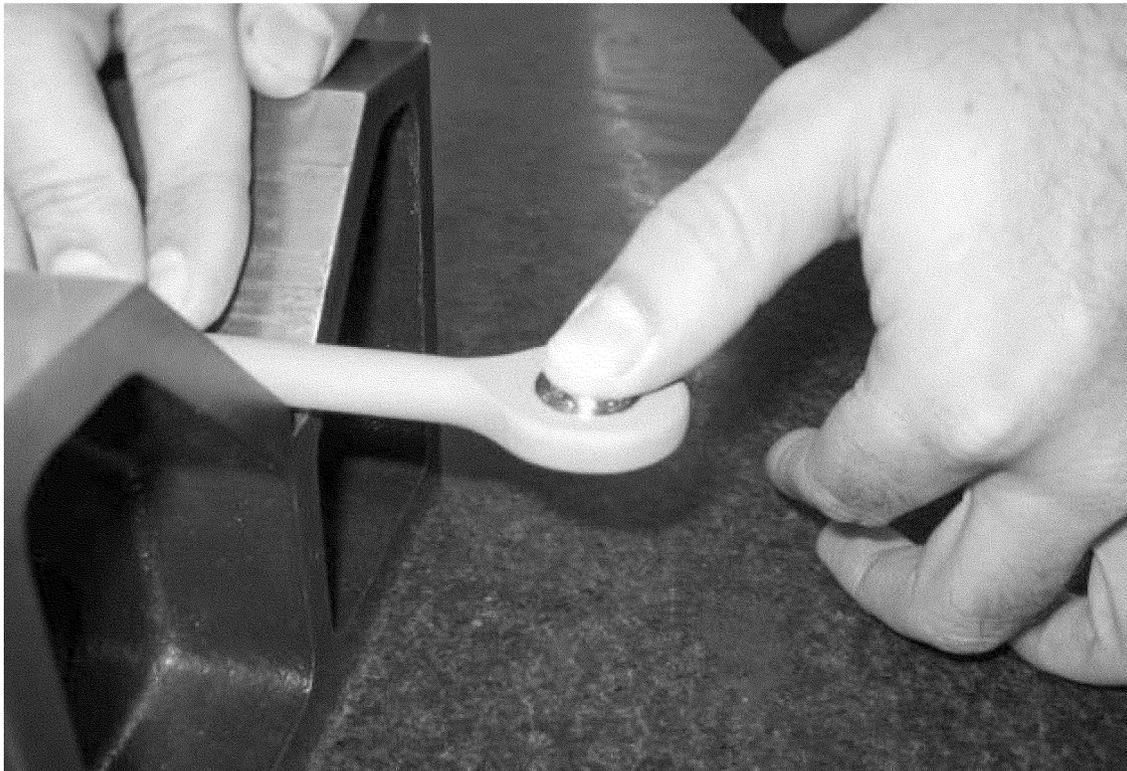
- (1) Remove the pitch link.
- (2) Clean the area around the spherical bearings and pitch link bearing bore chamfer.
- (3) Apply axial hand pressure to the faces of both spherical bearings as shown in Figure 1 to Paragraph (e) of this AD.
