**Airworthiness Directives; Eurocopter Deutschland GmbH Helicopters****AGENCY:** Federal Aviation Administration, DOT.**ACTION:** Notice of proposed rulemaking (NPRM).

**Eurocopter Deutschland GmbH:** Docket No. FAA-2012-0773; Directorate Identifier 2009-SW-71-AD.

This AD applies to Model MBB BK117 C-2 helicopters, with long tail rotor drive shaft assembly part number (P/N) B651M1002101 or B651M1002102 installed, certificated in any category.

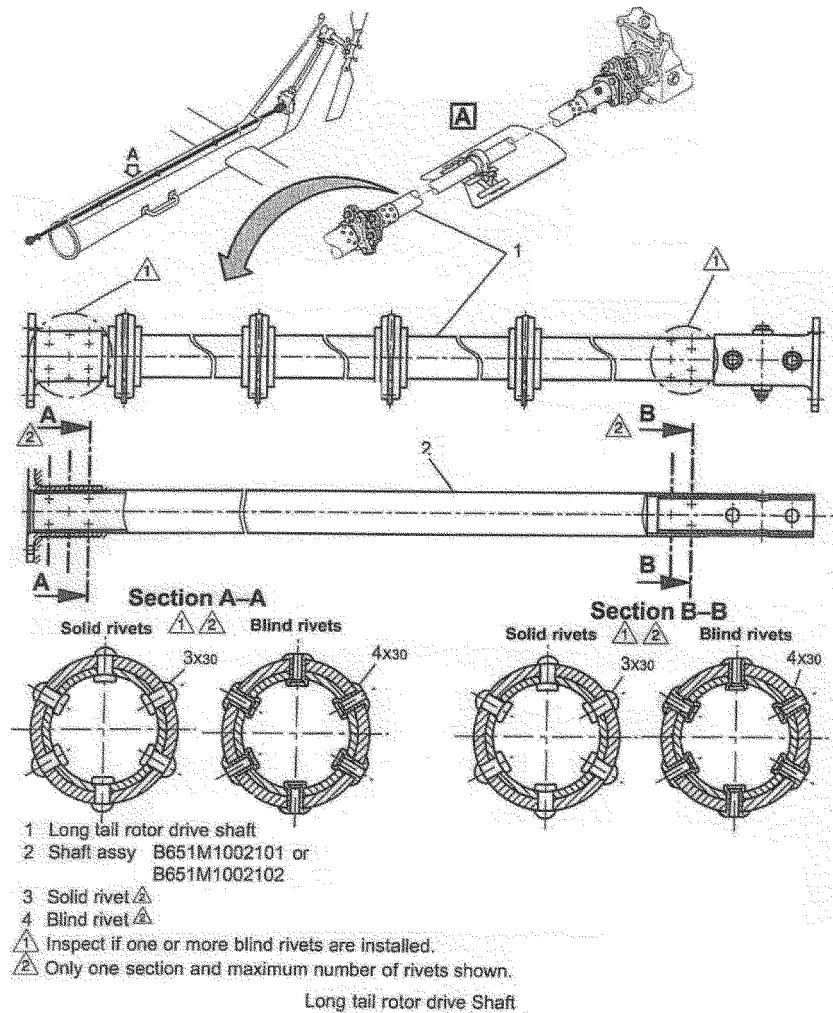
This AD defines the unsafe condition as the installation of blind rivets instead of solid rivets in the long tail rotor drive shaft. This condition could result in failure of the long tail rotor drive shaft and subsequent loss of control of the helicopter.

Within 100 hours time-in-service (TIS), inspect the long tail rotor drive shaft assembly for blind rivets as indicated in sections A-A and B-B of Figure 1 to Paragraph (d) of this AD.

(2) If there are one or more blind rivets installed on the shaft assembly in the areas depicted in Figure 1 to Paragraph (d) of this AD, before further flight, replace the shaft assembly of the long tail rotor drive shaft with an airworthy shaft assembly that does not have blind rivets installed.

(3) After the effective date of this AD, do not install a tail rotor drive shaft assembly that has blind rivets installed.
