Airworthiness Directives; Eurocopter Deutschland GmbH Helicopters

ACTION: Notice of proposed rulemaking (NPRM).

EUROCOPTER DEUTSCHLAND GmbH (ECD); Docket No. FAA-2012-0887; Directorate Identifier 2009-SW-02-AD.

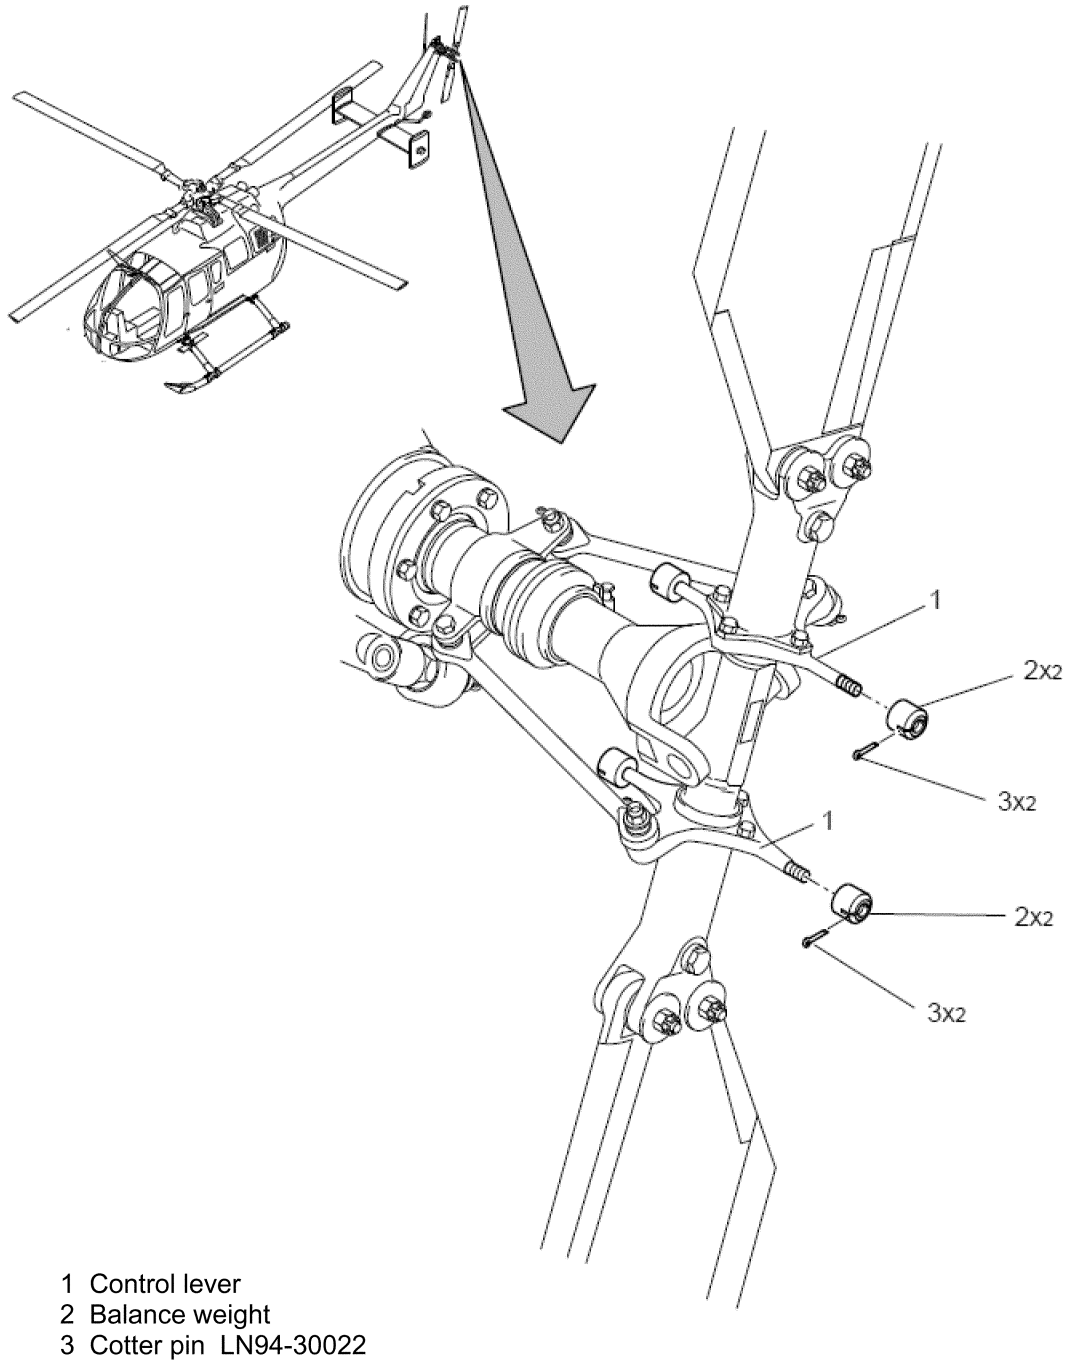
Figure 1 to paragraph (d) Tail Rotor Balance Weights

- (1) Remove the weights from the lever as depicted in Figure 1 to paragraph (d) of this AD. Apply marks to the weights before they are removed in order to be able to re-establish the correct assignment and the old installation position towards the lever when the weights are installed.

(3) Apply corrosion preventive paste onto the thread of the lever and install weights to

the lever as depicted in Figure 1 to paragraph (d) of this AD. Ensure during installation of the weights that the weights are correctly assigned and installed to the control lever in accordance with the applied marks.

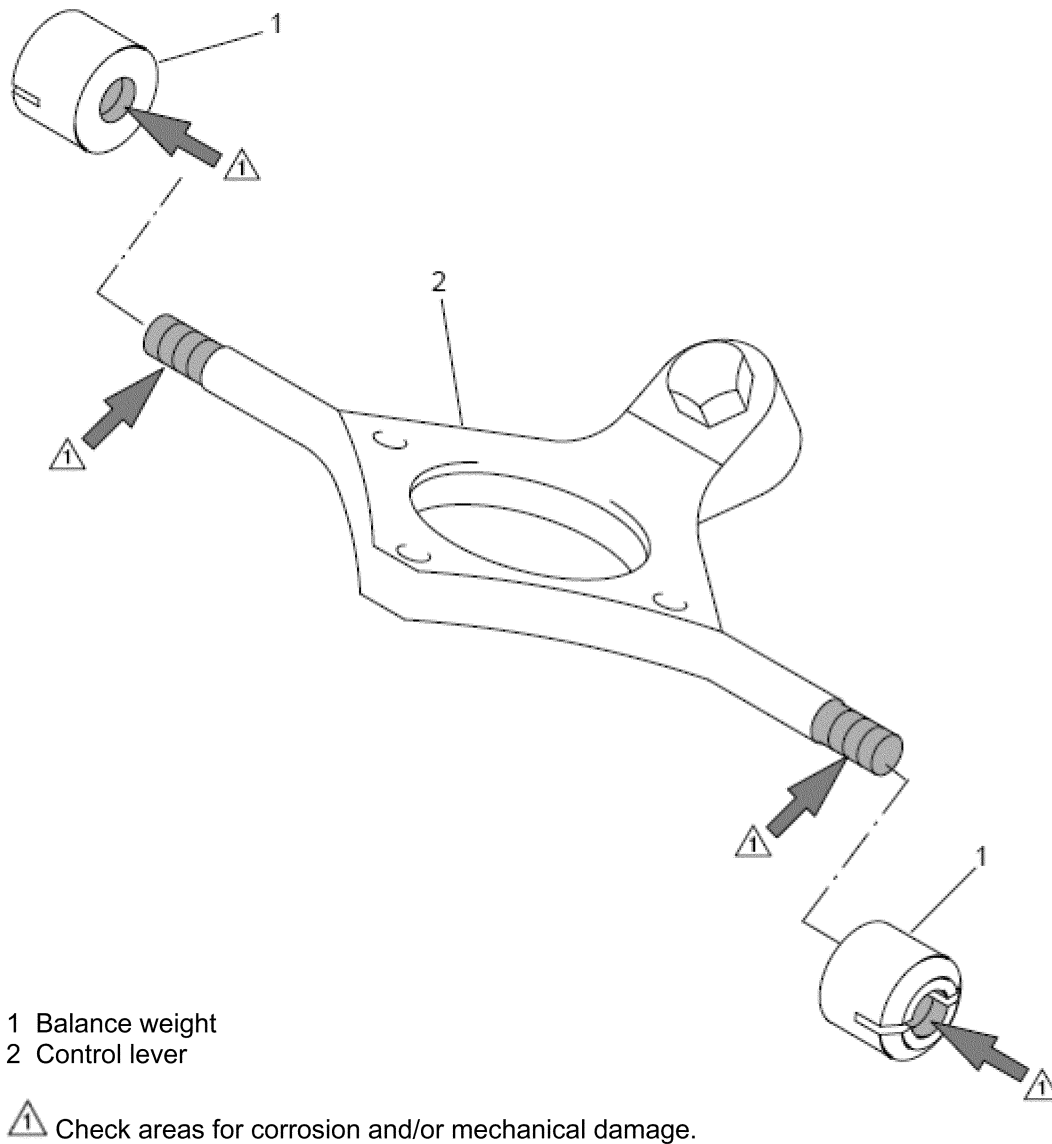
Figure 2 to paragraph (d) Inspection of Balance Weights and Control Lever

This AD defines the unsafe condition as corrosion or thread damage in the threaded area of a lever or weight. This condition could result in failure of a weight or lever, separation of a tail rotor part, severe tail rotor vibration, and subsequent loss of control of the helicopter.

(2) Visually inspect each weight and lever for corrosion and damage in the threaded

areas as depicted in Figure 2 to paragraph (d) of this AD.

(A) If the total area of corrosion or thread damage, or both, covers less than 25 percent of the length of the threaded area, the weight can be threaded (screwed) onto the lever, and the cylindrical mating surface has no damage, before further flight, remove the

corrosion and reinstall the weight by following paragraph (d)(3) of this AD.

(B) If the total area of corrosion or thread damage, or both, covers 25 percent or more of the length of the threaded area, the weight cannot be threaded (screwed) onto the lever, or the cylindrical mating surface has damage, before further flight, replace the weight with an airworthy weight by following paragraph (d)(3) of this AD.

(iii) If there is corrosion or thread damage on the threaded portion of the *lever*, polish out the corrosion and thread damage using a polishing cloth 600 and:

(A) If the thread depth does not exceed 0.3 millimeter (mm) and the diameter of the lever in the area before the threaded area is not less than 9.95 mm after polish out, before further flight, install airworthy weights to the lever by following paragraph (d)(3) of this AD.

(B) If the thread depth is 0.3 mm or greater or the diameter of the lever in the area before the threaded area is less than 9.95 mm after polish out, before further flight, replace the lever with an airworthy lever.
