[Docket No. FAA-2012-0896; Directorate Identifier 2010-SW-070-AD; Amendment 39-17173; AD 2012-17-10]

Airworthiness Directives; Various Restricted Category Helicopters

2012–17–10 Various Restricted Category

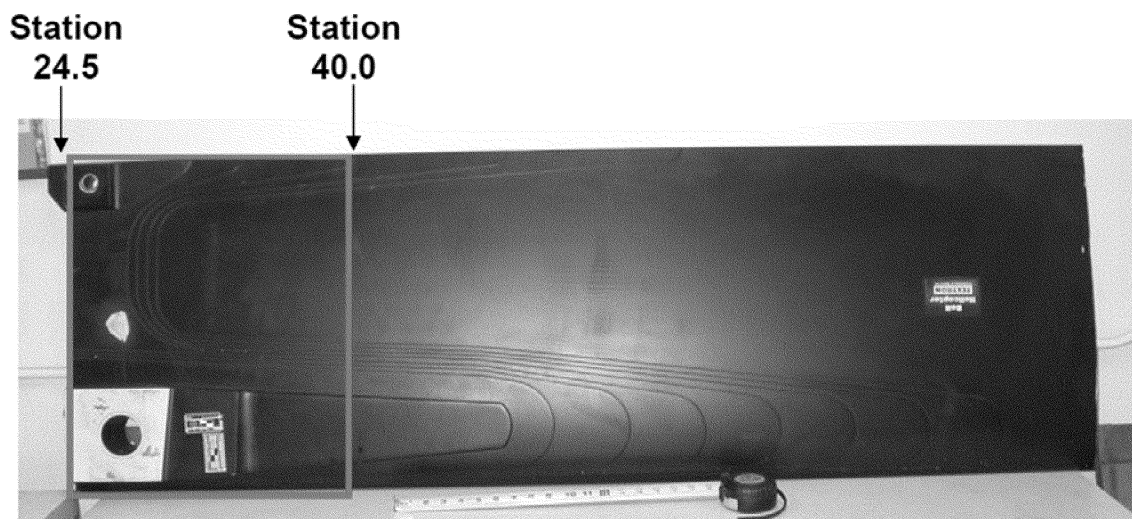
(ii) Using a 3x power or higher magnifying glass and a bright light, on each affected M/R blade, in an area from blade stations 24.5 to 40, including the entire width of the M/R blade chord, as depicted in Figure 1 to Paragraph (e) of this AD:

(A) Visually inspect the upper and lower grip plates and doublers of the M/R blade for an edge void, any corrosion, or a crack.

(B) Visually inspect the remaining upper and lower surfaces of the M/R blade for an edge void, any corrosion, or a crack.

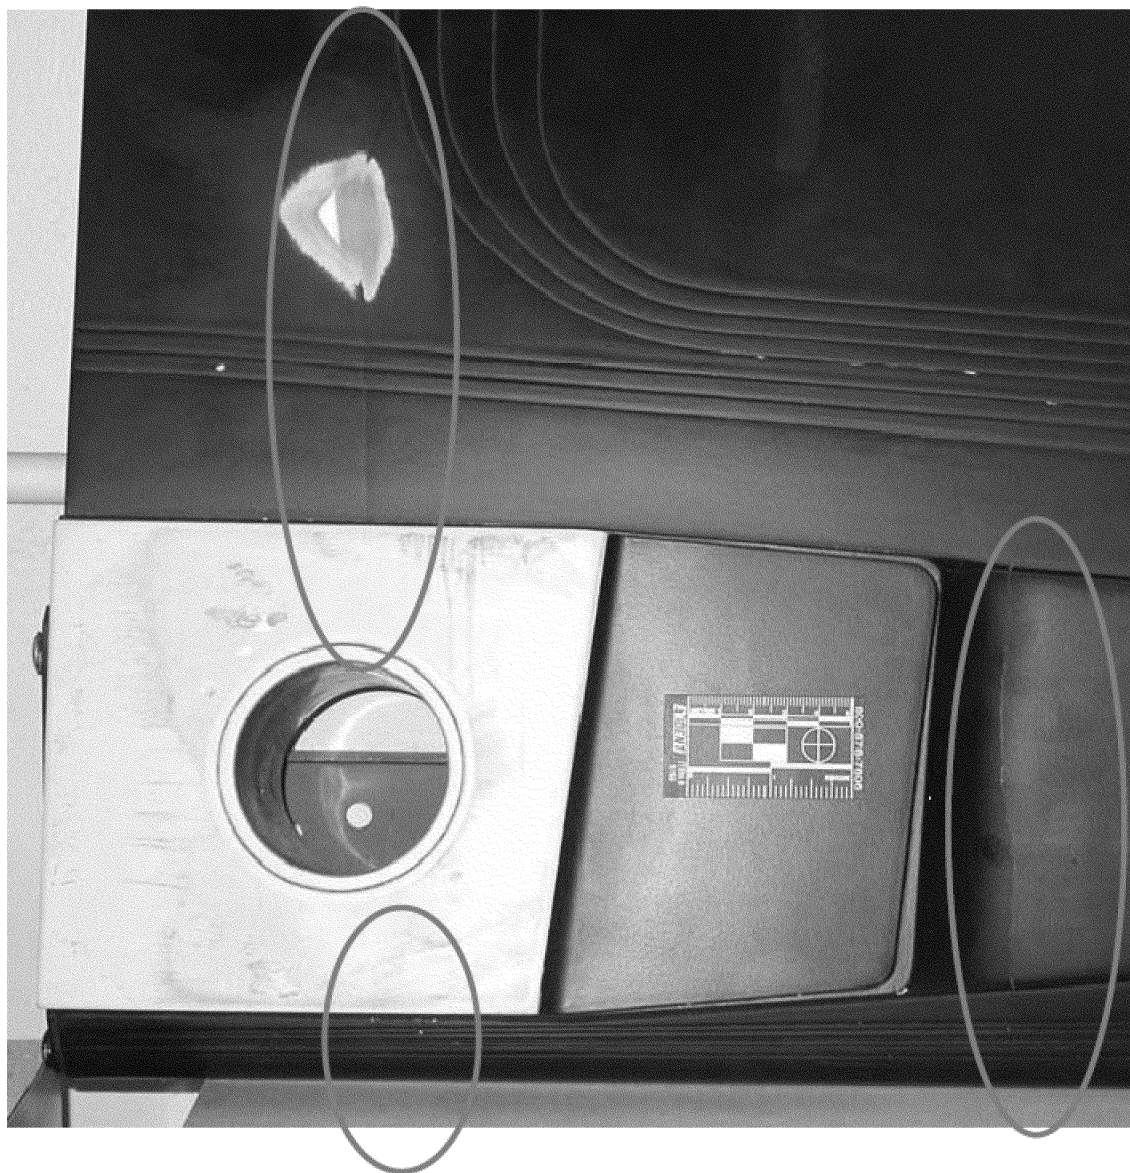
Note 2 to paragraph (e)(1)(ii): Crack indications on an actual M/R blade are shown in Figure 2 to Paragraph (e) of this AD.

(v) If there is a crack in any grip plate or doubler, replace the M/R blade with an airworthy M/R blade.

(vi) If there is a crack in the M/R blade skin, replace the M/R blade with an airworthy M/R blade, or repair the M/R blade if the damage is within the maximum repair damage limits.
