**[Docket No. FAA-2012-0008; Directorate Identifier 2011-NE-43-AD; Amendment 39-17115; AD 2012-14-01]**

#### **Airworthiness Directives; Rolls-Royce Deutschland Ltd & Co KG Turbofan Engines**

**2012–14–01 Rolls-Royce Deutschland Ltd & Co KG:** Amendment 39–17115; Docket No. FAA–2012–0008; Directorate Identifier 2011–NE–43–AD.

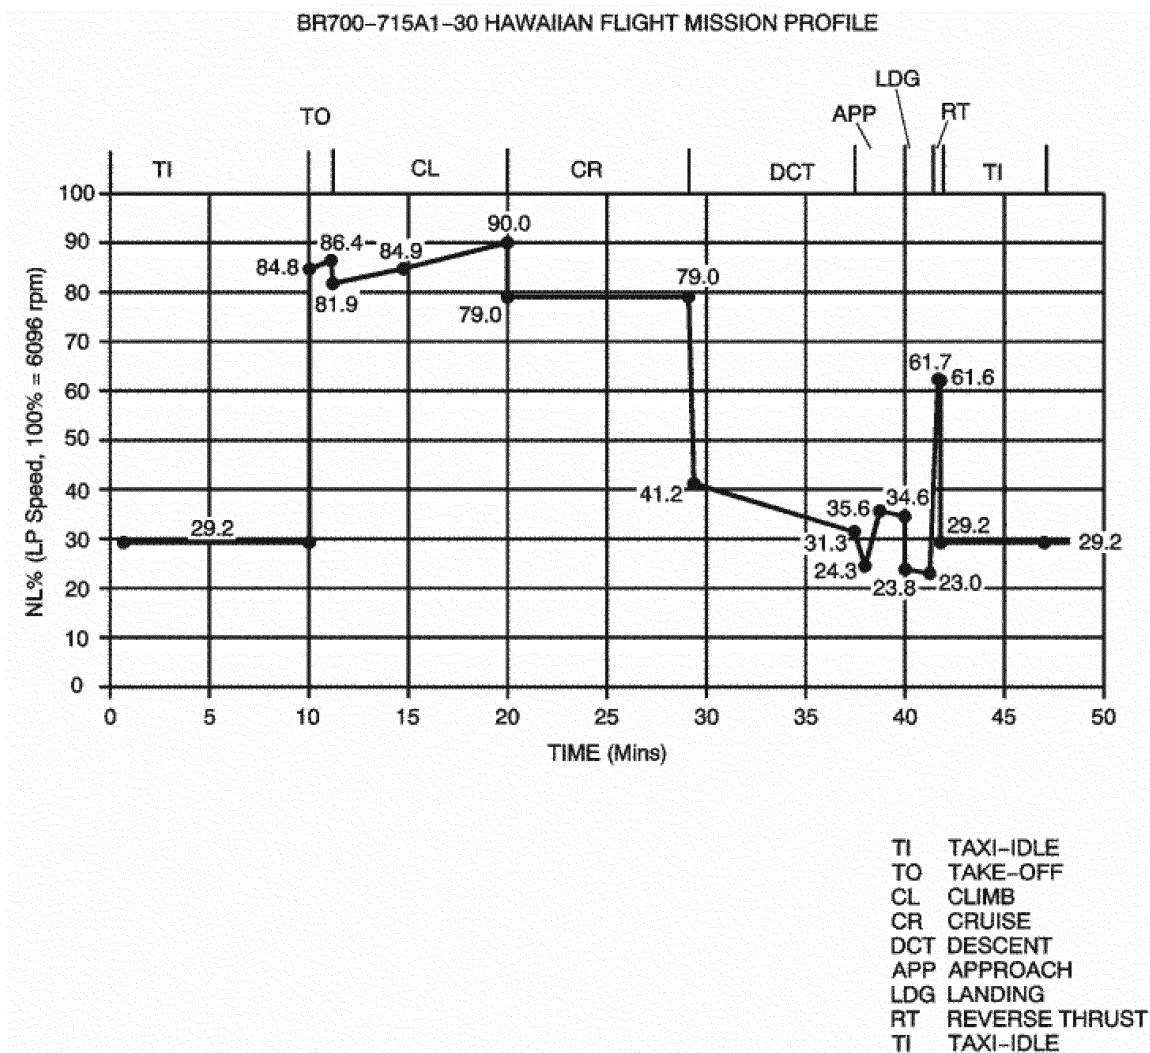
Figure 1 to paragraph (f)(2)

(2) The Hawaiian Flight Mission referenced in Table 1 to paragraph (e) is shown in Figure 1 to paragraph (f)(2):
