[Docket No. FAA-2012-1018; Directorate Identifier 2011-SW-052-AD; Amendment 39-17204; AD 2012-19-09]

#### Airworthiness Directives; Eurocopter France Helicopters

**SUMMARY:** We are adopting a new airworthiness directive (AD) for Eurocopter France (Eurocopter) Model EC 155B, EC155B1, SA-365N1, AS-365N2 and AS 365 N3 helicopters to require visually inspecting the tail rotor hub (TRH) for a crack and removing the TRH if a crack exists. This AD is prompted by reports of cracks on two TRHs. These actions are intended to prevent the tail rotor from jamming, which could lead to reduced or loss of control of the helicopter.

##### 2012-19-09 Eurocopter Helicopters:

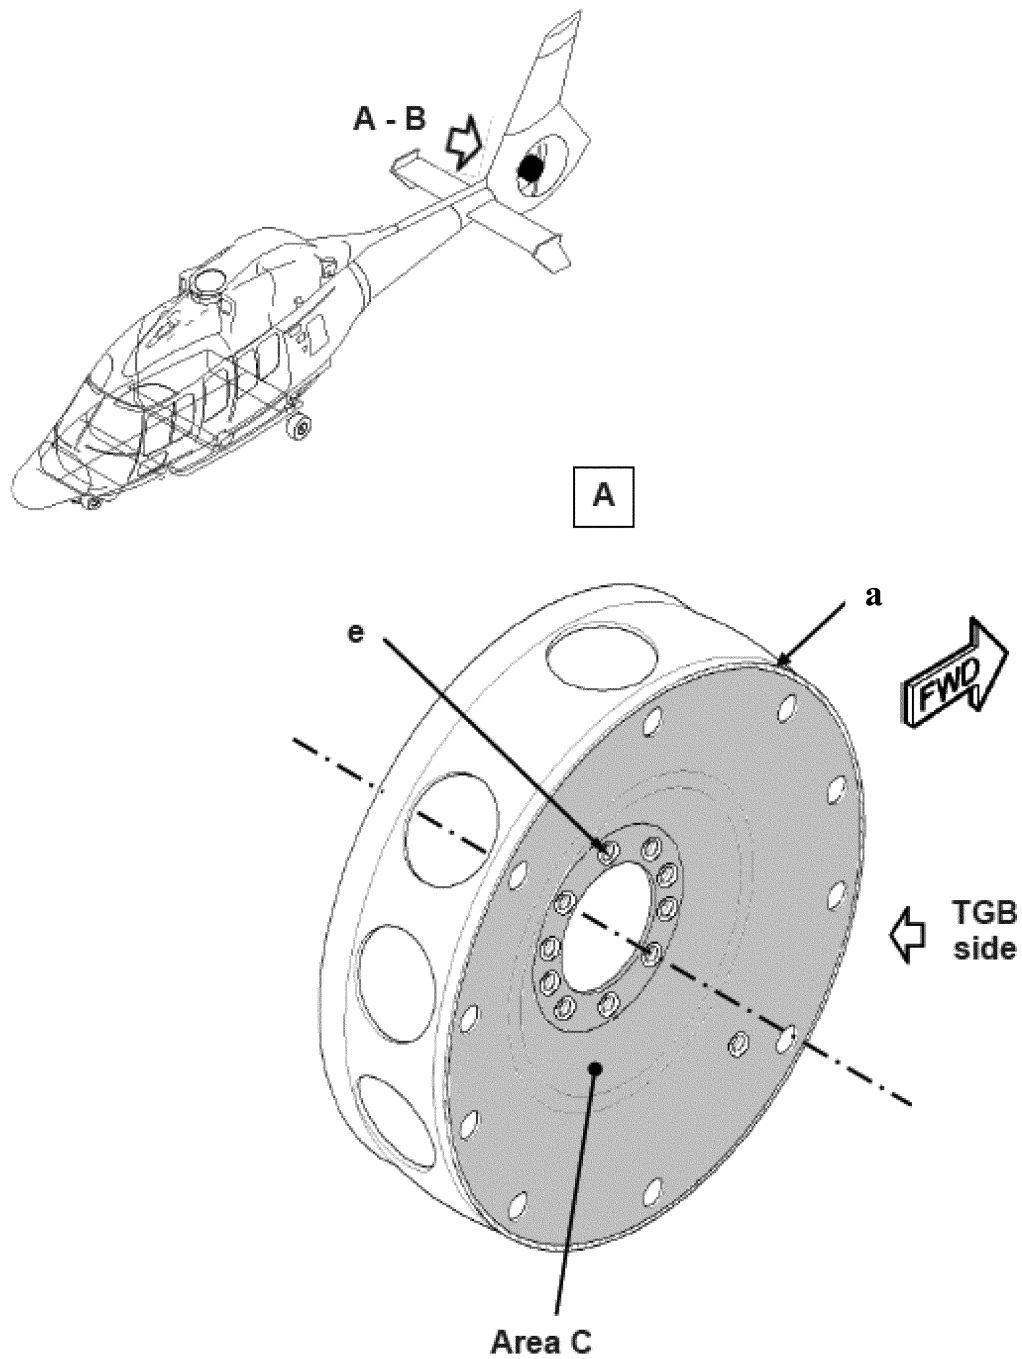
Figure 1 to Paragraph (e)(1) TRH Hub

(1) Within 55 hours time-in-service (TIS), and thereafter at intervals not to exceed 55 hours TIS, using a light, visually inspect the TRH for a crack in the entire area shown as Area C of the TRH (a) in Figure 1 to paragraph (e)(1) of this AD. The inspection area is on the tail gearbox (TGB) side of the TRH. The TGB is shown as (c) in Figures 2 and 3 to paragraph (e)(1) of this AD. You must pay particular attention to the area around the screws, shown as (e) in Figure 3 to paragraph (e)(1) of this AD, and the TRH between the lower part of the TGB and its fairing, shown as (d) in Figures 2 and 3 to paragraph (e)(1) of this AD, using details D and E of Figure 3 to paragraph (e)(1) of this AD. You must turn the tail rotor by hand to inspect the entire Area C.

(2) If there is a crack on the TRH, remove the TRH from service.
