[Docket No. FAA-2012-0060; Directorate Identifier 2012-NE-02-AD; Amendment 39-17123; AD 2012-14-09]

#### Airworthiness Directives; Pratt & Whitney (P&W) Division Turbofan Engines

**2012–14–09 Pratt & Whitney Division:**  
Amendment 39–17123; Docket No. FAA–2012–0060; Directorate Identifier 2012–NE–02–AD.

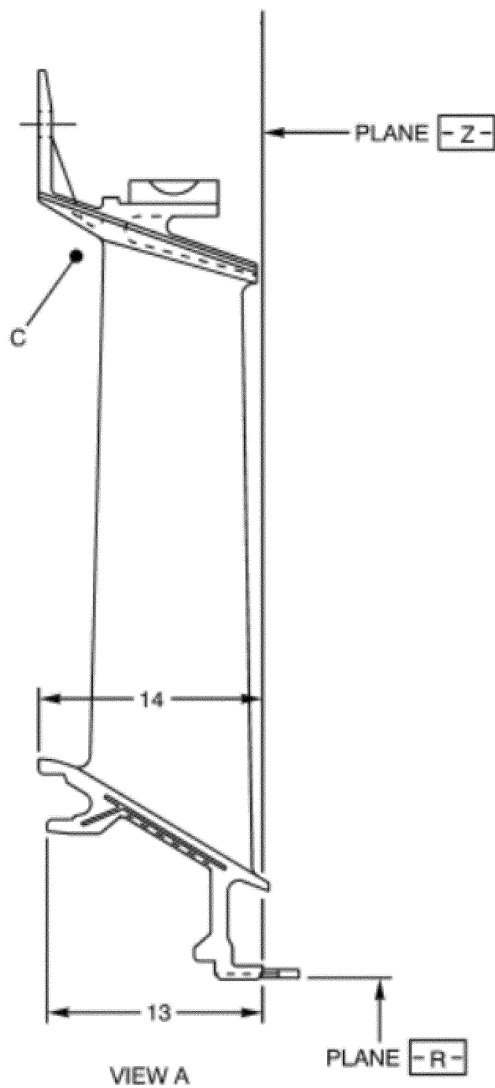
Figure 1 to Paragraph (e) - Determination of Vane Eligibility

(iii) Dimensionally examine index 13 through index 34 of the LPT 3rd stage vane cluster assembly. Use Table 2 to paragraph (e) of this AD and Figure 1, Figure 2, and

Figure 3 to paragraph (e) of this AD to determine whether the vane is eligible for installation.

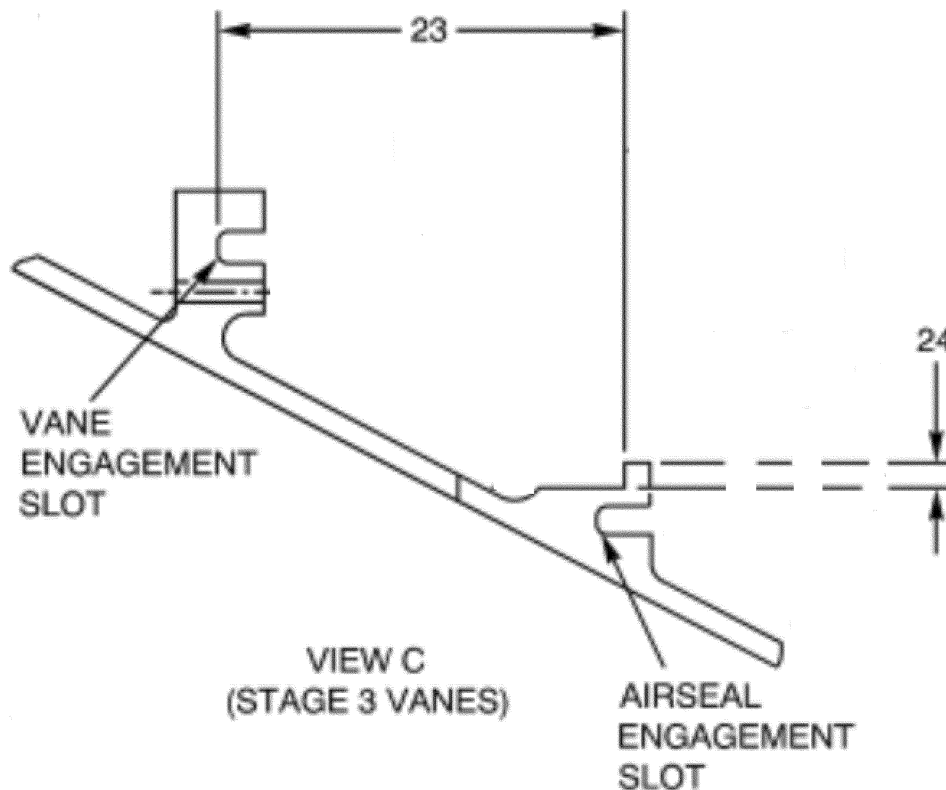
Figure 4 to Paragraph (e) - Determination of Case Eligibility

(iv) Dimensionally examine index 23 and index 24 of the vane engagement slots on the rear turbine case, where the 3rd stage vane is installed. Use Table 3 to paragraph (e) of this AD and Figure 4 to paragraph (e) of this AD to determine whether the case is eligible for installation.

Inspect:	Eligible for installation limits:
24 .....	0.097 inch (2.464 mm) minimum.

Inspect:	Eligible for installation limits:
23 .....	1.875 inch (47.625 mm) minimum.
