[Docket No. FAA-2012-1128; Directorate Identifier 2012-SW-064-AD; Amendment 39-17225; AD 2012-21-09]

Airworthiness Directives; Eurocopter France Helicopters

SUMMARY: We are adopting a new airworthiness directive (AD) for Eurocopter France (Eurocopter) Model EC225 helicopters with certain epicyclic modules installed. This AD requires inspecting the epicyclic module for the presence of a through-hole upstream of the magnetic plug. This AD is prompted by a report of a missing through-hole between the integrated collector and the magnetic plug, which would prevent the flow of chips from the integrated collector to the magnetic plug. This could result in the chip-detector system failing to detect deterioration of the main rotor mast lift bearing (lift bearing). These actions are intended to detect a missing through-hole and prevent lift bearing failure and subsequent loss of control of the helicopter.

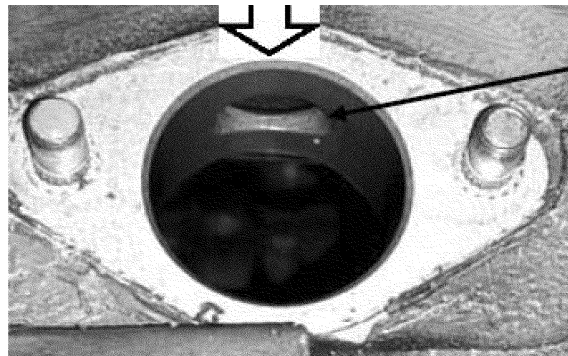
Figure 1 to paragraph (e)(1)(ii)

This AD defines the unsafe condition as a missing through-hole, joining the integrated collector to the magnetic plug. This condition could result in failure of the chip-detector system to detect deterioration of the main rotor mast lift bearing, failure of the lift bearing, and subsequent loss of control of the helicopter.

(ii) Determine if the hole above the magnetic plug is a through-hole as shown in figures 1 and 2 to paragraph (e)(1)(ii) of this AD.

(2) If the hole above the magnetic plug is not a through-hole, before further flight,

replace the epicyclic module with an airworthy epicyclic module.
