[Docket No. FAA-2012-1188; Directorate Identifier 2012-SW-049-AD; Amendment 39-17254; AD 2012-10-53]

**Airworthiness Directives; Eurocopter Deutschland GmbH Helicopters**

**2012–10–53 Eurocopter Deutschland GMBH (ECD):** Amendment 39–17254; Docket No. FAA–2012–1188; Directorate Identifier 2012–SW-049–AD.

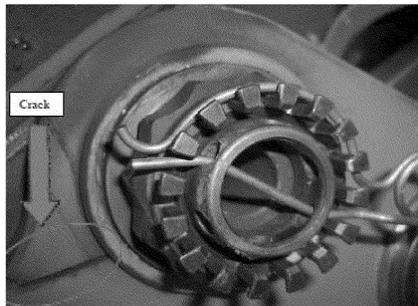
Figure 1 to Paragraph (f)(1)

(1) Before further flight, and thereafter at intervals not to exceed 6 hours time-in-service (TIS), check the MRH shaft lower flange and the visible area of the MRH shaft upper flange for a crack. Figures 1 and 2 to Paragraph (f)(1) of this AD are examples of cracks that have been discovered in the MRH shaft lower flange. The actions required by this paragraph may be performed by the owner/operator (pilot) holding at least a private pilot certificate, and must be entered into the aircraft records showing compliance with this AD in accordance with 14 CFR 43.9 (a)(1)-(4) and 14 CFR 91.417(a)(2)(v). The record must be maintained as required by 14 CFR 91.417, 121.380, or 135.439.

(3) If there is a crack in the upper or lower MRH shaft flange, before further flight, replace the MRH shaft. Replacing the MRH shaft with an MRH shaft having a part number listed in the applicability of this AD does not constitute terminating action for the requirements of this AD.

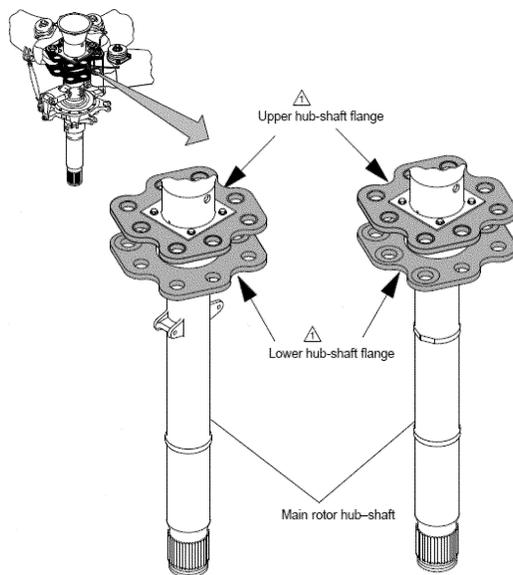
- (i) Remove rotor-hub cap.
- (ii) Clean the upper and lower MRH shaft flange as depicted in Figure 3 to Paragraph

(f)(2)(ii) of this AD and visually inspect for a crack.

⚠ Check visible area of the upper and lower hub-shaft flange.

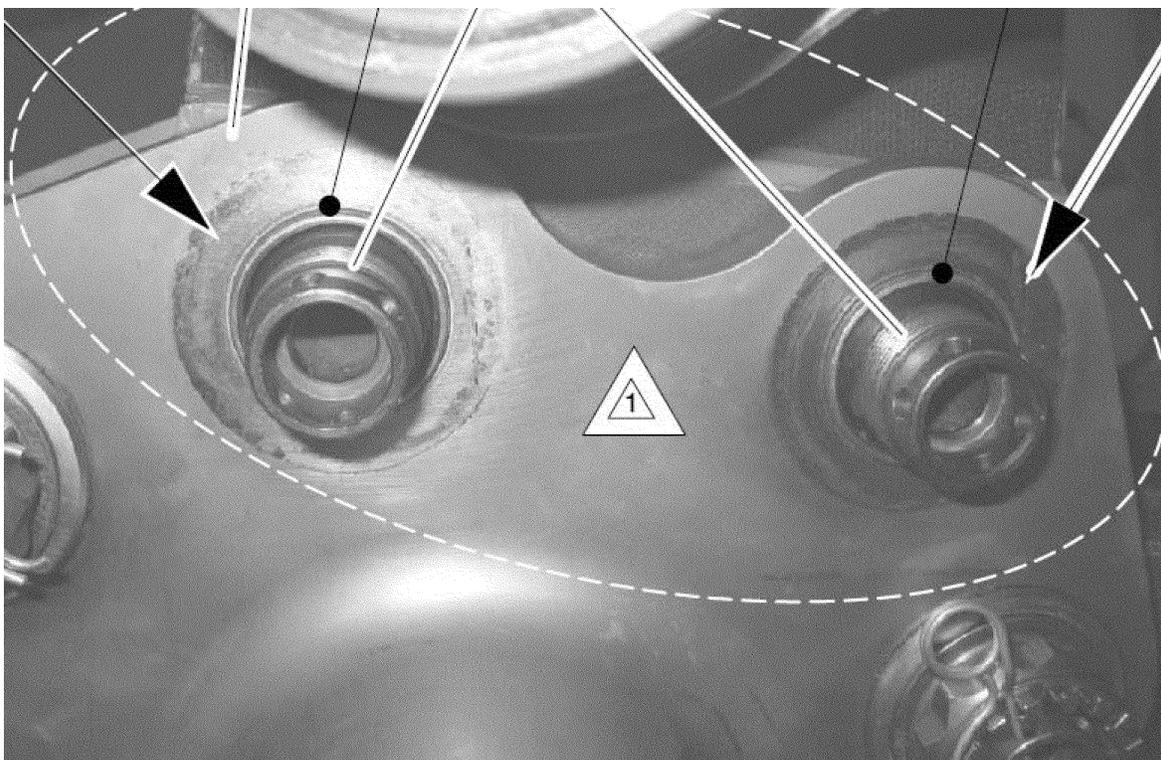
(iv) Clean the blade bolt attachment area.  
 (v) Using a 10X or higher power magnification, inspect all lower MRH shaft

flange blade bolt attachment areas for a crack as shown in Figure 4 to Paragraph (f)(2)(v) of this AD.
