[Docket No. FAA-2012-1135; Directorate Identifier 2012-SW-097-AD; Amendment 39-17281; AD 2012-21-52]

Airworthiness Directives; Agusta S.p.A. (Type Certificate Currently Held by AgustaWestland S.p.A.) (Agusta) Helicopters

SUMMARY: We are publishing a new airworthiness directive (AD) for Agusta Model AW139 helicopters, which was sent previously to all known U.S. owners and operators of these

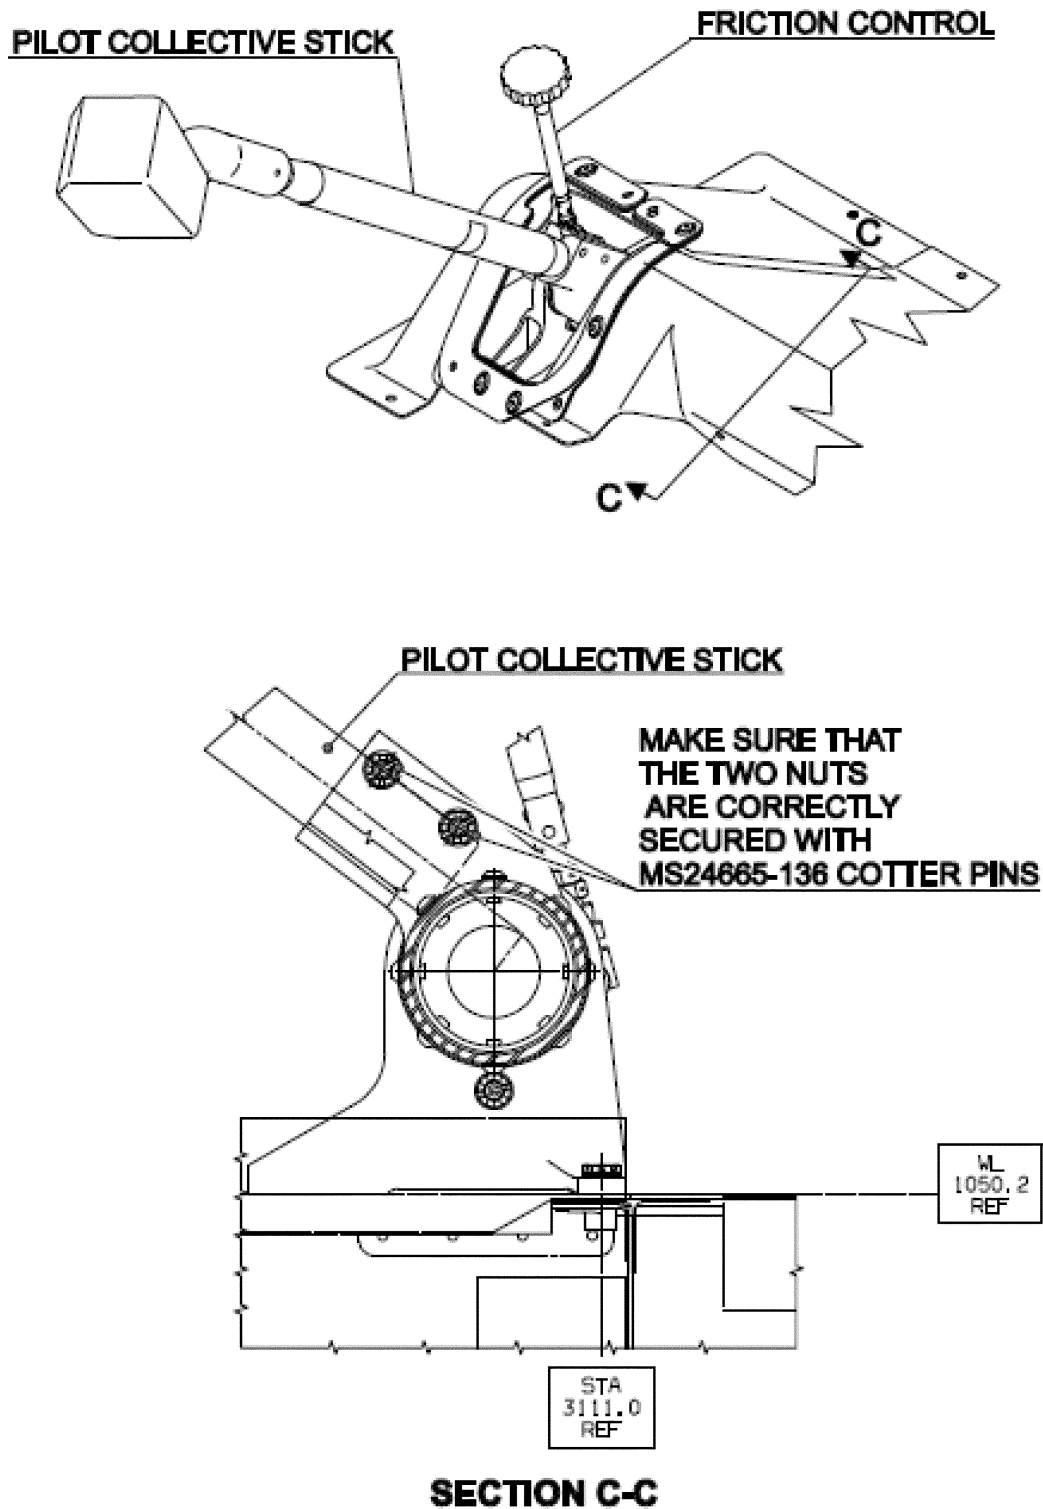
(1) Inspect the pilot collective stick installation to determine whether the self-locking nuts, part-number (P/N) MS17825–4, are secured with cotter pins, P/N MS24665–136, as depicted in Figure 1 to paragraph (e) of this AD. If the self-locking nuts are not secured with cotter pins, before further flight, reinstall the pilot collective stick.

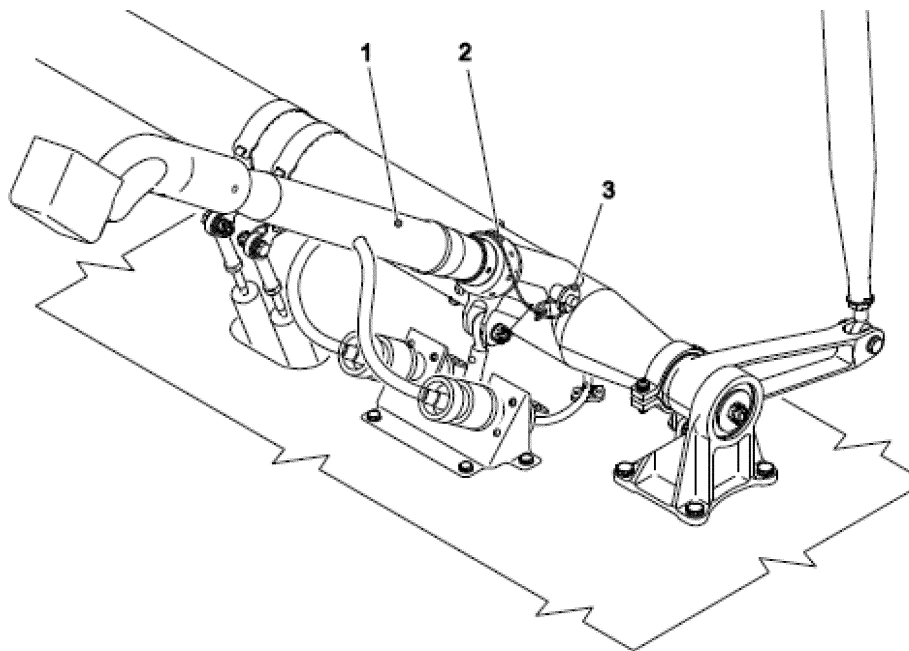
(2) Inspect the co-pilot collective stick installation to determine whether the ring nut (item 2) is loose and the quick-release pin

(item 3) is installed as depicted in Figure 2 to paragraph (e) of this AD. If the ring nut is loose or the quick-release pin is not installed,

before further flight, reinstall the co-pilot collective stick.

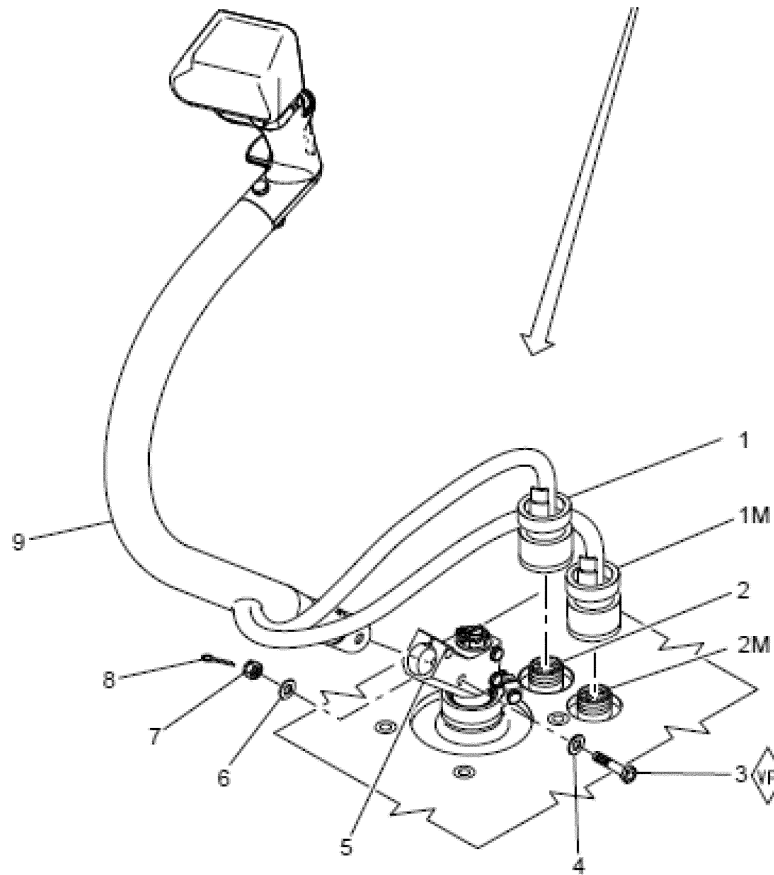
(3) Inspect the pilot cyclic stick installation for proper installation of the bolt (item 3), washer (item 4), self-locking nut (item 7),

washer (item 6), and the cotter pin (item 8), as depicted in Figure 3 to paragraph (e) of this AD. If the pilot cyclic stick is not

installed as depicted, before further flight, reinstall the pilot cyclic stick.

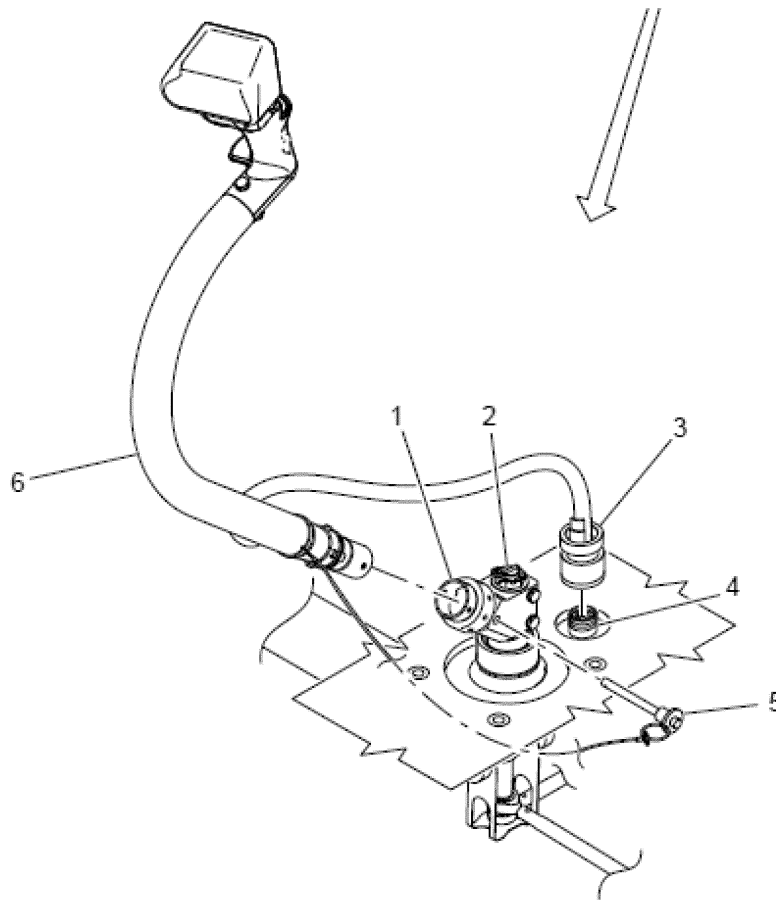
(4) Inspect the co-pilot cyclic stick installation to determine whether the ring nut (item 1) is loose and the quick-release pin

(item 5) is installed as depicted in Figure 4 to paragraph (e) of this AD. If the ring nut is loose or the quick-release pin is not installed

as depicted, before further flight, reinstall the co-pilot cyclic stick.
