Federal Register

Wednesday, January 16, 2013

[Docket No. FAA-2013-0023; Directorate Identifier 96-CE-072-AD]

Airworthiness Directives; Various Aircraft Equipped With Wing Lift Struts

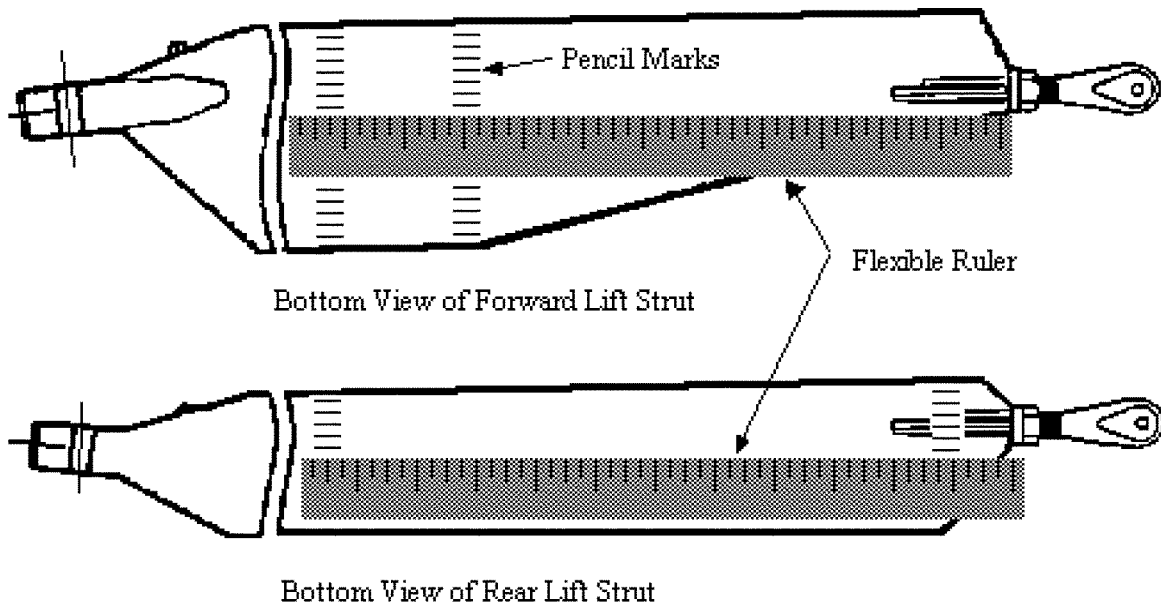
Figure 1

8. A measurement of 0.024-inch or less shall require replacement of the strut prior to further flight.

9. If at any time during testing an area is encountered where a valid thickness measurement cannot be obtained due to a loss of signal strength or quality, the area shall be considered suspect. These areas may have a remaining wall thickness of less than 0.020-inch, which is below the range of this setup, or they may have small areas of localized corrosion or pitting present. The latter case will result in a reduction in signal strength due to the sound being scattered from the rough surface and may result in a signal that includes echoes from the pits as well as the backwall. The suspect area(s) shall be tested with a Maule "Fabric Tester" as specified in Piper Service Bulletin No. 528D or 910A.
