[Docket No. FAA–2013–0146; Directorate Identifier 2012–SW–060–AD]

Airworthiness Directives; Agusta S.p.A. Helicopters

ACTION: Notice of proposed rulemaking (NPRM).

AGUSTA S.p.A. (Agusta); Docket No. FAA–2013–0146; Directorate Identifier 2012–SW–060–AD.

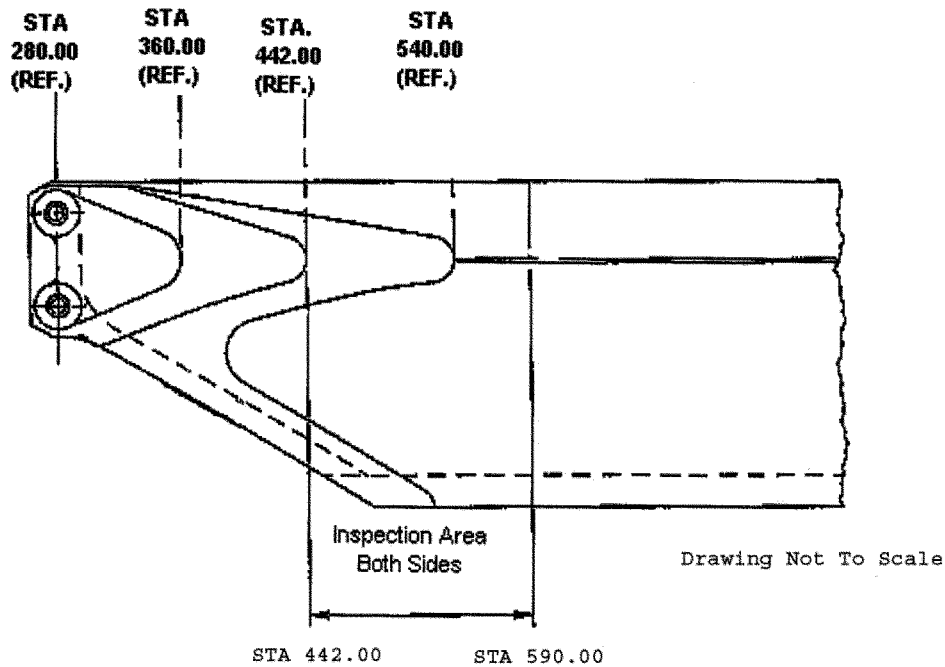
This AD defines the unsafe condition as a fatigue crack in a T/R blade. This condition could result in failure of the T/R blade and subsequent loss of control of the helicopter.

(1) Before each start of the helicopter engines, visually check both sides of each T/R blade for a crack in the inspection area depicted in Figure 1 to paragraph (f) of this AD. This action may be performed by the owner/operator (pilot) holding at least a private pilot certificate, and must be entered into the aircraft records showing compliance with this AD in accordance with 14 CFR 43.9 (a)(1)–(4) and 14 CFR 91.417(a)(2)(v). The record must be maintained as required by 14 CFR 91.173, 121.380, or 135.439.

Part Number 109-8132-01-111 Tail Rotor Blade

(5) If there is a crack in a T/R blade, before further flight, replace the cracked T/R blade.
