[Docket No. FAA-2012-0630; Directorate Identifier 2011-SW-010-AD; Amendment 39-17409; AD 2013-07-05]

Airworthiness Directives; Eurocopter France Helicopters

2013-07-05 Eurocopter France:

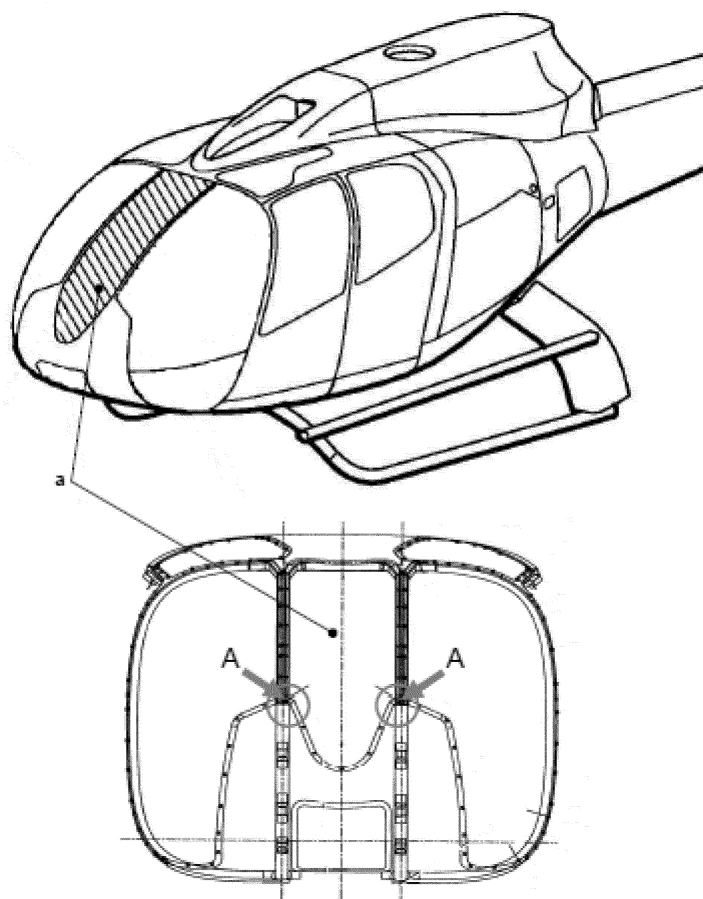
Figure 1 to Paragraph (e)(1)

This AD defines the unsafe condition as a crack in the blending radii of the center windshield, which could lead to failure of the center windshield, injury to the flight crew, and subsequent loss of control of the helicopter.

(1) Until the center windshield is replaced with center windshield P/N 350A25-9045-20, before each flight, visually check the center windshield for a crack in the area of the blending radii where the front-lower part of the center windshield joins the front fuselage as depicted in Figure 1 to paragraph (e)(1) of this AD. This visual check may be performed by the owner/operator (pilot) holding at least a private pilot certificate, and must be entered into the aircraft records showing compliance with this AD in accordance with Title 14 Code of Federal Regulations (14 CFR) 43.9 (a)(1)-(4) and 14 CFR 91.417(a)(2)(v). The record must be maintained as required by 14 CFR 91.417, 121.380, or 135.439.

(2) If there is a crack or if a pilot indicates that the center windscreen distorted during flight, before further flight, replace the center windscreen with an airworthy center windscreen, P/N 350A25-9045-20, in accordance with the Accomplishment Instructions, paragraphs 2.B.2.b. through 2.B.2.b.4., of Eurocopter Service Bulletin No. 56-003, Revision 0, dated November 16, 2010.

(3) Within 12 months, replace the center windscreen with an airworthy center windscreen, P/N 350A25-9045-20, in accordance with the instructions contained in paragraph (e)(2) of this AD.
