DEPARTMENT OF TRANSPORTATION

Federal Aviation Administration

[Docket No. FAA-2013-0340; Directorate Identifier 2010-SW-081-AD]

Airworthiness Directives; Eurocopter Deutschland GmbH Helicopters

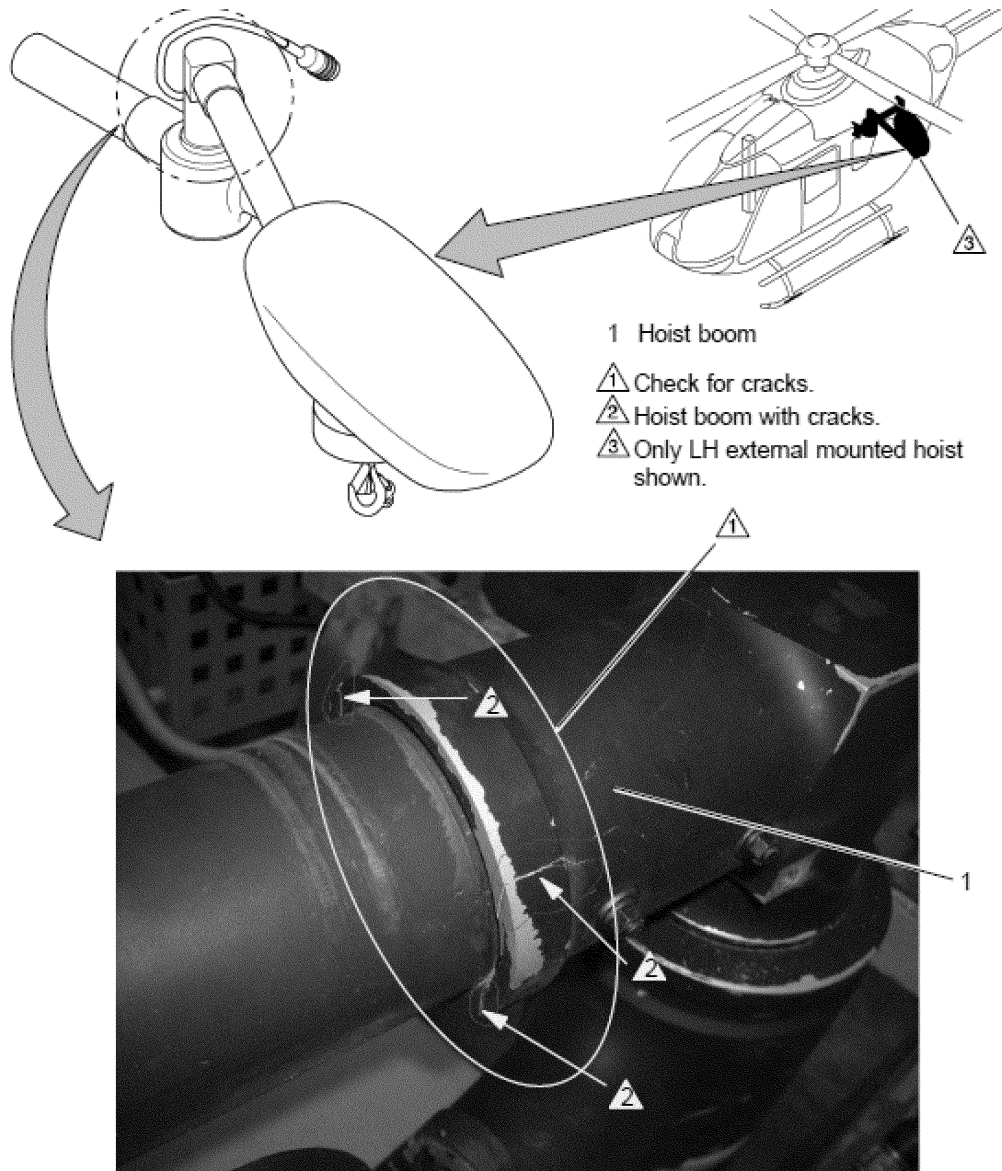
This AD defines the unsafe condition as a crack in the boom. This condition could result in loss of the boom and attached loads, and subsequent loss of helicopter control.

(1) Before further flight, and thereafter before the first flight of each day until you have performed the inspection required by paragraph (e)(2) of this AD, clean the hoist and visually check for a crack, paying particular attention to the areas that are circled as depicted in Figure 1 to paragraph (e) of this AD. The actions required by this paragraph may be performed by the owner/operator (pilot) holding at least a private pilot certificate, and must be entered into the aircraft records showing compliance with this AD in accordance with 14 CFR 43.9 (a)(1)-(4) and 14 CFR 91.417 (a)(2)(v). The record must be maintained as required by 14 CFR 91.417, 121.380, or 135.439.

(2) Within 30 days, perform a dye penetrant inspection of the boom in accordance with the Accomplishment Instructions, Section 2.D, of the Goodrich Service Bulletin 44307-500-03, Revision 2, dated April 30, 2010 (SB).

(3) If a crack exists in the boom, replace the cracked boom with an airworthy boom before further flight.
