[Docket No. FAA-2012-1297; Directorate Identifier 2012-SW-100-AD; Amendment 39-17285; AD 2012-25-04]

Airworthiness Directives; Eurocopter France Helicopters

2012–25–04 Eurocopter France:

This AD defines the unsafe condition as severe vibrations due to failure of laminated half-bearings (bearings). This condition could result in failure of the tail rotor and subsequent loss of control of the helicopter.

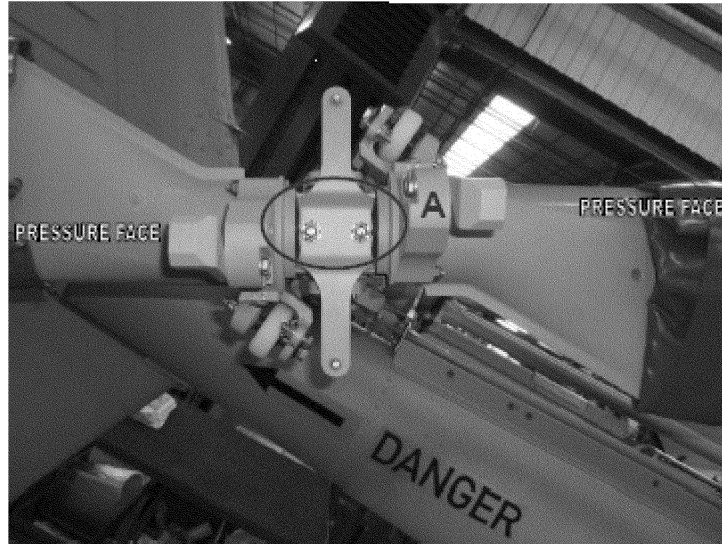
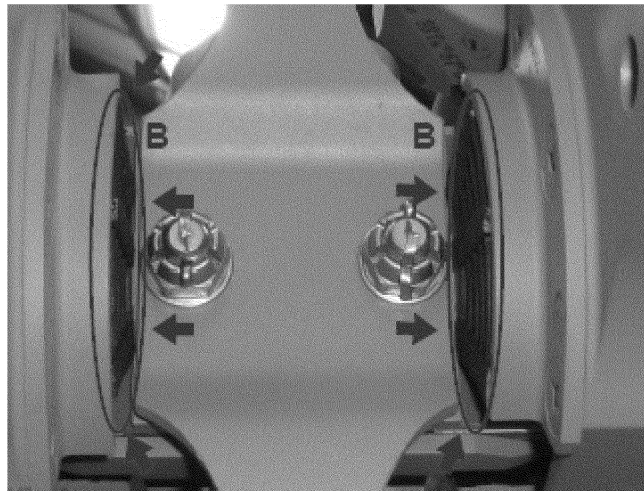
- (i) Position both tail rotor blades horizontally.
- (ii) Apply load (F) by hand, perpendicular to the pressure face of one tail rotor blade (a), as shown in Figure 1 to paragraph (f) of this AD, taking care not to reach the extreme position against the tail rotor hub. The load will deflect the tail rotor blade towards the tail boom.
- (iii) While maintaining the load, check all the visible faces of the bearings (front and side faces) in area B of DETAIL A of Figure 1 to paragraph (f) of this AD for separation between the elastomer and metal parts, a crack in the elastomer, or an extrusion (see example in Figure 2 to paragraph (f) of this AD). A flashlight may be used to enhance the check.

(5) If there is an extrusion on any bearing, before further flight, replace the four bearings with airworthy bearings.

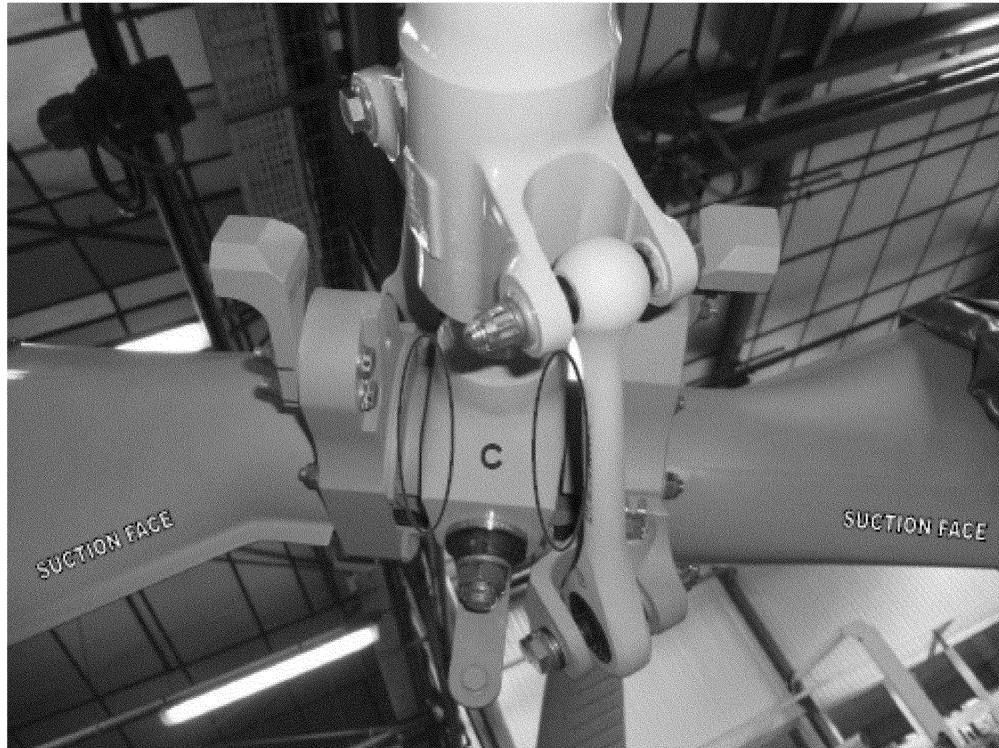
(v) Apply load (G) by hand perpendicular to the suction face of one tail rotor blade as shown in Figure 3 to paragraph (f) of this AD.

(vi) While maintaining the load, check visible faces of Area C as shown in Figure 3 to paragraph (f) of this AD for any extrusion. A flashlight may be used to enhance the check.

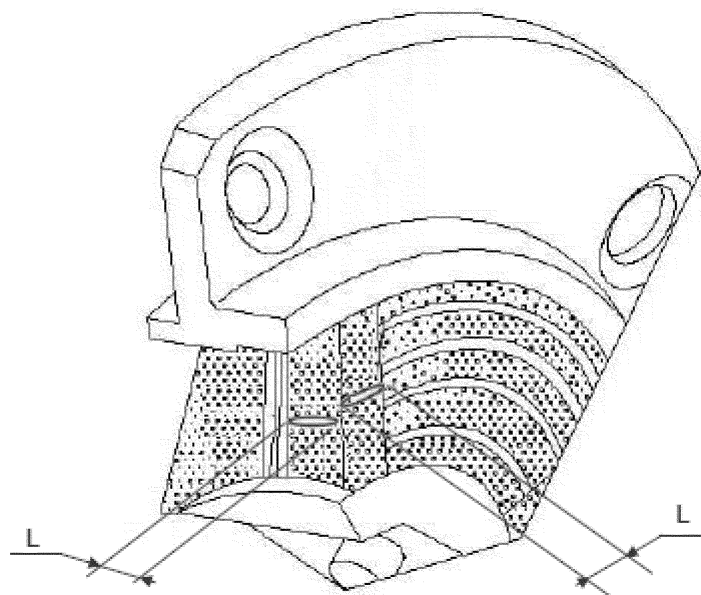
Figure 4 to paragraph (f)

(6) If there is a separation or a crack on the pressure side bearing, measure the separation or the crack. If the separation or crack is greater than 5 millimeters (.196 inches) as indicated by dimension “L” in Figure 4 to paragraph (f), before further flight, replace the four bearings with airworthy bearings.
