Federal Register

Monday, May 6, 2013

[Docket No. FAA-2011-1231; Directorate Identifier 2011-NM-088-AD; Amendment 39-17418; AD 2013-08-01]

Airworthiness Directives; The Boeing Company Airplanes

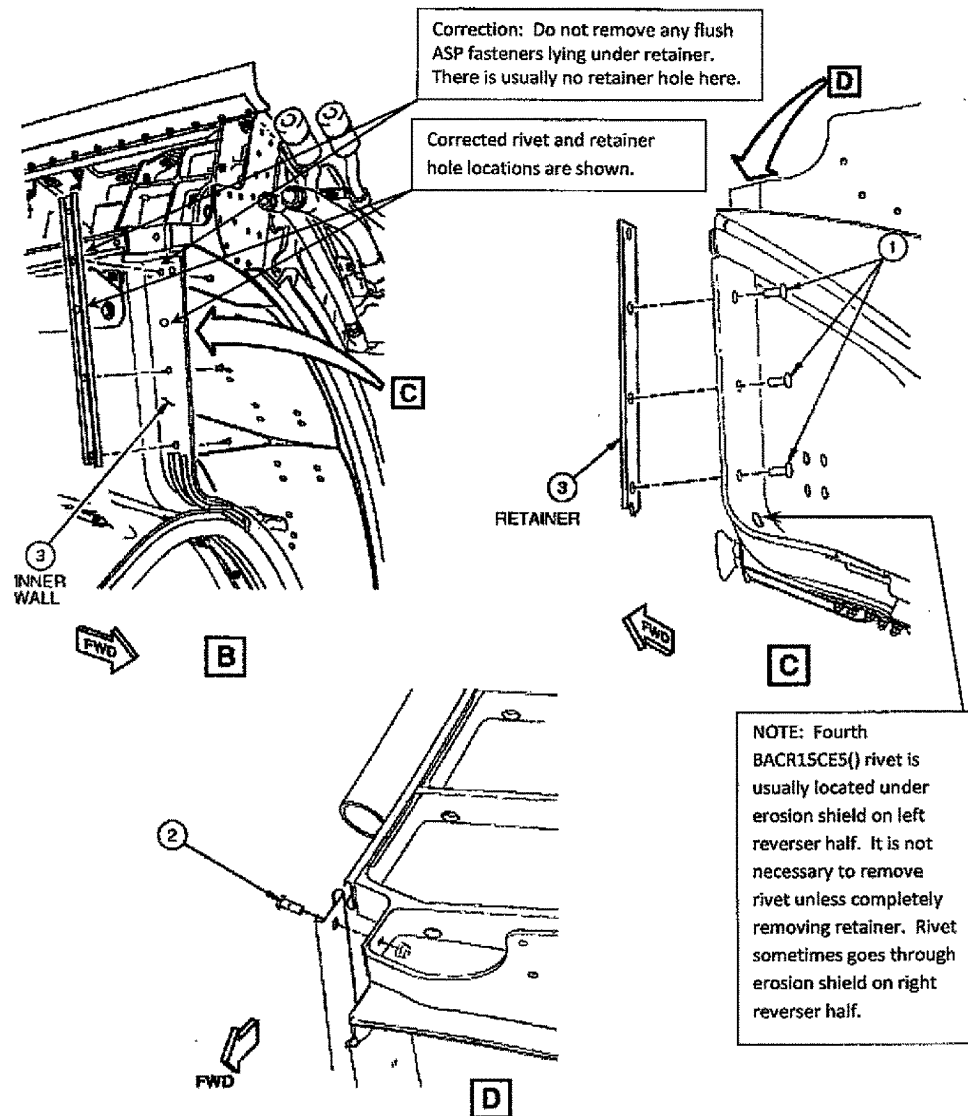
Figure 1, Fastener Removal of the Retainer Support on the Left Thrust Reverser Half

(2) Figures 1 and 3 of this AD, titled “Fastener Removal of the Retainer Support on the Left (Right) Thrust Reverser Half,” have View B showing the top fastener in the center of three adjustable sustained preload (ASP) fasteners. That top fastener does not require removal in order to remove the retainer. The figures in this AD point to the correct information for those fasteners.
