[Docket No. FAA-2013-0486; Directorate Identifier 2010-SW-031-AD]

Airworthiness Directives; MD Helicopters, Inc. (MDHI), Helicopters

ACTION: Notice of proposed rulemaking (NPRM).

MD Helicopters, Inc. (MDHI): Docket No. FAA–2013–0486; Directorate Identifier 2010–SW–031–AD.

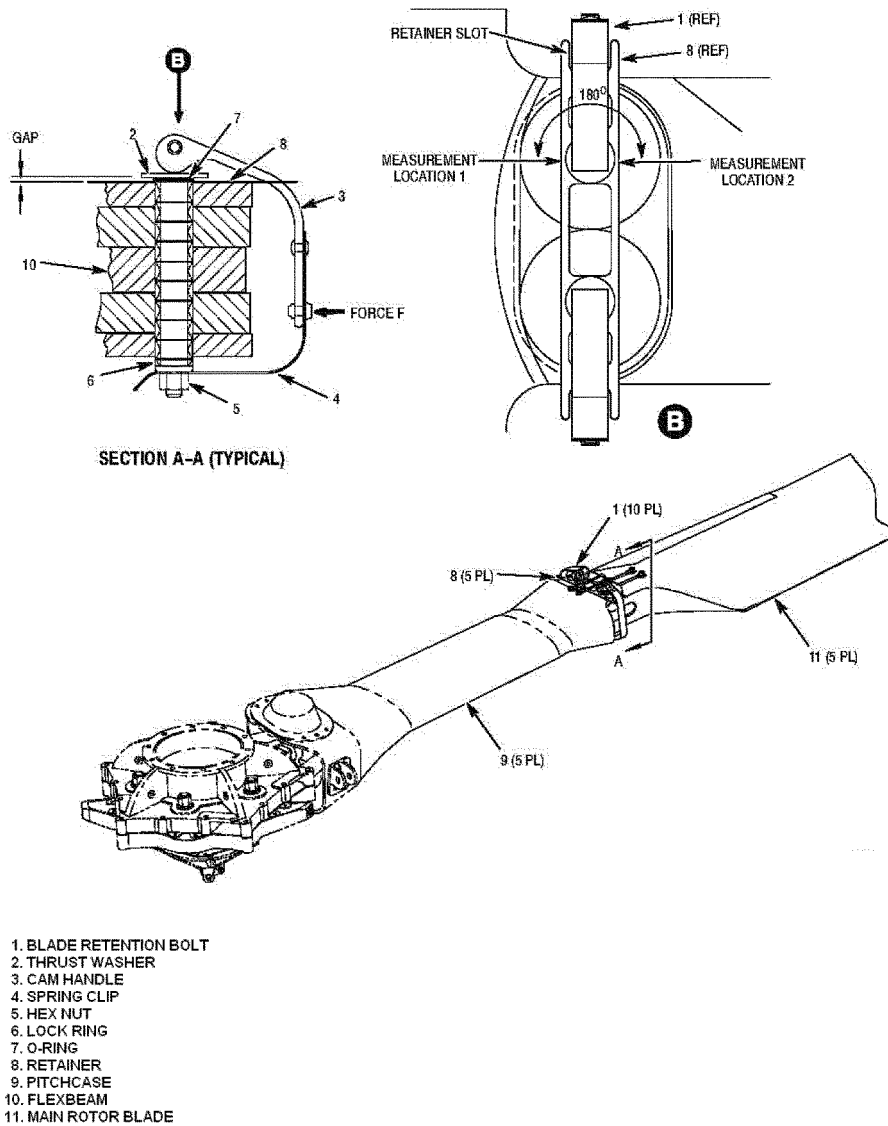
Figure 1 to paragraph (e) of this AD

- (1) Before the first flight of each day:
 - (i) Visually check each bolt for failure. Failure of a bolt may be indicated by movement of the bolt out of the bolt hole or by inconsistent extension of the bolt above or below the other bolts being inspected (a failed bolt migrates out of the bolt hole).
 - (ii) Visually check for a gap between the thrust washer and the retainer, P/N 900R2100009–101 or –103. The thrust washer is depicted as item 2 and the retainer is depicted as item 8 in Figure 1 to paragraph (e) of this AD.

Gap and Force Check of the Blade Retention Bolts

(iv) If there is any indication of bolt failure or if there is no gap between the thrust washer and retainer, before further flight, remove and inspect the bolt for a crack.

Replace any cracked bolt with an airworthy bolt.

(iii) If there is a gap between the thrust washer and retainer, measure the gap in two locations, 180 degrees apart, with a feeler gage. If the gap is more than 0.100 inch (2.54 mm) at either location, before further flight, remove and inspect the bolt for a crack. Replace any cracked bolt with an airworthy bolt.
