[Docket No. FAA-2013-0019; Directorate Identifier 2010-SW-051-AD; Amendment 39-17485; AD 2013-12-07]

#### Airworthiness Directives; Bell Helicopter Textron Canada Helicopters

**SUMMARY:** We are adopting a new airworthiness directive (AD) for Bell

Helicopter Textron Canada (BHTC) Model 407 helicopters with certain tailboom assemblies installed. This AD requires, at specified intervals, inspecting the tailboom assembly for a crack, loose rivet, or other damage. This AD was prompted by a stress analysis of the tailboom skin that revealed that high-stress-concentration areas are susceptible to skin cracking. This condition, if not detected, could result in a crack in the tailboom assembly, failure of the tailboom, and subsequent loss of control of the helicopter.

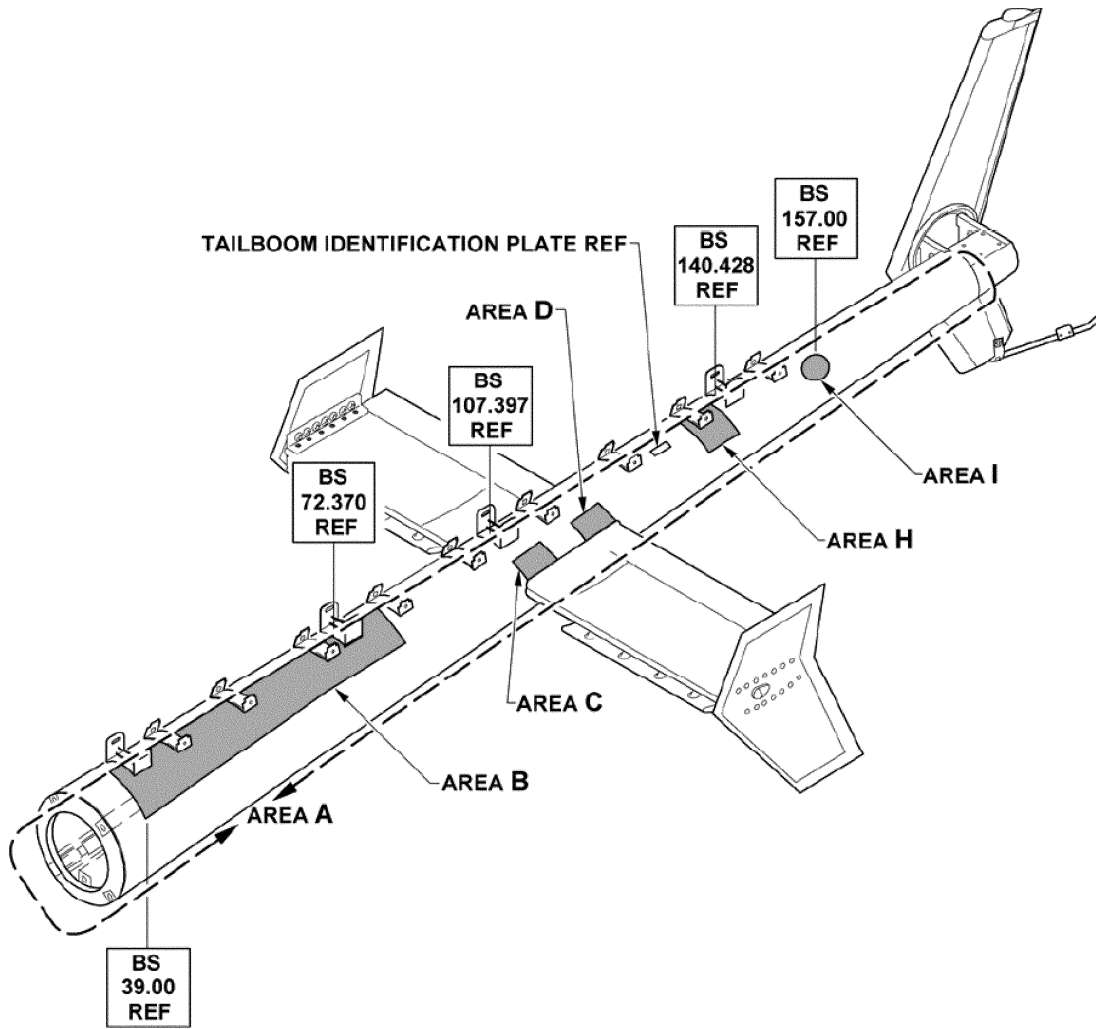
Figure 1 to Paragraph (e)

This AD defines the unsafe condition as high-stress-concentration areas in the tailboom skin that are at risk of cracking. This condition could result in a crack in the tailboom assembly, failure of the tailboom, and subsequent loss of helicopter control.

(A) Before the first flight of each day, visually check for a crack in the "C" and "D" areas depicted in Figures 1 and 2 to Paragraph (e) of this AD. The actions required by this paragraph may be performed by the owner/operator (pilot) holding at least a private pilot certificate, and must be entered into the aircraft records showing compliance with this AD in accordance with 14 CFR 43.9 (a)(1)-(4) and 14 CFR § 91.417(a)(2)(v). The record must be maintained as required by 14 CFR 91.417, 121.380, or 135.439; or

(5) If there is a crack in the tailboom assembly, before further flight, replace it with an airworthy tailboom assembly.

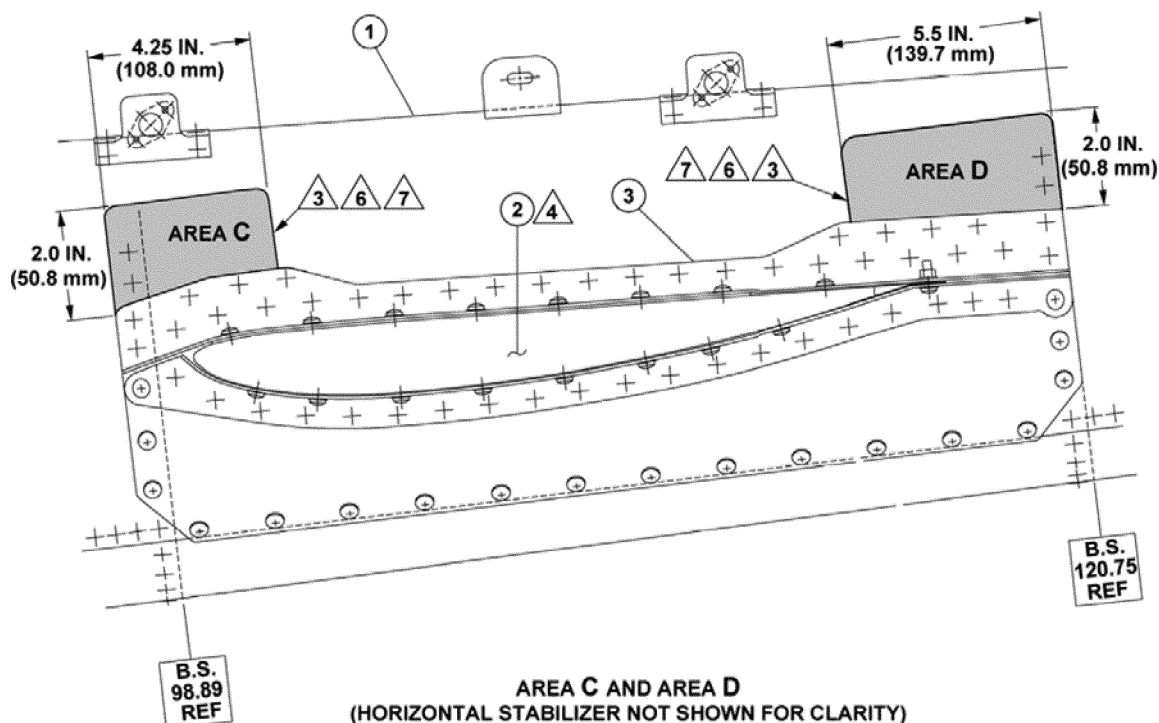
(B) Within 25 hours TIS, or 30 days, whichever comes first, and thereafter at intervals not to exceed 50 hours TIS, clean and inspect for a crack around each fastener and just above the edge of the upper stabilizer support in the "C" and "D" areas on the left side of the tailboom assembly, as depicted in Figure 2 to Paragraph (e) of this AD, using a 10X or higher power magnifying glass.
