[Docket No. FAA-2013-0695; Directorate
Identifier 2011-NM-264-AD]

Airworthiness Directives; Saab AB, Saab Aerosystems Airplanes

ACTION: Notice of proposed rulemaking
(NPRM).

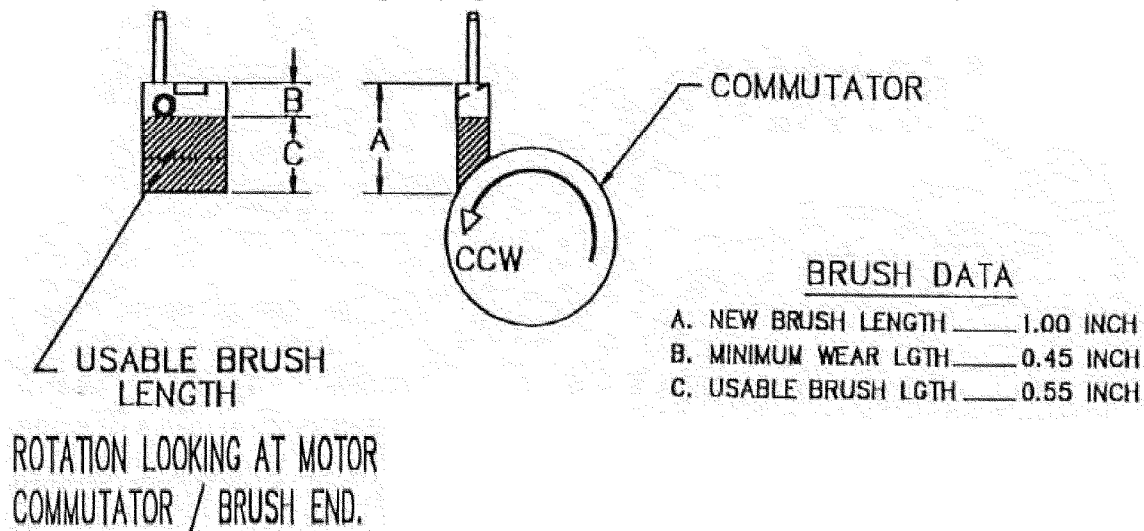
Figure 1 to paragraph (m)(2)(vii) of this AD – Measuring the Brush

(vii) Measure each brush as shown in figure below and record values.

(viii) Using the brush with the shortest measured length calculate the wear by subtracting the measured value from 1.000 inch.

(11) Install each new brush set by lifting brush springs, sliding brush into holder (with brush leading edge in direction of motor rotation) and lightly releasing the brush spring on the brush. (See Figure 1 to paragraph (m)(2)(vii) of this AD). CAUTION: Do not allow brush spring to strike hard into place or damage to brush may result.

(ix) Replace brushes in accordance with the instructions specified in paragraphs (j)(9) through (j)(23) of this AD.
