DEPARTMENT OF TRANSPORTATION

Federal Aviation Administration

[Docket No. FAA-2013-0822; Directorate Identifier 2013-SW-004-AD]

Airworthiness Directives; Eurocopter France Helicopters

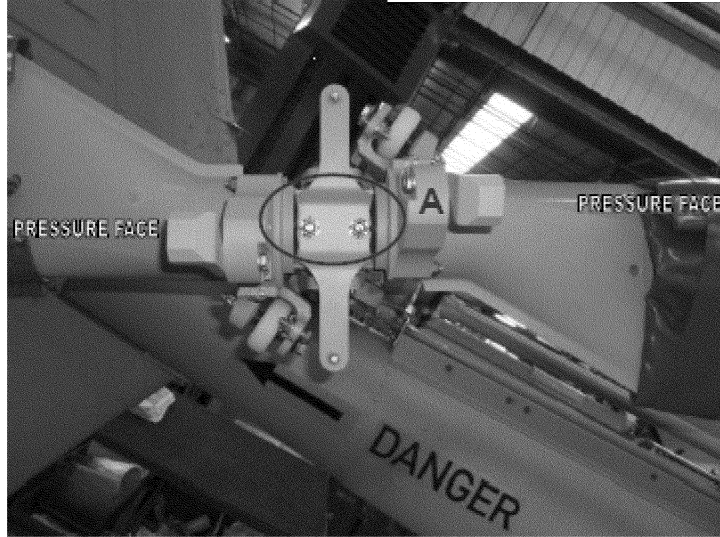
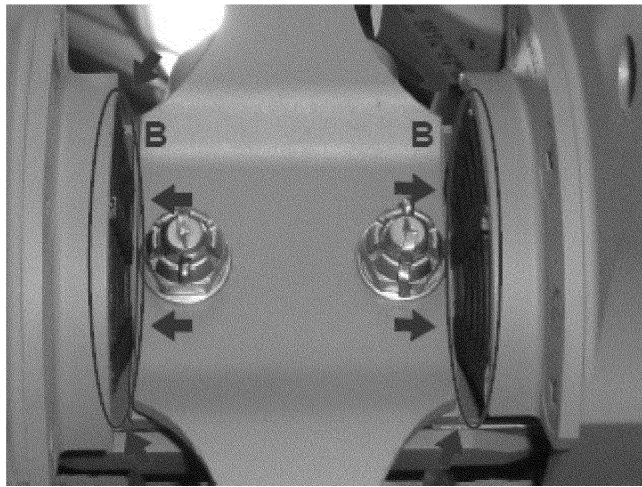
(B) Apply load (F) by hand, perpendicular to the pressure face of one tail rotor blade (a), as shown in Figure 1 to paragraph (f) of this AD, taking care not to reach the extreme position against the tail rotor hub. The load will deflect the tail rotor blade towards the tail boom.

(C) While maintaining the load, check all the visible faces of the bearings (front and side faces) in area B of DETAIL A of Figure 1 to paragraph (f) of this AD for separation between the elastomer and metal parts, a crack in the elastomer, or an extrusion (see example in Figure 2 to paragraph (f) of this AD). A flashlight may be used to enhance the check.

(v) If there is an extrusion on any bearing, before further flight, replace the four bearings with airworthy bearings.

(vi) If there is a separation or a crack on the pressure side bearing, measure the separation or the crack. If the separation or crack is greater than 5 millimeters (.196 inches) as indicated by dimension “L” in Figure 4 to paragraph (f) of this AD, before further flight, replace the four bearings with airworthy bearings.

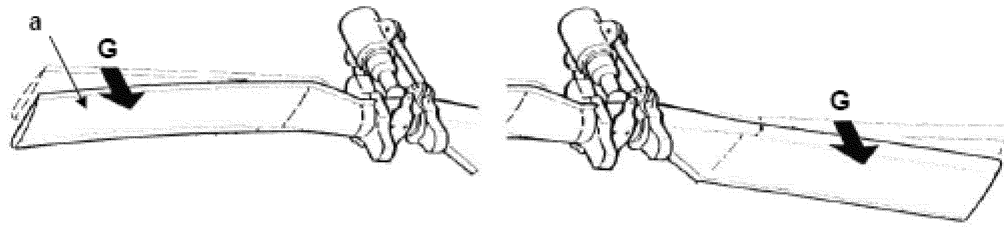
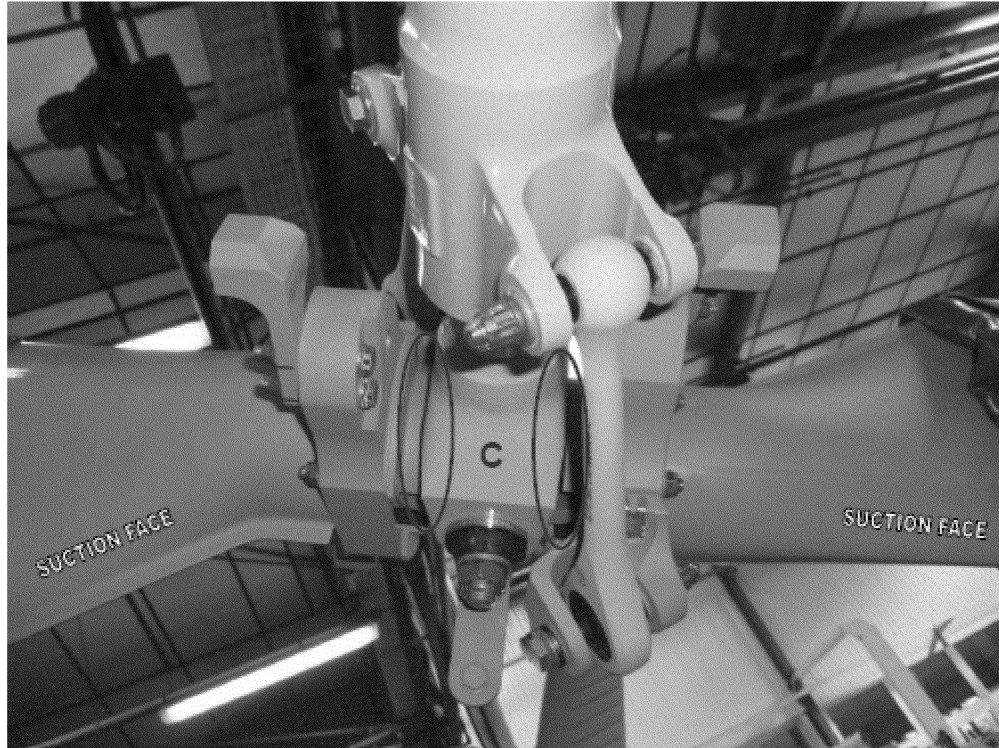
(E) Apply load (G) by hand perpendicular to the suction face of one tail rotor blade as shown in Figure 3 to paragraph (f) of this AD.

(F) While maintaining the load, check visible faces of Area C as shown in Figure 3 to paragraph (f) of this AD for any extrusion. A flashlight may be used to enhance the check.
