[Docket No. FAA-2013-0146; Directorate Identifier 2012-SW-060-AD; Amendment 39-17559; AD 2013-16-21]

Airworthiness Directives; Agusta S.p.A. (Type Certificate Currently Held by Agusta Westland S.p.A) (Agusta) Helicopters

ACTION: Final rule.

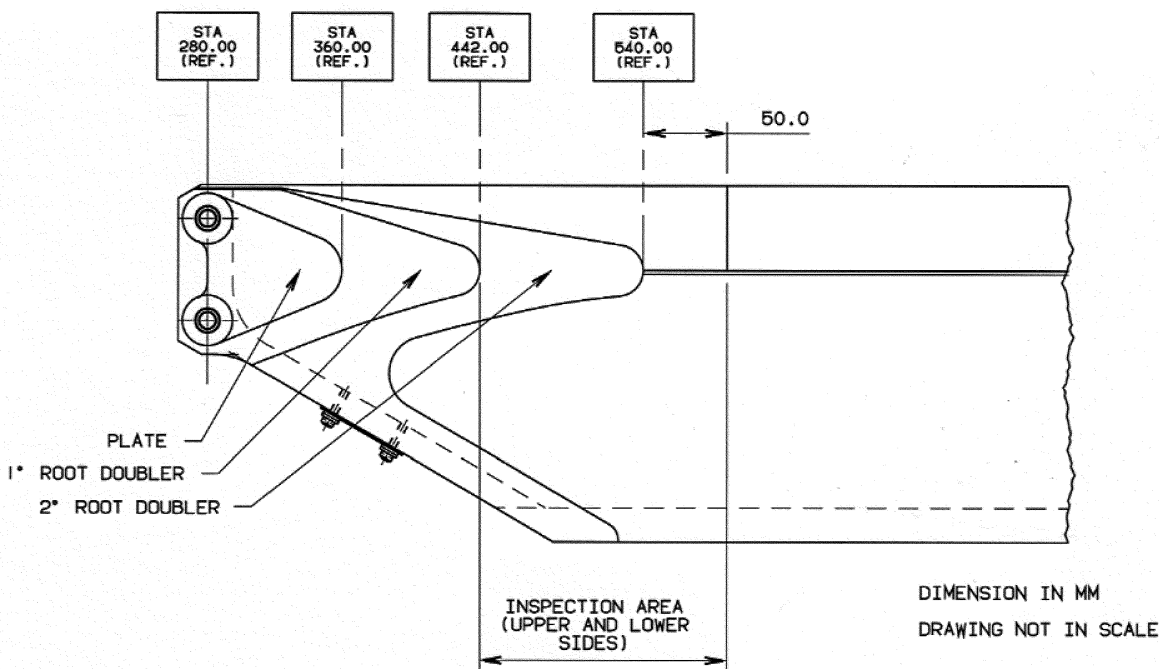
Figure 1 to Paragraph (f)(1), T/R Blade, P/N 109-8132-01-111

This AD defines the unsafe condition as a fatigue crack in a T/R blade. This condition could result in failure of the T/R blade and subsequent loss of control of the helicopter.

(1) Before each start of the helicopter engines, visually check both sides of each T/R blade for a crack in the inspection area depicted in Figure 1 to paragraph (f)(1) of this AD. This action may be performed by the owner/operator (pilot) holding at least a private pilot certificate, and must be entered into the aircraft records showing compliance with this AD in accordance with 14 CFR 43.9 (a)(1)-(4) and 14 CFR 91.417(a)(2)(v). The record must be maintained as required by 14 CFR 91.417, 121.380, or 135.439.

(5) If there is a crack in a T/R blade, before further flight, replace the cracked T/R blade.
