#### Airworthiness Directives; Eurocopter France Helicopters

**ACTION:** Notice of proposed rulemaking (NPRM).

**Eurocopter France:** Docket No. FAA-2011-1158; Directorate Identifier 2010-SW-018-AD.

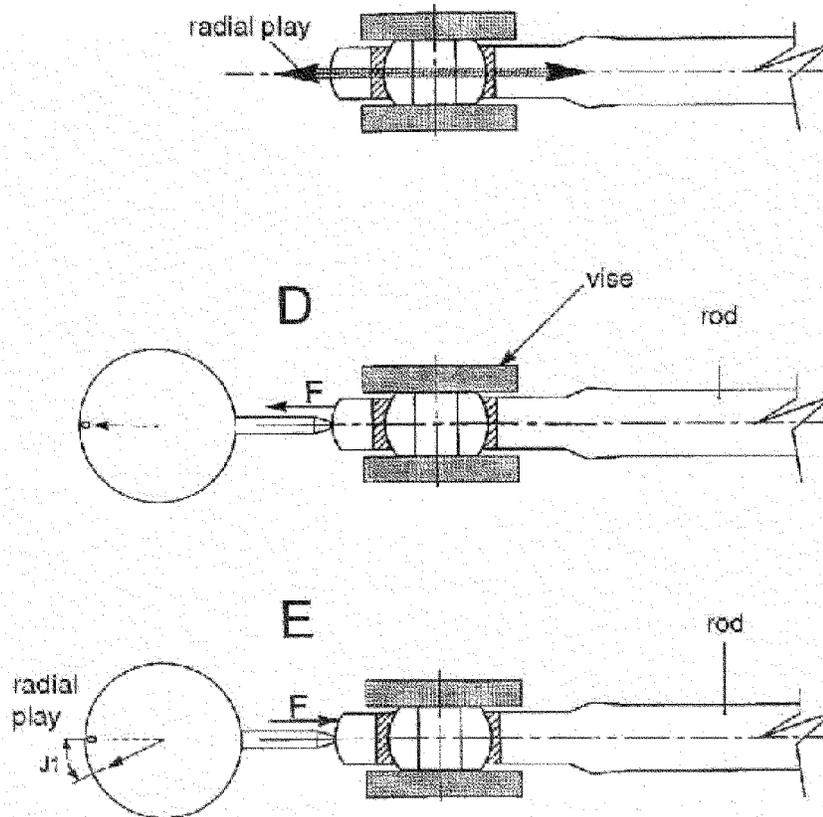
Figure (3) to Paragraph (f)

Measurement of the Radial Play (R) of the Bearing

(vi) Using a dial indicator, take radial play measurements by moving the control rod in the direction F as shown in Figure 3 to Paragraph (f) of this AD.

(viii) If the radial play exceeds 0.008 inch or axial play exceeds 0.016 inch, replace the control rod with an airworthy control rod before further flight.
