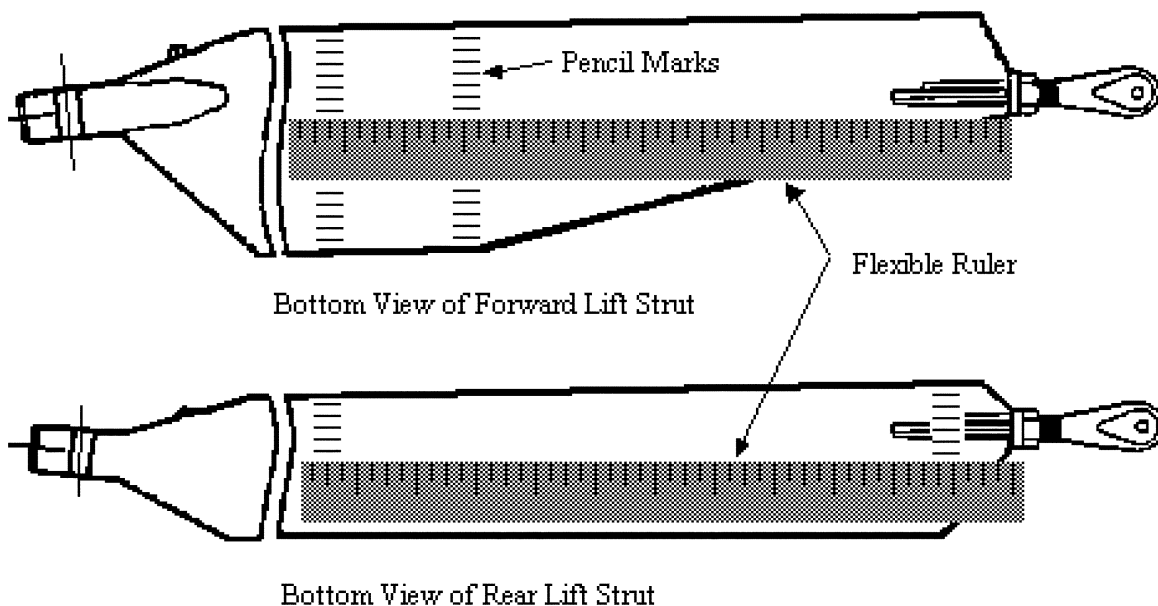
Figure 1

• NOTE: The strut wall contains a fabrication bead at approximately 40% of the strut chord. The bead may interfere with accurate measurements in that specific location.

shall be considered suspect. These areas may have a remaining wall thickness of less than 0.020-inch, which is below the range of this setup, or they may have small areas of localized corrosion or pitting present. The latter case will result in a reduction in signal strength due to the sound being scattered from the rough surface and may result in a signal that includes echoes from the pits as well as the backwall. The suspect area(s) shall be tested with a Maule "Fabric Tester" as specified in Piper SB No. 528D, dated October 19, 1990, or Piper SB No. 910A, dated October 10, 1989.

8. A measurement of 0.024-inch or less shall require replacement of the strut prior to further flight.
