[Docket No. FAA–2013–0725; Directorate Identifier 98–CE–01–AD; Amendment 39–17690; AD 98–15–18 R1]

Airworthiness Directives; Maule Aerospace Technology, Inc. Airplanes

SUMMARY: We are revising Airworthiness Directive (AD) 98–15–18 that applies to certain Maule Aerospace Technology, Inc. Models M–4, M–5, M–6, M–7, MT–7, MX–7, MXT–7, and M–8 airplanes that are equipped with rear wing lift struts, part number (P/N) 2079E, and/or front wing lift struts, P/N 2080E. AD 98–15–18 required repetitively inspecting certain wing lift struts for internal corrosion and replacing of any wing lift strut where corrosion was found. Since we issued AD 98–15–18, we were informed by the manufacturer that Model MXT–7–420 airplanes are no longer in existence, are no longer type certificated, and should be removed from the Applicability section. We were also informed that paragraph (b) in AD 98–15–18 had been misinterpreted and caused confusion. This AD removes Model MXT–7–420 airplanes from the Applicability section and clarifies the intent of the language in paragraph (b) of AD 98–15–18. This AD also retains all other requirements of AD 98–15–18. We are issuing this AD to correct the unsafe condition

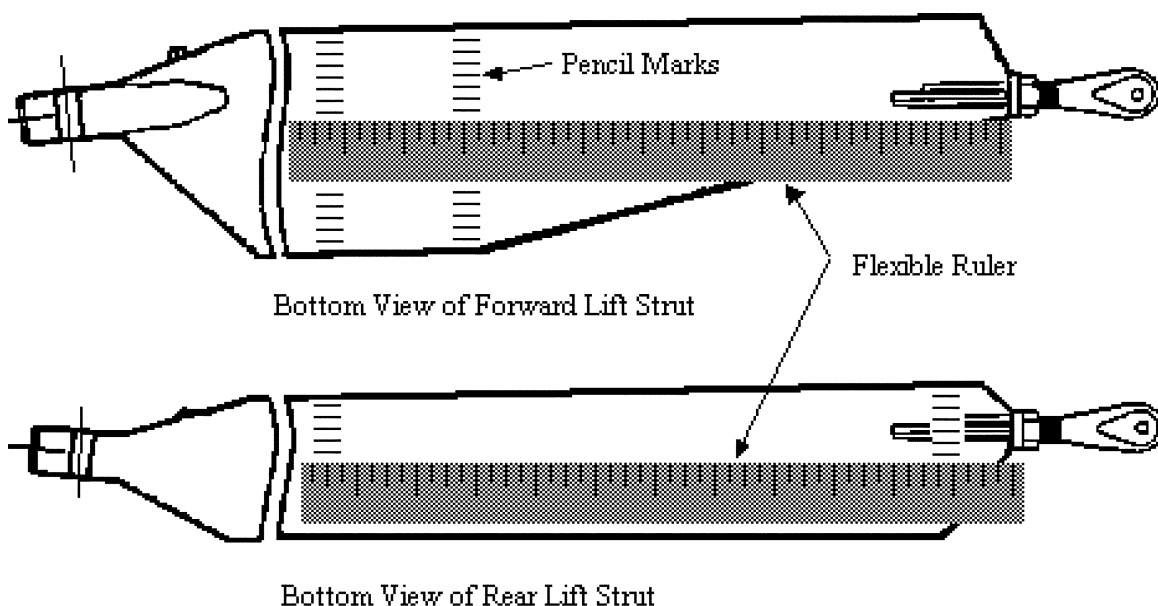
Figure 1

8. A measurement of 0.024 inch or less shall require replacement of the strut prior to further flight.

9. If at any time during testing an area is encountered where a valid thickness measurement cannot be obtained due to a loss of signal strength or quality, the area shall be considered suspect. These areas may have a remaining wall thickness of less than 0.020-inch, which is below the range of this setup, or they may have small areas of localized corrosion or pitting present. The latter case will result in a reduction in signal strength due to the sound being scattered from the rough surface and may result in a signal that includes echoes from the pits as well as the backwall. The suspect area(s) shall be tested with a Maule "Fabric Tester" as specified in Maule Air, Inc. Service Bulletin No. 11, dated October 30, 1995.
