[Docket No. FAA-2013-0340; Directorate Identifier 2010-SW-081-AD; Amendment 39-17630; AD 2013-21-06]

Airworthiness Directives; Eurocopter Deutschland GmbH Helicopters

2013-21-06 Eurocopter Deutschland GmbH Helicopters: Amendment 39-17630; Docket No. FAA-2013-0340; Directorate Identifier 2010-SW-081-AD.

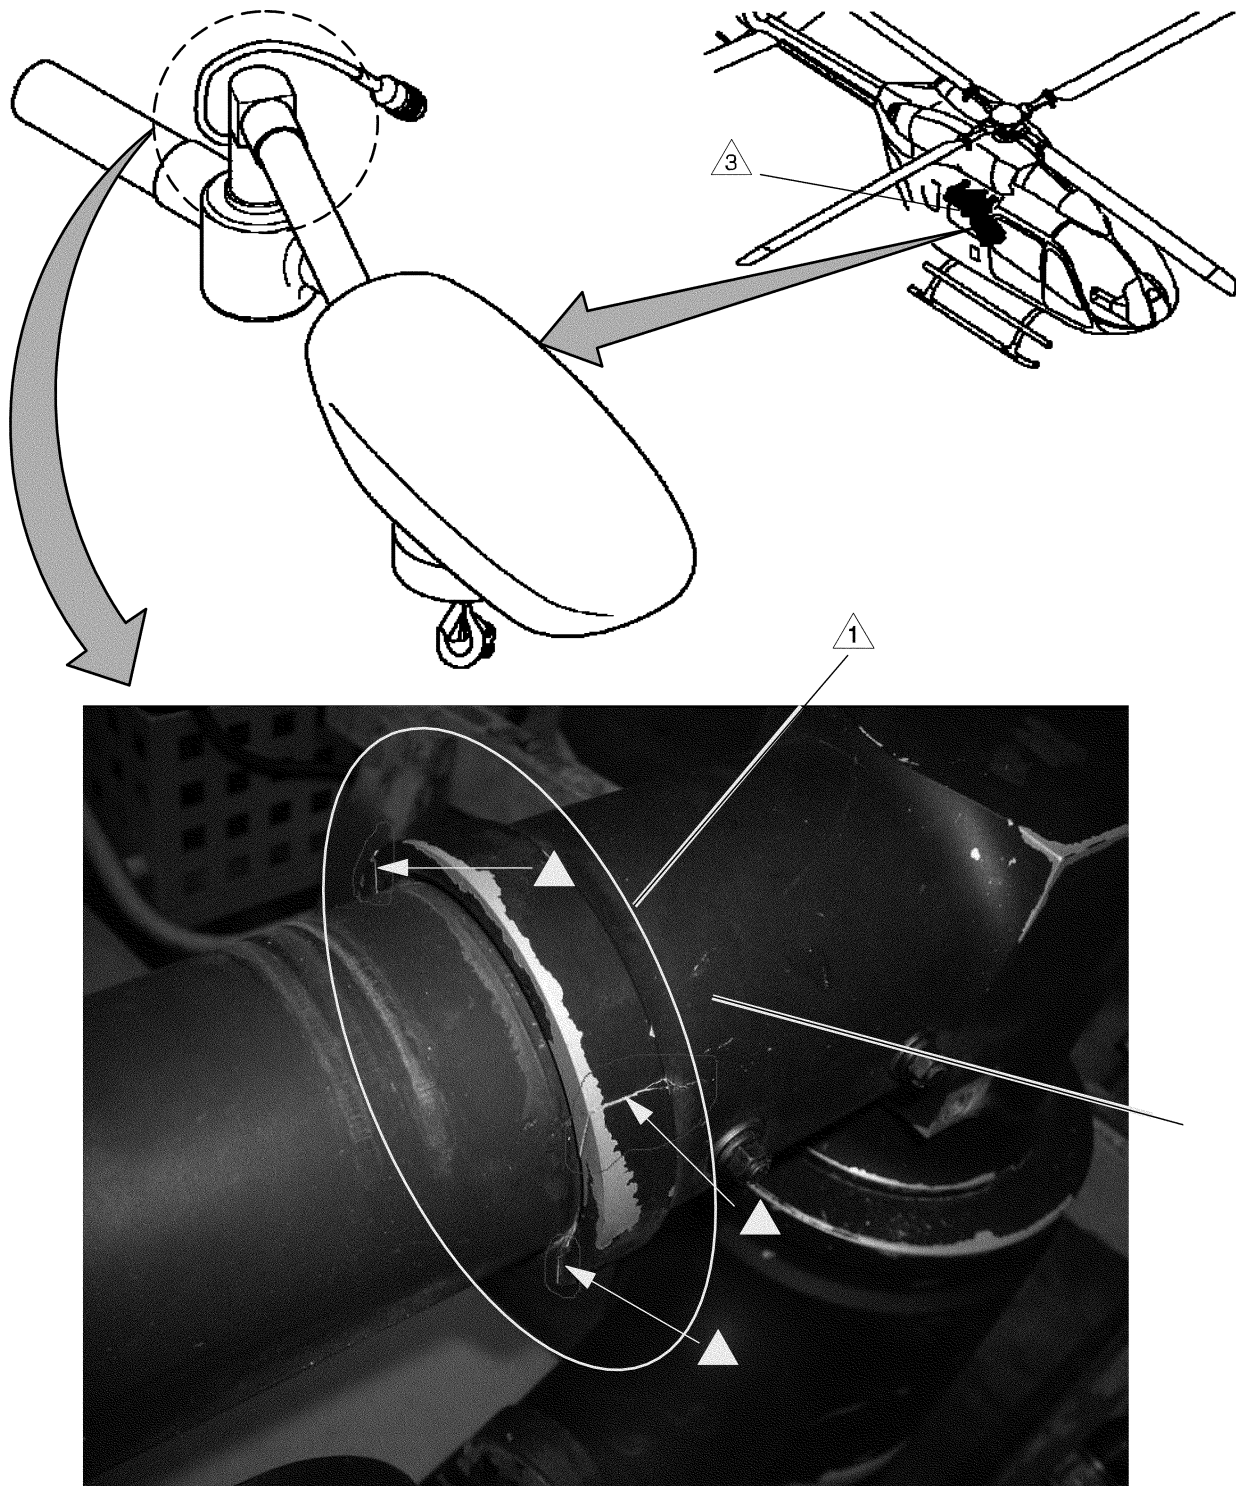
Figure 1 to Paragraph (e)

This AD defines the unsafe condition as a crack in the boom. This condition could result in loss of the boom and attached loads, and subsequent loss of helicopter control.

(1) Before further flight, and thereafter before the first flight of each day until you have performed the inspection required by paragraph (e)(2) of this AD, clean the hoist and visually check for a crack, paying particular attention to the areas that are circled as depicted in Figure 1 to paragraph (e) of this AD. The actions required by this paragraph may be performed by the owner/operator (pilot) holding at least a private pilot certificate, and must be entered into the aircraft records showing compliance with this AD in accordance with 14 CFR 43.9(a)(1)-(4) and 14 CFR 91.417(a)(2)(v). The record must be maintained as required by 14 CFR 91.417, 121.380, or 135.439.

(2) Within 30 days, perform a dye penetrant inspection of the boom in accordance with the Accomplishment Instructions, Section 2.D, of the Goodrich Service Bulletin 44307-500-03, Revision 2, dated April 30, 2010 (SB).

(3) If a crack exists in the boom, replace the cracked boom with an airworthy boom before further flight.
