Learjet Inc.: Docket No. FAA-2014-0010; Directorate Identifier 2012-NM-218-AD.

[Docket No. FAA-2012-0807; Directorate Identifier 2011-NM-191-AD]

Airworthiness Directives; Airbus Airplanes

Airbus: Docket No. FAA–2012–0807; Directorate Identifier 2011–NM–191–AD.

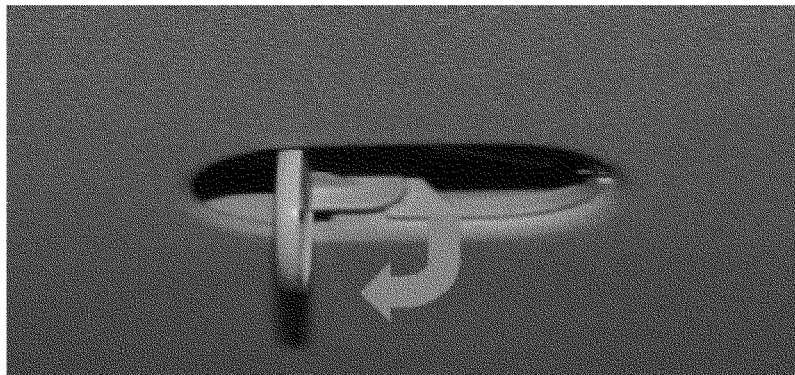
Picture B:

(7) The requirements of paragraphs (g) and (h) of this AD apply only to passenger oxygen containers that are Design A, as defined in figure 1 to paragraph (i)(7) of this AD.

Design A: The placard on the passenger oxygen container test button is as described in Picture A of Appendix 1 of this AD. The Mask configuration ("ZZ" in Picture A) is a number and the test button is as shown in Picture B.
