[Docket No. FAA-2013-0822; Directorate Identifier 2013-SW-004-AD; Amendment 39-17783; AD 2014-05-10]

Airworthiness Directives; Airbus Helicopters (Type Certificate Previously Held by Eurocopter France) (Airbus Helicopters)

2014–05–10 Airbus Helicopters (Type Certificate Previously Held By Eurocopter France): Amendment 39–17783; Docket No. FAA–2013–0822; Directorate Identifier 2013–SW–004–AD.

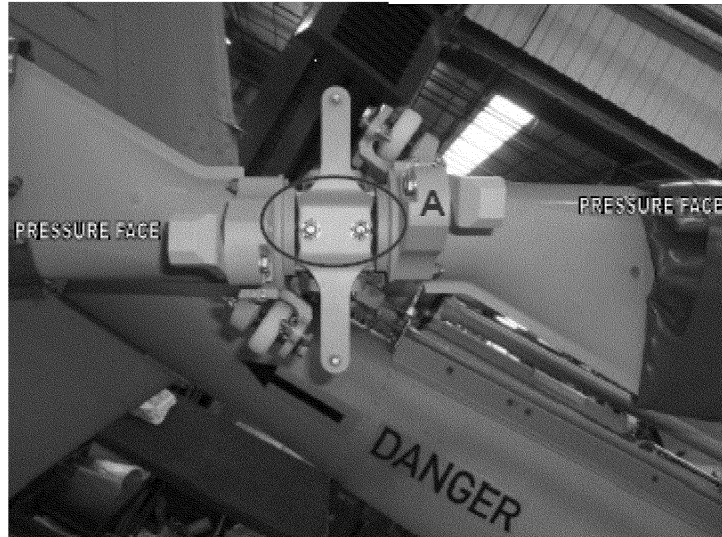
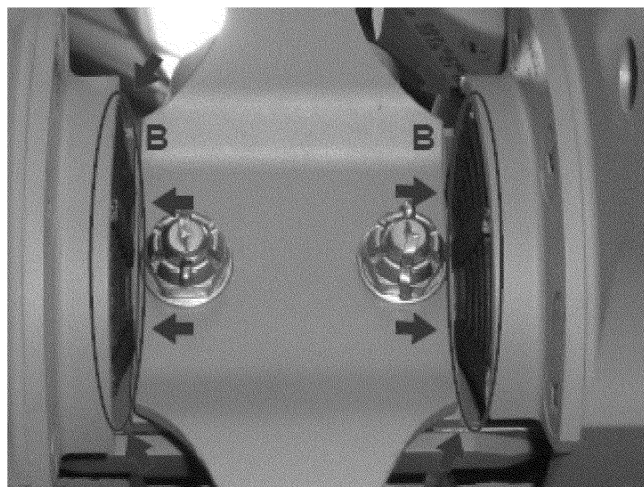
(C) While maintaining the load, check all the visible faces of the bearings (front and side faces) in area B of DETAIL A of Figure 3 to paragraph (f) of this AD for separation between the elastomer and metal parts, a crack in the elastomer, or an extrusion (see example in Figure 4 to paragraph (f) of this AD). A flashlight may be used to enhance the check.

(v) If there is an extrusion on any bearing, before further flight, replace the four bearings with airworthy bearings.

(vi) If there is a separation or a crack on the pressure side bearing, measure the separation or the crack. If the separation or crack is greater than 5 millimeters (.196 inches) as indicated by dimension “L” in Figure 6 to paragraph (f) of this AD, before further flight, replace the four bearings with airworthy bearings.

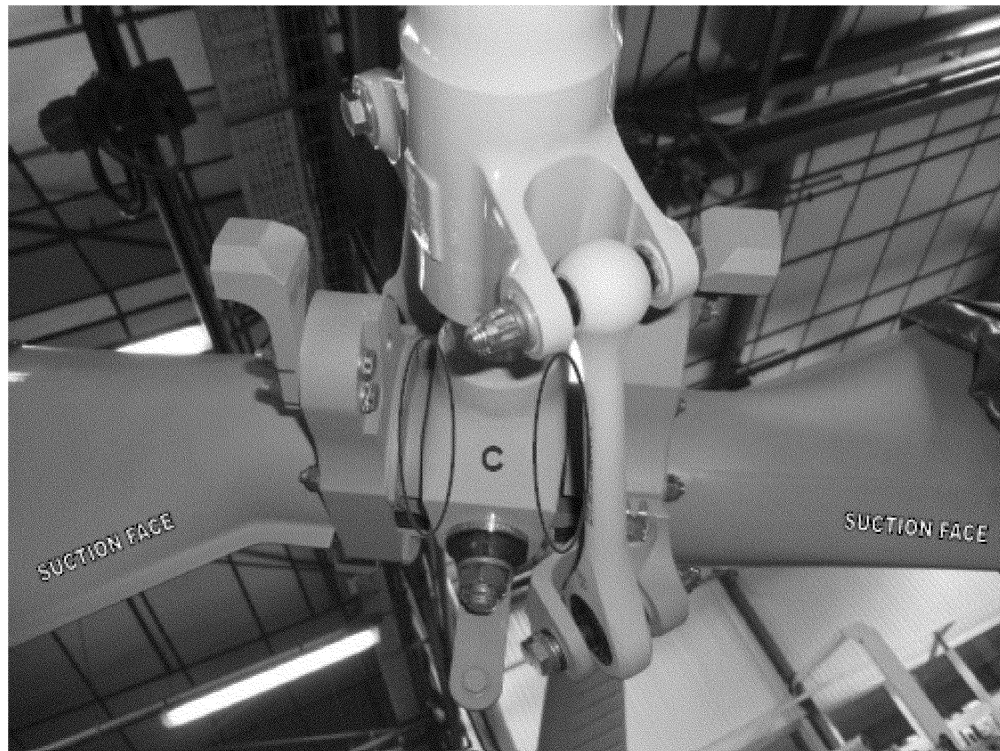
(F) While maintaining the load, check visible faces of Area C as shown in Figure 5 to paragraph (f) of this AD for any extrusion. A flashlight may be used to enhance the check.
