**Airworthiness Directives; Various Restricted Category Helicopters**

**ACTION:** Notice of proposed rulemaking (NPRM).

#### Various Restricted Category Helicopters:

Docket No. FAA–2014–0337; Directorate Identifier 2013–SW–029–AD.

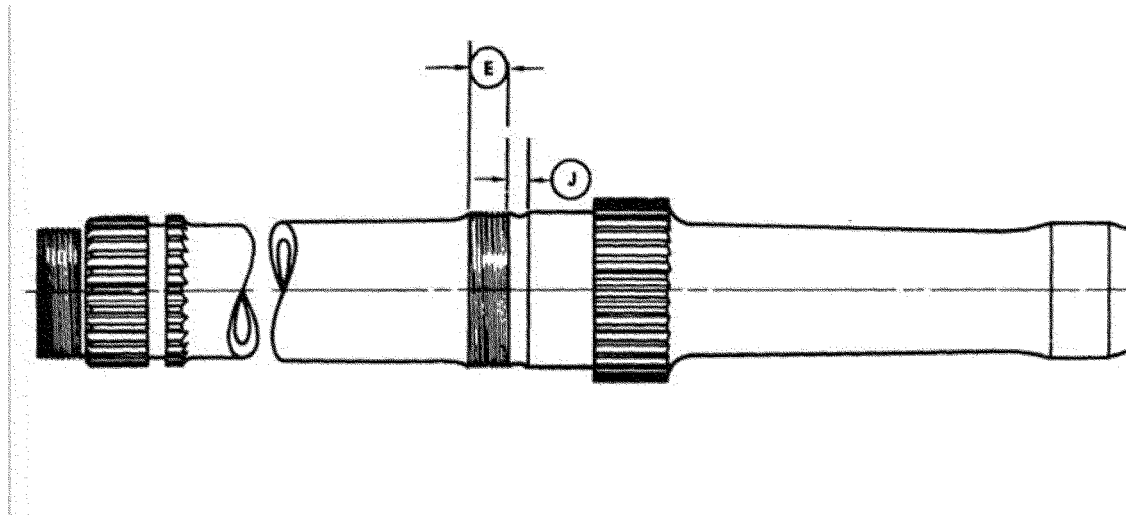
This AD defines the unsafe condition as a crack in the main rotor mast, which could result in failure of the mast and subsequent loss of control of the helicopter.

- (i) Remove any surface rust with a wire brush or steel wool and, using a 10X or higher power magnifying glass, inspect the areas of the mast as shown in area E and area J of Figure 1 to Paragraph (f) of this AD for pitting, corrosion, or a crack.
- (ii) Overhaul the main rotor mast assembly and magnetic particle inspect the mast; mast bearing nut; plate, mast and seal; and bearing liner for a crack.
- (iii) Fluorescent penetrant inspect the locking plate for a crack.

(2) If there is a crack, pitting, or corrosion, before further flight, replace the mast with an airworthy mast.
