[Docket No. FAA-2012-0415; Directorate Identifier 2008-SW-065-AD; Amendment 39-17865; AD 2014-12-04]

Airworthiness Directives; Bell Helicopter Textron, Inc. (BHTI) Helicopters

2014-12-04 Bell Helicopter Textron, Inc. (BHTI): Amendment 39-17865; Docket No. FAA-2012-0415; Directorate Identifier 2008-SW-065-AD.

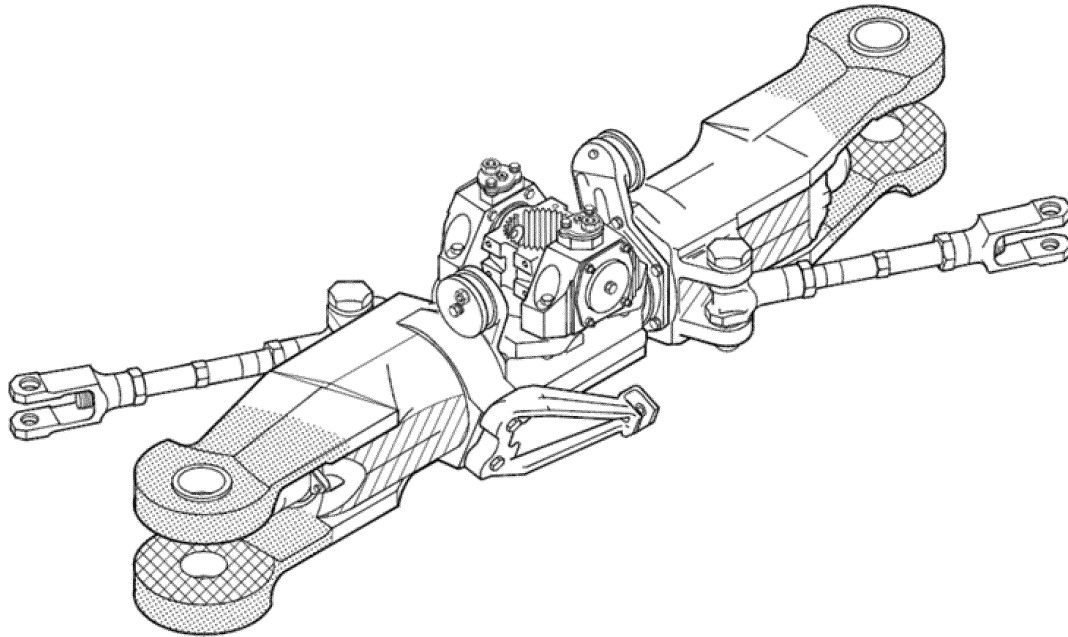
Figure 1 to Paragraphs (f)(2)(ii) and (f)(4)(ii)
Inspection of Main Rotor Hub Grip Tangs

This AD defines the unsafe condition as a crack in the main rotor grip (grip), which could result in failure of a grip, separation of a main rotor blade, and subsequent loss of control of the helicopter.

- (i) Clean the exposed surfaces of the upper and lower tangs of each grip with denatured alcohol, and wipe dry.
- (ii) Using a 10-power or higher magnifying glass, visually inspect the exposed surfaces of the upper and lower tangs of each grip for a crack. Pay particular attention to the lower surface of each lower grip tang from the main rotor blade bolt-bushing flange to the leading and trailing edge of each grip tang as depicted in Figure 1 to Paragraphs (f)(2)(i) and (f)(4)(ii) of this AD.

INSPECT BUFFER PAD FOR DELAMINATION (IF INSTALLED)

AREA TO BE INSPECTED UPPER AND LOWER TANGS ALL EXPOSED SURFACES

(ii) Inspect each grip buffer pad on the inner surfaces of each grip tang for delamination as depicted in Figure 1 to Paragraphs (f)(2)(ii) and (f)(4)(ii) of this AD. If there is any delamination, remove the buffer pad and inspect the grip surface for corrosion or other damage.

(i) Replace any cracked grip with an airworthy grip.

(ii) Replace any grip with any corrosion or other damage with an airworthy grip, or repair the grip if the corrosion or other damage is within maximum repair damage limitations.
