[Docket No. FAA-2013-0574; Directorate Identifier 2008-SW-22-AD; Amendment 39-17766; AD 2014-04-07]

Airworthiness Directives; Bell Helicopter Textron Canada (Bell) Helicopters

SUMMARY: We are superseding Airworthiness Directive (AD) 2003-05-03 for Bell Model 407 helicopters. AD 2003-05-03 required preflight checking and repetitively inspecting for a crack in certain tailbooms that have been redesigned, replacing the tailboom if there is a crack, modifying and re-identifying certain tailbooms, installing an improved horizontal stabilizer assembly, and assigning a 5,000 hour time-in-service (TIS) limit. This new AD retains the requirements of AD 2003-05-03 and requires additional inspection requirements. This AD was prompted by additional reports of cracked tailboom skins. The actions in this AD are intended to prevent separation of the tailboom and subsequent loss of control of the helicopter.

2014–04–07 Bell Helicopter Textron Canada: Amendment 39–17766; Docket No. FAA–2013–0574; Directorate Identifier 2008–SW–22–AD.

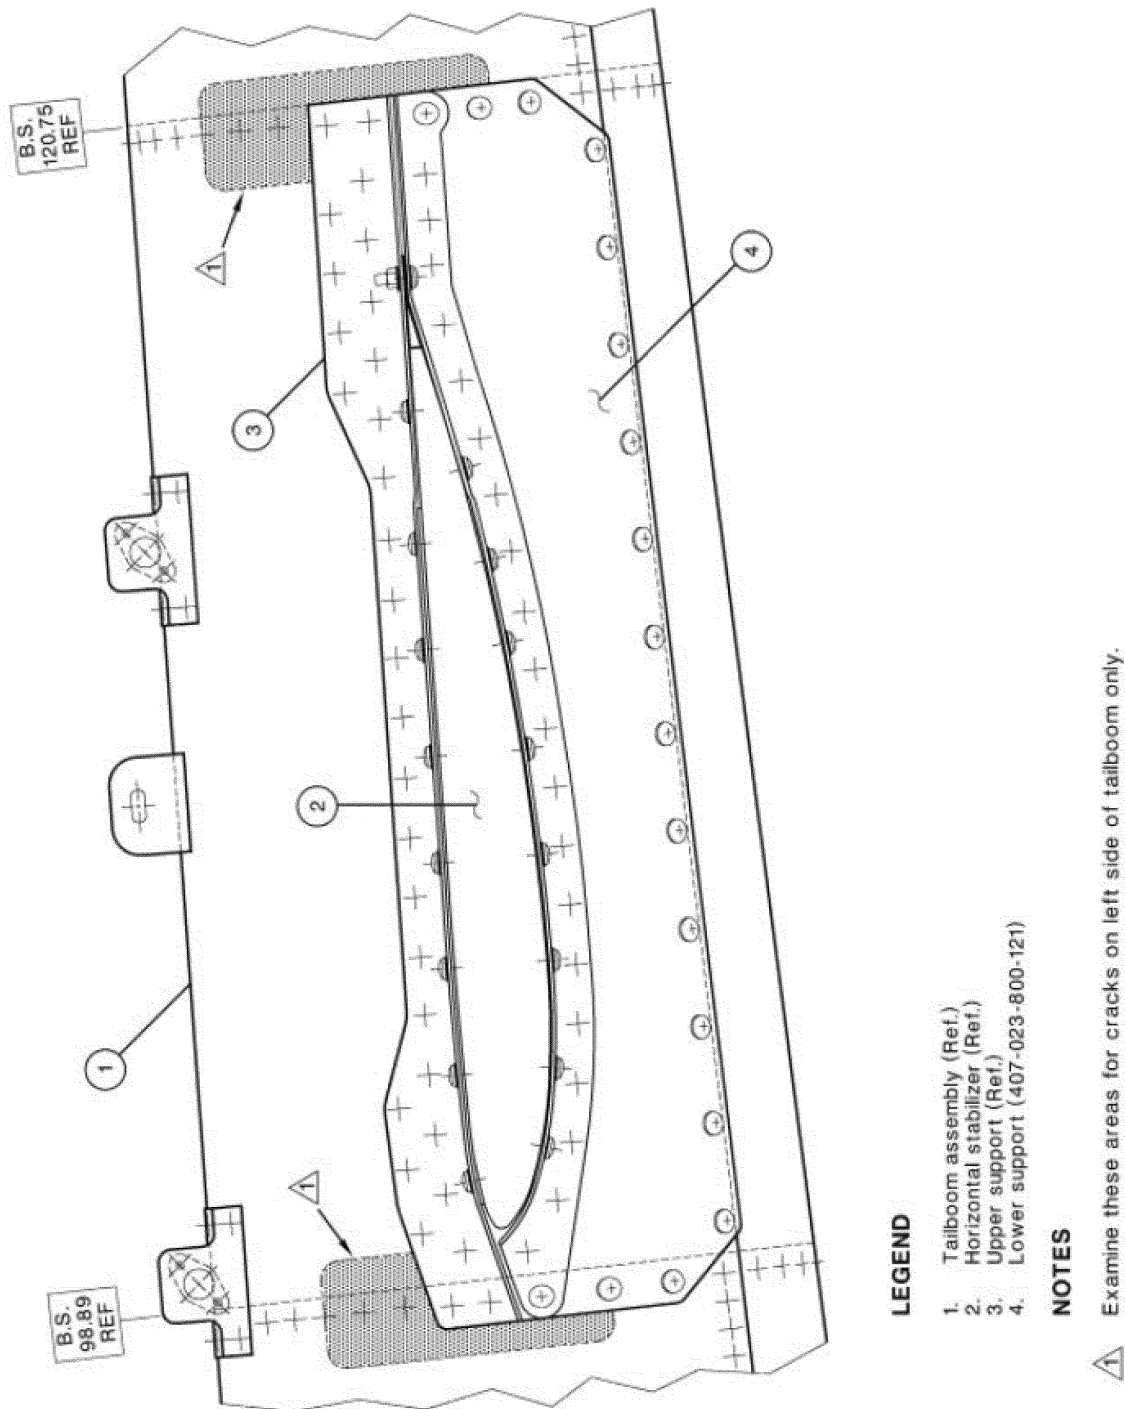
This AD defines the unsafe condition as cracks in the tailboom skin on the left side in the area of horizontal stabilizer, which could result in separation of the tailboom and subsequent loss of control of the helicopter.

(A) Before the first flight of each day, visually check the tailboom for a crack, as depicted in Figure 1 to Paragraph (f)(1)(i)(A) of this AD.

(3) If there is a crack, before further flight, replace the tailboom.
