Federal Register

[Docket No. FAA-2012-0807; Directorate Identifier 2011-NM-191-AD; Amendment 39-17888; AD 2014-13-12]

Airworthiness Directives; Airbus Airplanes

ACTION: Final rule.

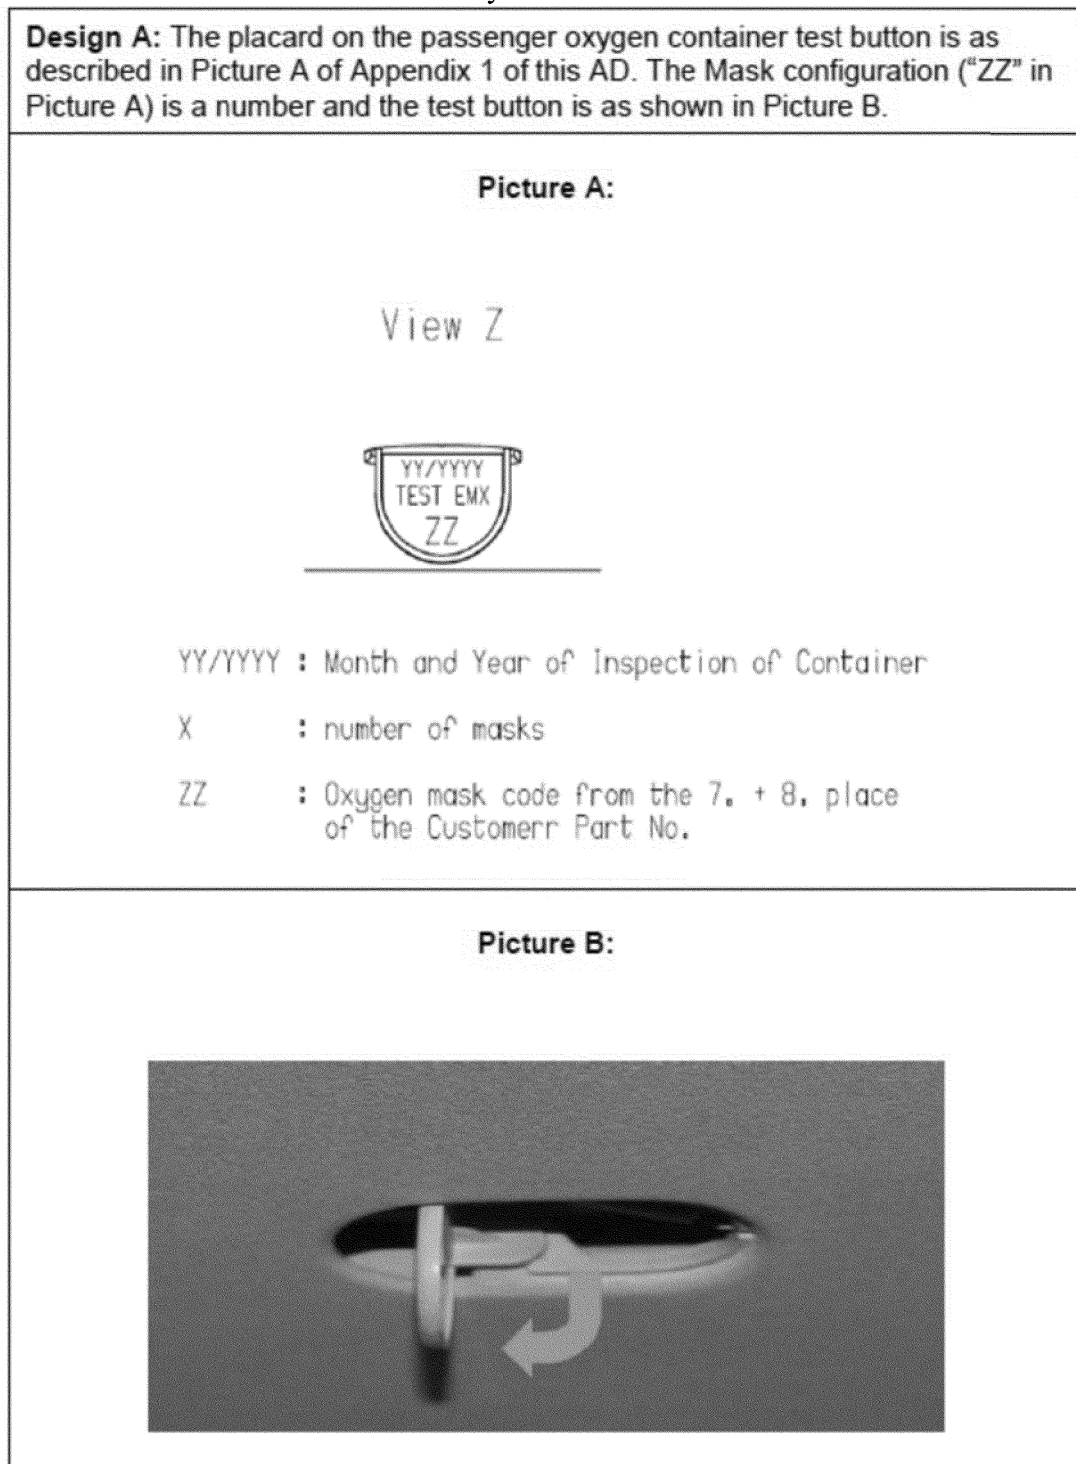
Figure 1 to paragraph (i)(7) of this AD – Design A of the Passenger Oxygen Containers Affected by this AD

(7) The requirements of paragraphs (g) and (h) of this AD apply only to passenger oxygen containers that are Design A, as defined in figure 1 to paragraph (i)(7) of this AD.
