**[Docket No. FAA-2014-0034; Directorate Identifier 2013-SW-006-AD; Amendment 39-17948; AD 2014-16-24]**

**Airworthiness Directives; Airbus Helicopters Deutschland GmbH (Previously Eurocopter Deutschland GbmH) (Airbus Helicopters) Helicopters**

**2014–16–24 Airbus Helicopters  
Deutschland GmbH (Previously  
Eurocopter Deutschland GmbH)  
Helicopters:** Amendment 39–17948;  
Docket No. FAA–2014–0034; Directorate  
Identifier 2013–SW–006–AD.

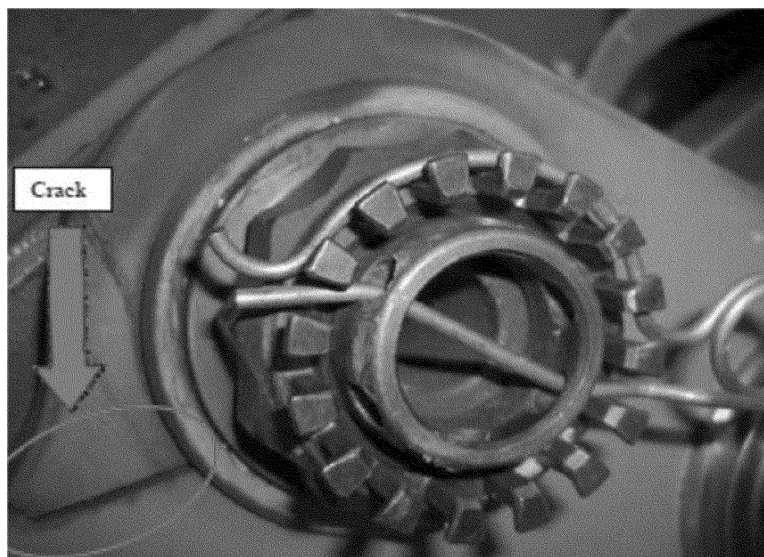
Figure 1 to Paragraph (f)(1)

(1) Before further flight, and thereafter at intervals not to exceed 6 hours time-in-service (TIS), check the MRH shaft lower flange and the visible area of the MRH shaft upper flange for a crack. Figures 1 and 2 to Paragraph (f)(1) of this AD are examples of cracks that have been discovered in the MRH shaft lower flange. The actions required by this paragraph may be performed by the owner/operator (pilot) holding at least a private pilot certificate, and must be entered into the aircraft records showing compliance with this AD in accordance with 14 CFR 43.9 (a)(1) through (4) and 14 CFR 91.417(a)(2)(v). The record must be maintained as required by 14 CFR 91.417, 121.380, or 135.439.

(3) If there is a crack in the upper or lower MRH shaft flange, before further flight, replace that MRH shaft with an airworthy MRH shaft. Replacing the MRH shaft with an MRH shaft having a P/N listed in paragraph
