[Docket No. FAA–2014–0337; Directorate Identifier 2013–SW–029–AD; Amendment 39–18008; AD 2014–22–03]

Airworthiness Directives; Various Restricted Category Helicopters

2014–22–03 Various Restricted Category

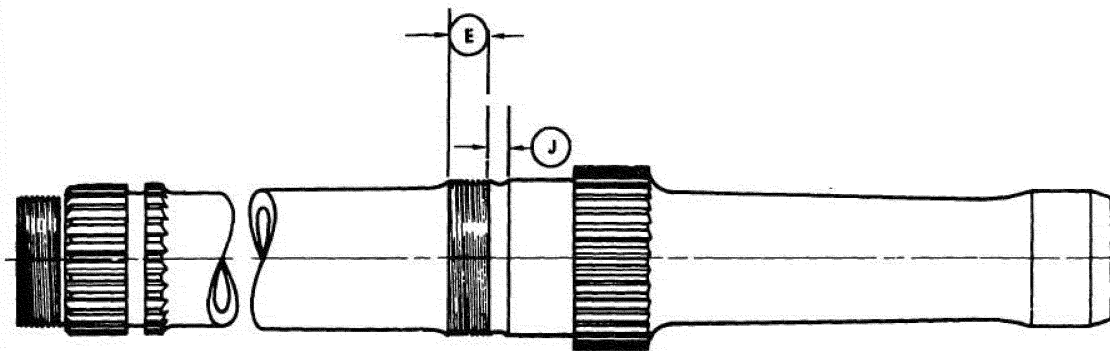
This AD defines the unsafe condition as a crack in the main rotor mast, which could result in failure of the mast and subsequent loss of control of the helicopter.

(i) Remove any surface rust with a wire brush or steel wool and, using a 10X or higher power magnifying glass, inspect the areas of the mast as shown in area E and area J of Figure 1 to Paragraph (f) of this AD for pitting, corrosion, or a crack.

(2) If there is a crack, pitting, or corrosion, before further flight, replace the mast with an airworthy mast.
