[Docket No. FAA–2015–0497; Directorate Identifier 2012–NM–192–AD; Amendment 39–18128; AD 2015–06–10]

#### Airworthiness Directives; ATR–GIE Avions de Transport Régional Airplanes

**2015-06-10 ATR-GIE Avions de Transport Régional:** Amendment 39-18128. Docket No. FAA-2015-0497; Directorate Identifier 2012-NM-192-AD.

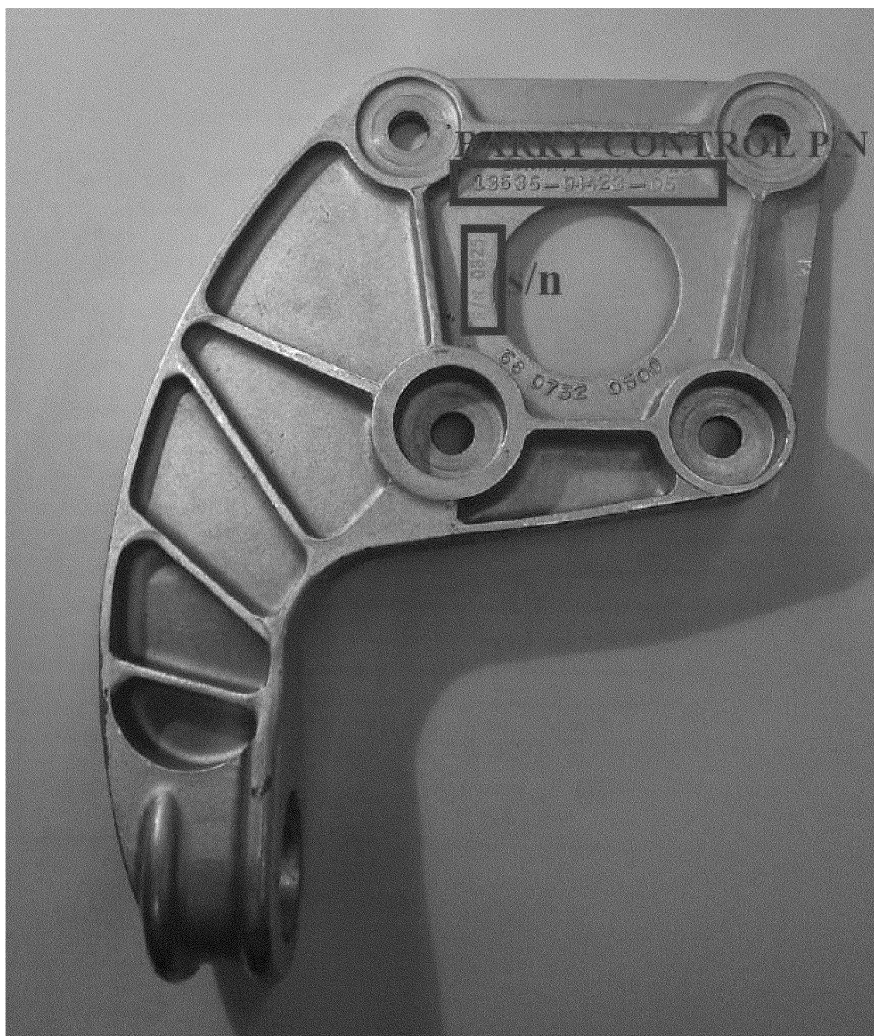
**Figure 1 to paragraph (g)(1) of this AD - Location of Fitting Part Number and Serial Number**

- (1) Identify the serial number (S/N) of the part number (P/N) S54210394200 (Barry Control P/N 94423-05) LH and right-hand (RH) shock mount pick-up fittings installed on both engine nacelles. Figure 1 to paragraph (g)(1) of this AD identifies the fitting part number and serial number locations.

(2) If the serial number of the LH shock mount pick-up fitting, identified during any inspection required by paragraph (g)(1) of this AD, is lower than 2451 or is unreadable, and no crack has been found during any

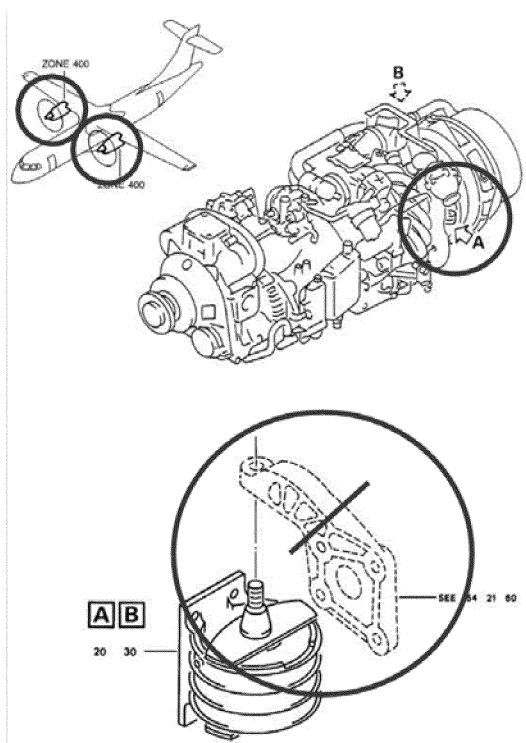
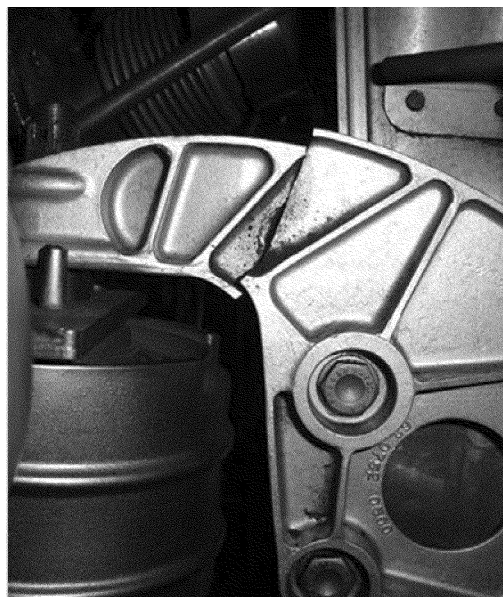
**Figure 2 to Paragraph (g)(2) of this AD - Shock Mount Pick-up Fitting**

Several cases of engine shock mount pick-up fitting with crack or failure have been reported, always on engine Left Hand (LH) aft side attachment. Prompted by those reports, improved Part Number (P/N) S54210394200 (Barry Control P/N 94423-05) fittings (machined radius modification) have been introduced in production, having serial number (s/n) 2451 and higher. No crack has been reported on aeroplanes equipped with those improved fittings.

(2) Do a detailed inspection of both LH and RH aft side isolator pick-up fittings on both engines to detect cracks, in accordance with

paragraph 004.1 of ATR ATR72 Aircraft Maintenance Manual (AMM) Job Instruction Card (JIC) 54-11-61 DVI 10000, dated March

1, 2012. Refer to figure 2 to paragraph (g)(2) of this AD for potential crack location.

(1) If any crack is found during any inspection required by paragraphs (g)(2) and (g)(3) of this AD: Before further flight, repair in accordance with a method approved by

the Manager, International Branch, ANM-116, Transport Airplane Directorate, FAA; or EASA; or ATR's EASA Design Organization Approval (DOA).

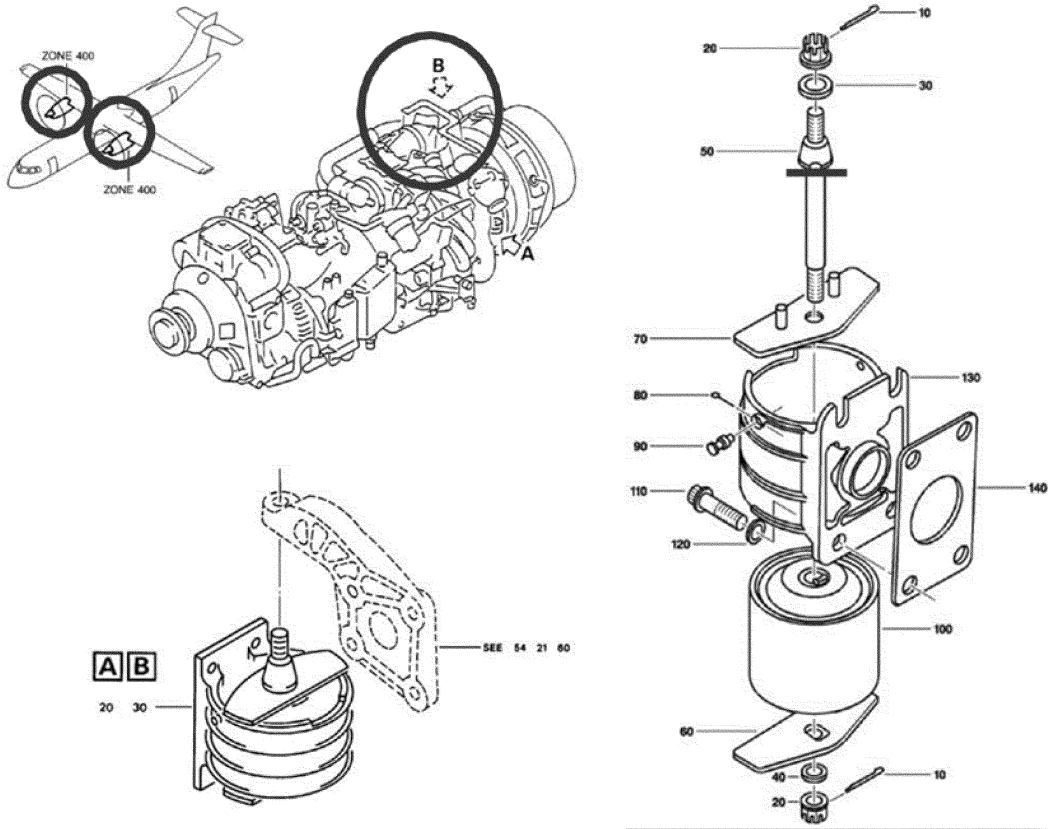
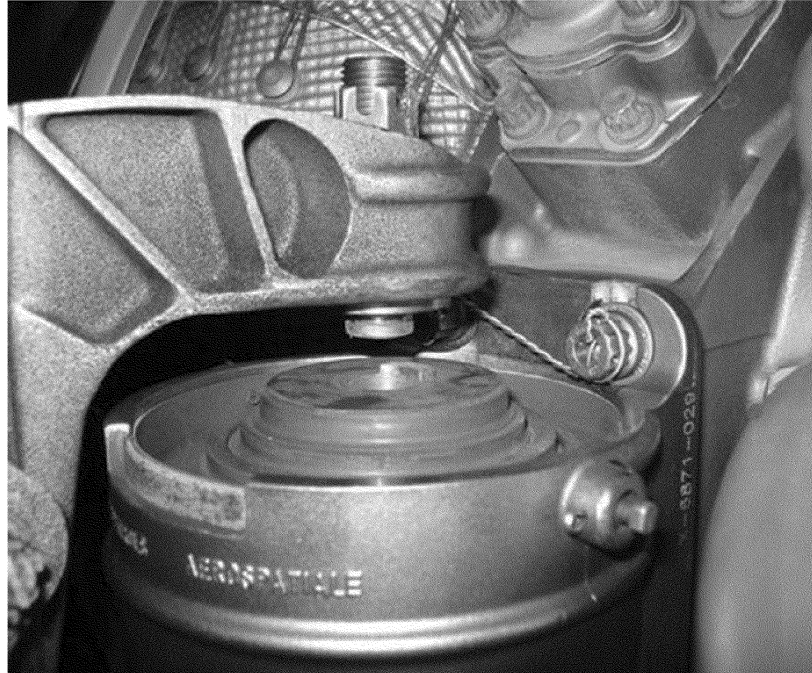
**Figure 3 to paragraph (g)(3) of this AD - Shock Mount Cone Bolt**

Two recent cases of failed cone bolt have been reported on ATR 72-212A aeroplanes, both on engine Right Hand (RH) aft side isolator.

(3) Do a detailed inspection of both LH and RH aft shock mount cone bolts on both engines to detect cracks, in accordance with

paragraph 006.3.A. of ATR ATR72 AMM JIC 71-20-00 DVI 10000. Refer to figure 3 to

paragraph (g)(3) of this AD for potential crack location.
