[Docket No. FAA-2014-1083; Directorate Identifier 2014-CE-036-AD; Amendment 39-18140; AD 2015-08-04]

Airworthiness Directives; Various Aircraft Equipped With Wing Lift Struts

ACTION: Final rule.

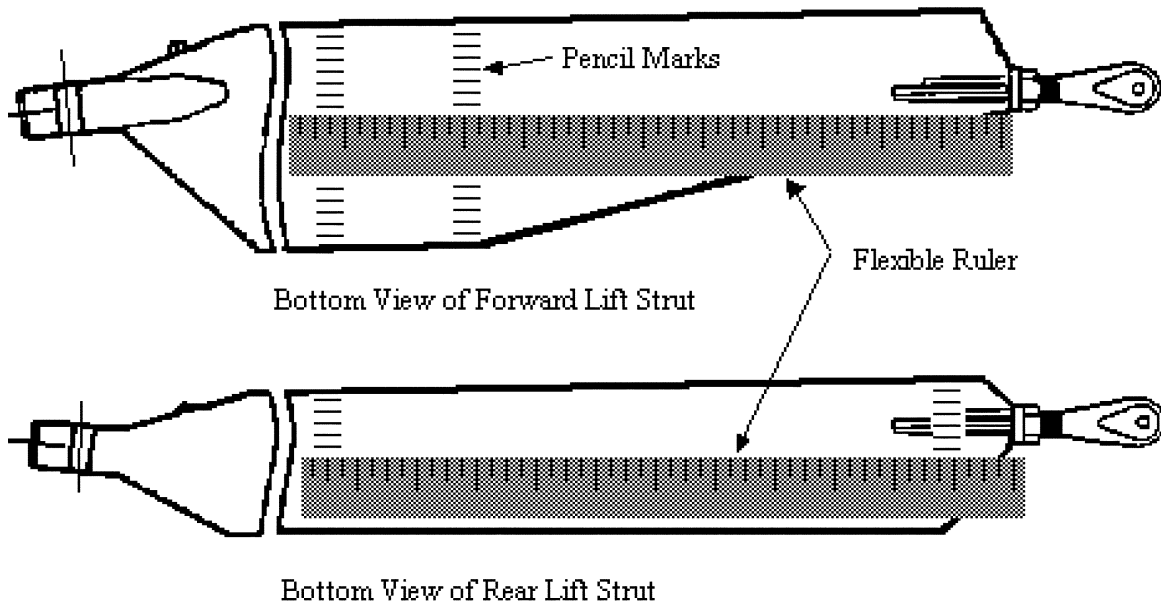
Figure 1

11. Place couplant on an area of the lift strut which is thought to be free of corrosion and "ring" the transducer to surface. Minor adjustments to the signal and gate settings may be required to account for coupling improvements resulting from the paint layer. The thickness gate level should be set just high enough so as not to be triggered by irrelevant signal noise. An area on the upper surface of the lift strut above the inspection area would be a good location to complete this step and should produce a thickness reading between 0.034-inch and 0.041-inch.

8. A measurement of 0.024-inch or less shall require replacement of the strut prior to further flight.
