DEPARTMENT OF TRANSPORTATION**National Highway Traffic Safety Administration****Denial of Motor Vehicle Defect Petition**

ACTION: Denial of a petition for a defect investigation.

SUMMARY: This notice sets forth the reasons for denying a petition (DP14-003) submitted to NHTSA 49 U.S.C. 30162, 49 CFR part 552, requesting that the agency open “an investigation into low-speed surging in the 2006–2010 Toyota Corolla [vehicles] with ETCS-i, in which the brakes fail to stop the vehicle in time to prevent a crash.”

Appendix—Petition Analysis—DP14-003**1.0 Introduction**

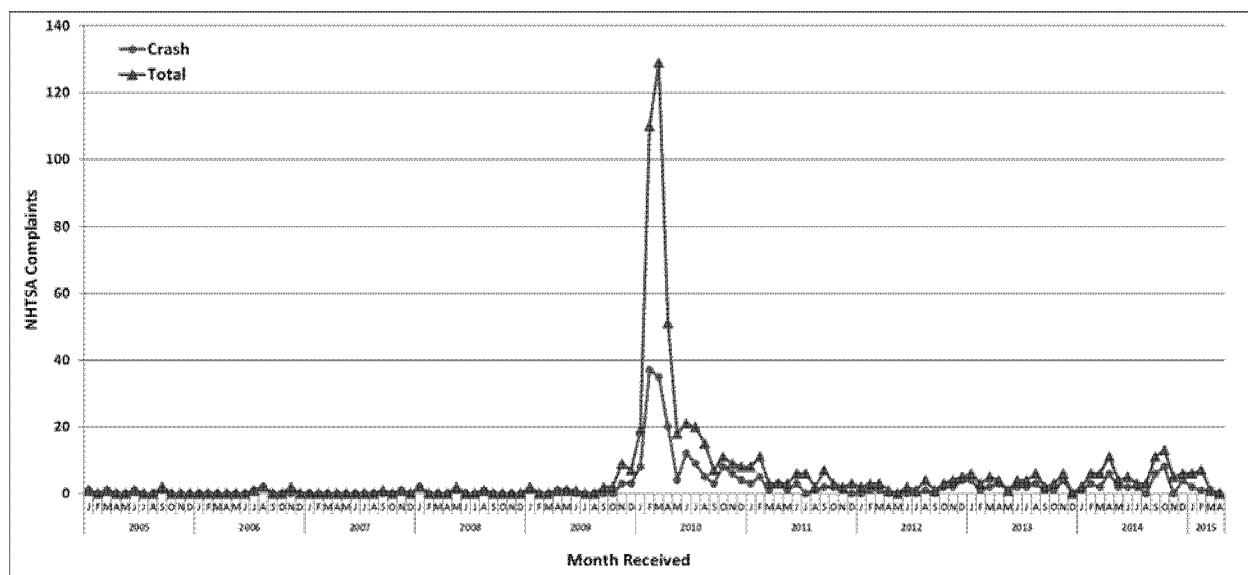
Figure 2. MY 2005-2015 Toyota Corolla Speed Control Complaints by Month Reported.

Complaints to ODI alleging SA related crashes are far less common. In the same period from 2004 through 2008 that the pedal error study identified over 2,400 pedal error related crashes in North Carolina police reports, ODI received less than 40 complaints alleging SA crashes in North Carolina in all light vehicles—or less than 2 percent of the number of crash incidents identified in the pedal error study. However, publicity can significantly increase ODI complaint volumes, as is evident for Toyota Corolla vehicles equipped with

ETCS-i, which saw a 7,900% increase in speed control complaints alleging crashes and a 12,800% increase in total speed control complaints from the first quarter of 2009 to the first quarter of 2010, after news media coverage of Toyota's pedal entrapment and sticky pedal recalls (Figure 2). Each of these factors, as well as the incident characteristics used for identifying complaints likely to be related to a common cause (see Section 2.1, *Definitions*), must be considered before conducting any analysis of, or drawing
