Airworthiness Directives; Airbus Airplanes

ACTION: Notice of proposed rulemaking (NPRM).

Airbus: Docket No. FAA-2015-3989; Directorate Identifier 2014-NM-250-AD.

Air Transport Association (ATA) of America Code 35, Oxygen.

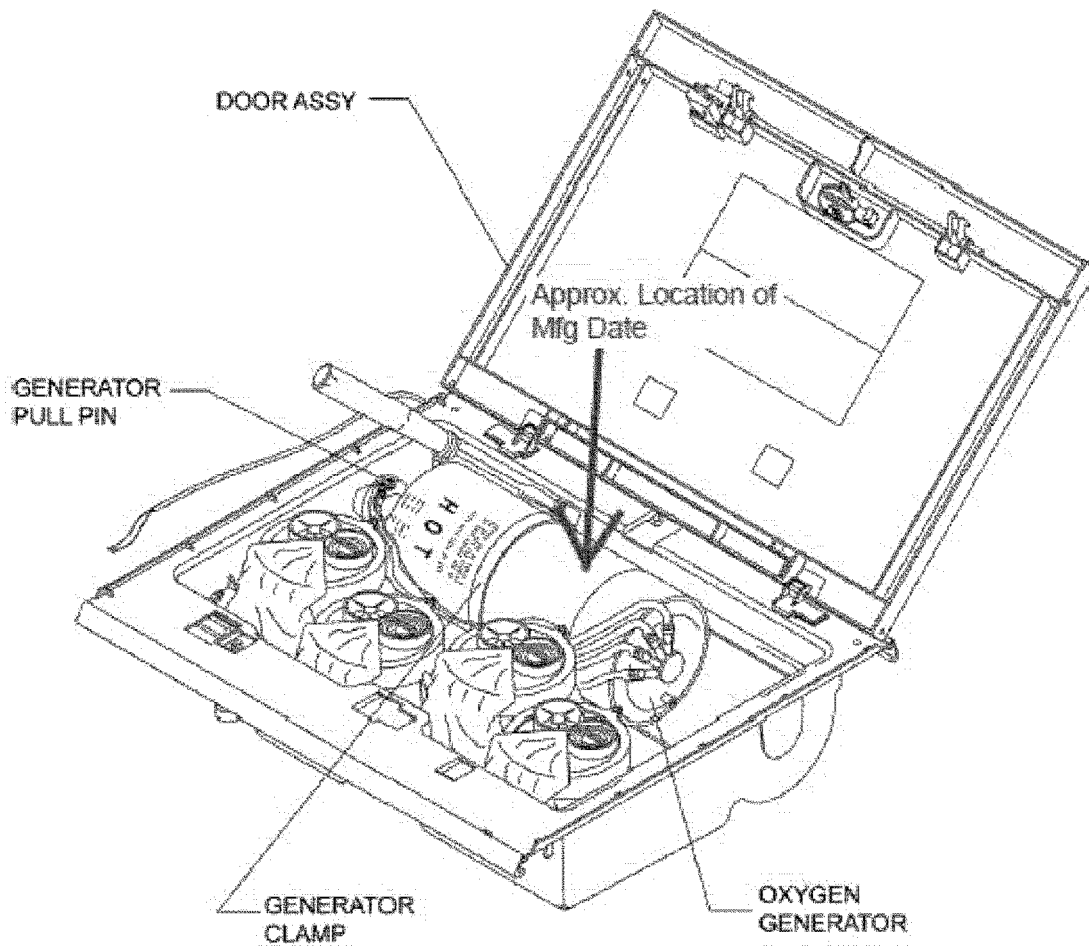
Figure 1 to paragraph (g) of this AD - location of date (MM-YY)

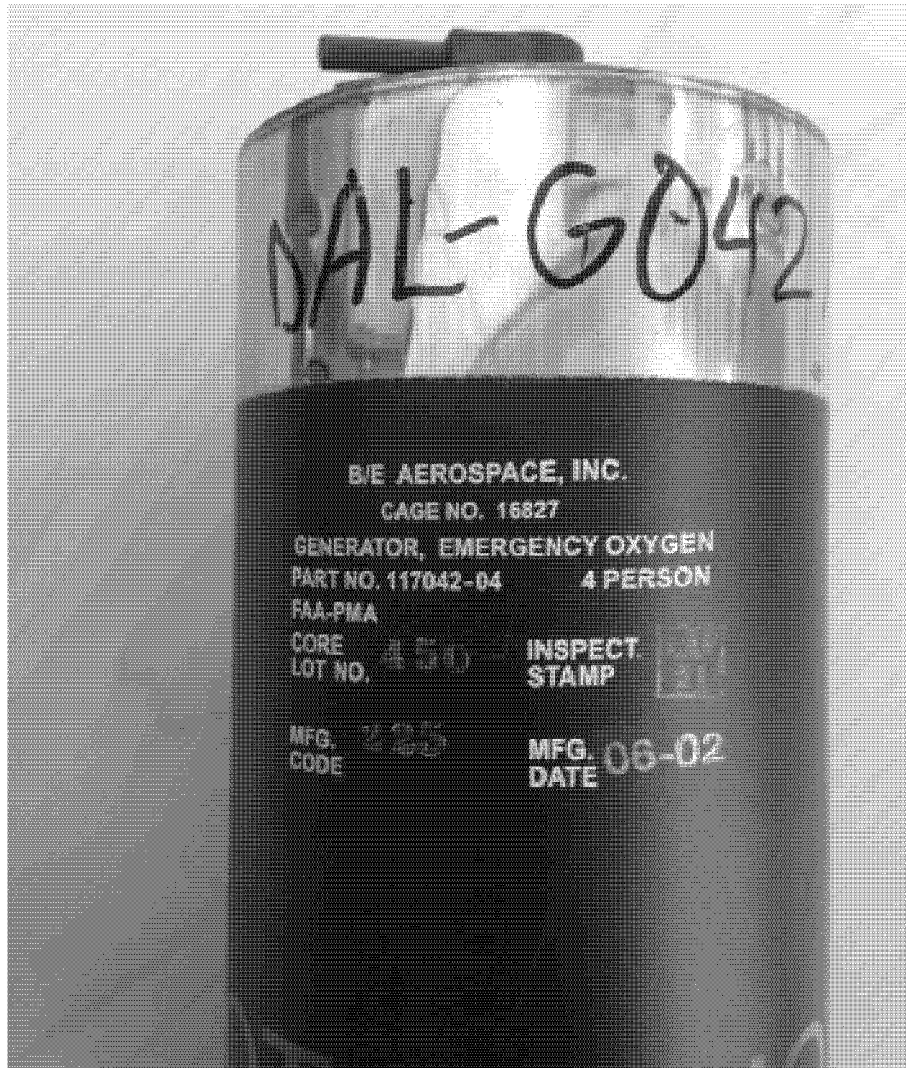
Figure 2 to paragraph (g) of this AD - MFG.DATE (06-02 = June 2002) example
