Federal Register

[Docket No. FAA-2015-3149; Directorate Identifier 2015-NM-014-AD; Amendment 39-18394; AD 2016-03-07]

Airworthiness Directives; Airbus Airplanes

SUMMARY: We are adopting a new airworthiness directive (AD) for all Airbus Model A330-200, -200 Freighter, and -300 series airplanes, and all Airbus Model A340-200, -300, -500, and -600 series airplanes. This AD was prompted by reports of premature aging of certain chemical oxygen generators in the passenger compartment that resulted in failure of the generators to activate. This AD requires inspecting to determine if certain passenger chemical oxygen generators are installed, and replacement of affected generators. We are issuing this AD to prevent failure of the chemical oxygen generator to activate during an emergency situation, which could result in unavailability of oxygen and possible incapacitation of the occupants.

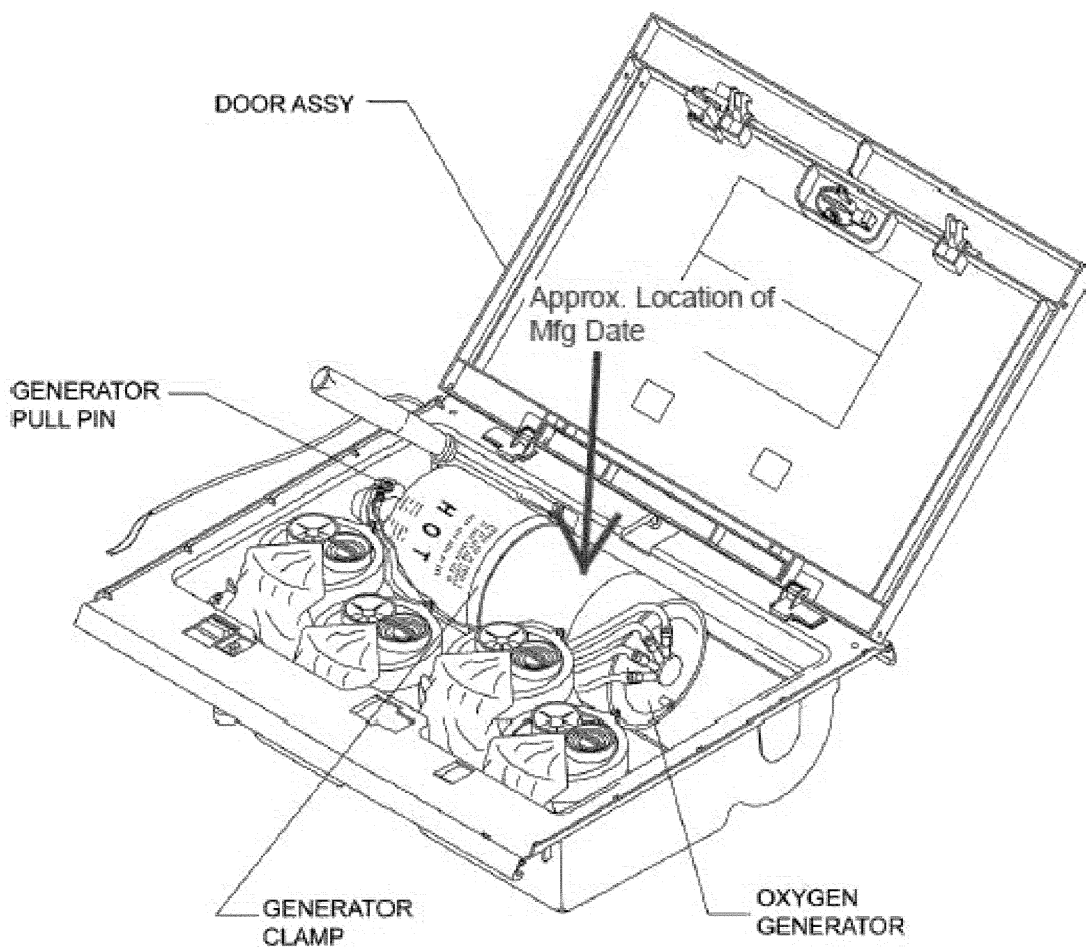
Figure 1 to paragraph (g) of this AD - Location of date (MM-YY)

Within 30 days after the effective date of this AD: Inspect each passenger chemical oxygen generator to identify the date of manufacture (refer to figures 1 and 2 to paragraph (g) of this AD for the location of the date) of each passenger chemical oxygen generator having any part number (P/N) listed in paragraphs (g)(1) through (g)(6) of this AD, in accordance with the Instructions of Airbus Alert Operators Transmission (AOT) A35L007-14, Revision 01, June 17, 2015, including Appendix A, Revision 01,

If, during any inspection required by paragraph (g) of this AD, any passenger chemical oxygen generator having a date of manufacture of 1999, 2000, or 2001 is found: At the time specified in paragraph (h)(1), (h)(2), or (h)(3) of this AD, as applicable, replace the affected passenger chemical oxygen generator, in accordance with the Instructions of Airbus AOT A35L007-14, Revision 01, June 17, 2015; including Appendix A, Revision 01, dated June 17, 2015 (for 15- and 22-minute passenger chemical oxygen generators); or in accordance with the Accomplishment Instructions of B/E Aerospace Service Bulletin 117042-35-001, dated December 10, 2014 (for 15-minute passenger chemical oxygen generators).

If, during any inspection required by paragraph (g) of this AD, any passenger chemical oxygen generator having a date of manufacture of 2002 or later is found: At the time specified in paragraph (i)(1), (i)(2), (i)(3), (i)(4), (i)(5), (i)(6), (i)(7), or (i)(8) of this AD, as applicable, replace the affected passenger chemical oxygen generator with a serviceable unit, in accordance with the Instructions of Airbus AOT A35L007-14, Revision 01, June 17, 2015; including Appendix A, Revision 01, dated June 17, 2015 (for 15- and 22-minute passenger chemical oxygen generators); or in accordance with the Accomplishment Instructions of B/E Aerospace Service Bulletin 117042-35-001, dated December 10, 2014 (for 15-minute passenger chemical oxygen generators).

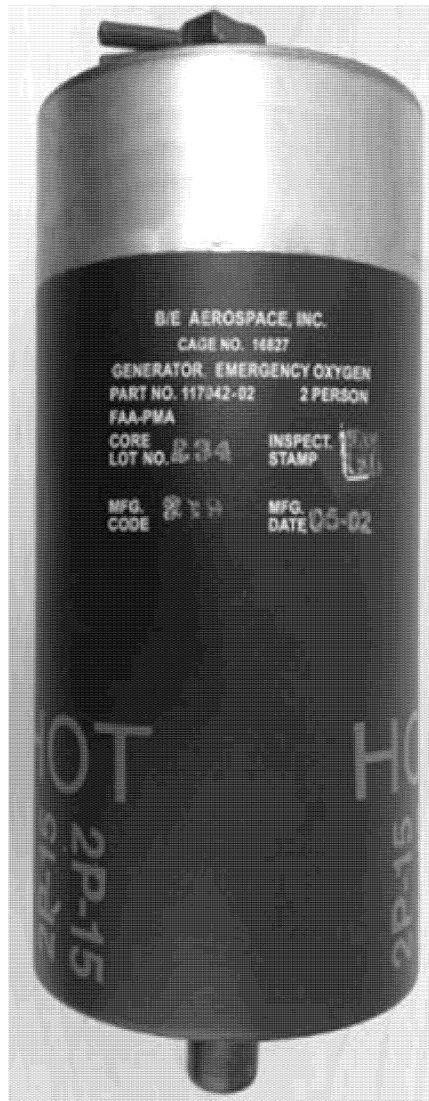
Figure 2 to paragraph (g) of this AD – Manufacturing (MFG.) date (05-02 = May 2002) example

Airbus asked that we remove the operator identification from the chemical oxygen generator pictured in Figure 2 to paragraph (g) of the proposed AD (80 FR 52419, August 31, 2015). Airbus stated that Figure 2 to paragraph (g) should replicate Figure 2

We agree with the commenter for the reason provided. We have changed the oxygen generator picture in Figure 2 to paragraph (g) of this AD accordingly.
