[Docket No. FAA-2015-8463; Directorate Identifier 2014-NM-226-AD; Amendment 39-18612; AD 2016-16-14]

Airworthiness Directives; Airbus Airplanes

SUMMARY: We are superseding Airworthiness Directive (AD) 2013-20-11, for all Airbus Model A318, A319, A320, and A321 series airplanes. AD 2013-20-11 required modifying the passenger emergency oxygen container assembly. This new AD expands the affected group of oxygen containers to include those labeled "DAe Systems." This AD was prompted by a determination that the unsafe condition also affects oxygen containers labeled "DAe Systems." We are issuing this AD to prevent a high temperature oxygen generator and mask from falling down and possibly resulting in an ignition source in the passenger compartment, injury to passengers, and reduced availability of supplemental oxygen.

2016–16–14 Airbus: Amendment 39–18612; Docket No. FAA–2015–8463; Directorate Identifier 2014–NM–226–AD.

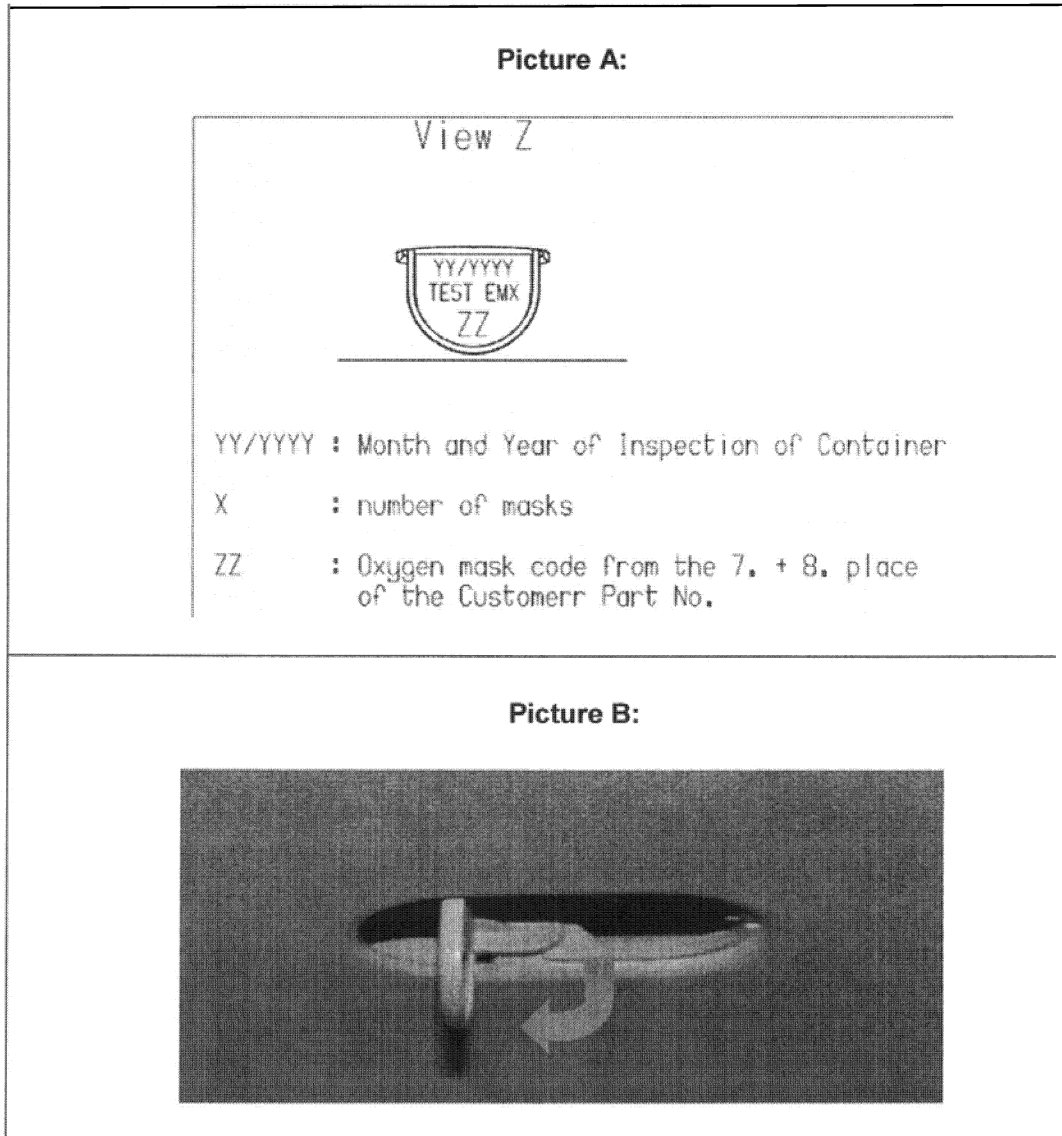
Figure 1 to Paragraph (l)(4) of this AD – Design A of the Passenger Oxygen Containers

(4) Airplanes on which the design of the passenger oxygen container is not Design A, as defined in figure 1 to paragraph (l)(4) of this AD, are excluded from the requirements of paragraph (i) of this AD for that passenger oxygen container.

Note 2 to paragraph (l)(4) of this AD: For "Design A," the placard on the passenger oxygen container test button is as described in "Picture A" in figure 1 to paragraph (l)(4) of this AD. The mask configuration ("ZZ" in "Picture A") is a number, and the test button is as shown in "Picture B."
