[Docket No. FAA-2015-7527; Directorate Identifier 2015-NM-094-AD; Amendment 39-18686; AD 2016-21-05]

Airworthiness Directives; The Boeing Company Airplanes

2016–21–05 The Boeing Company:
Amendment 39–18686; Docket No. FAA–2015–7527; Directorate Identifier 2015–NM–094–AD.

Figure 1 to paragraph (h) of this AD: Wiring Installation - Right Engine Fuel Spar Valve

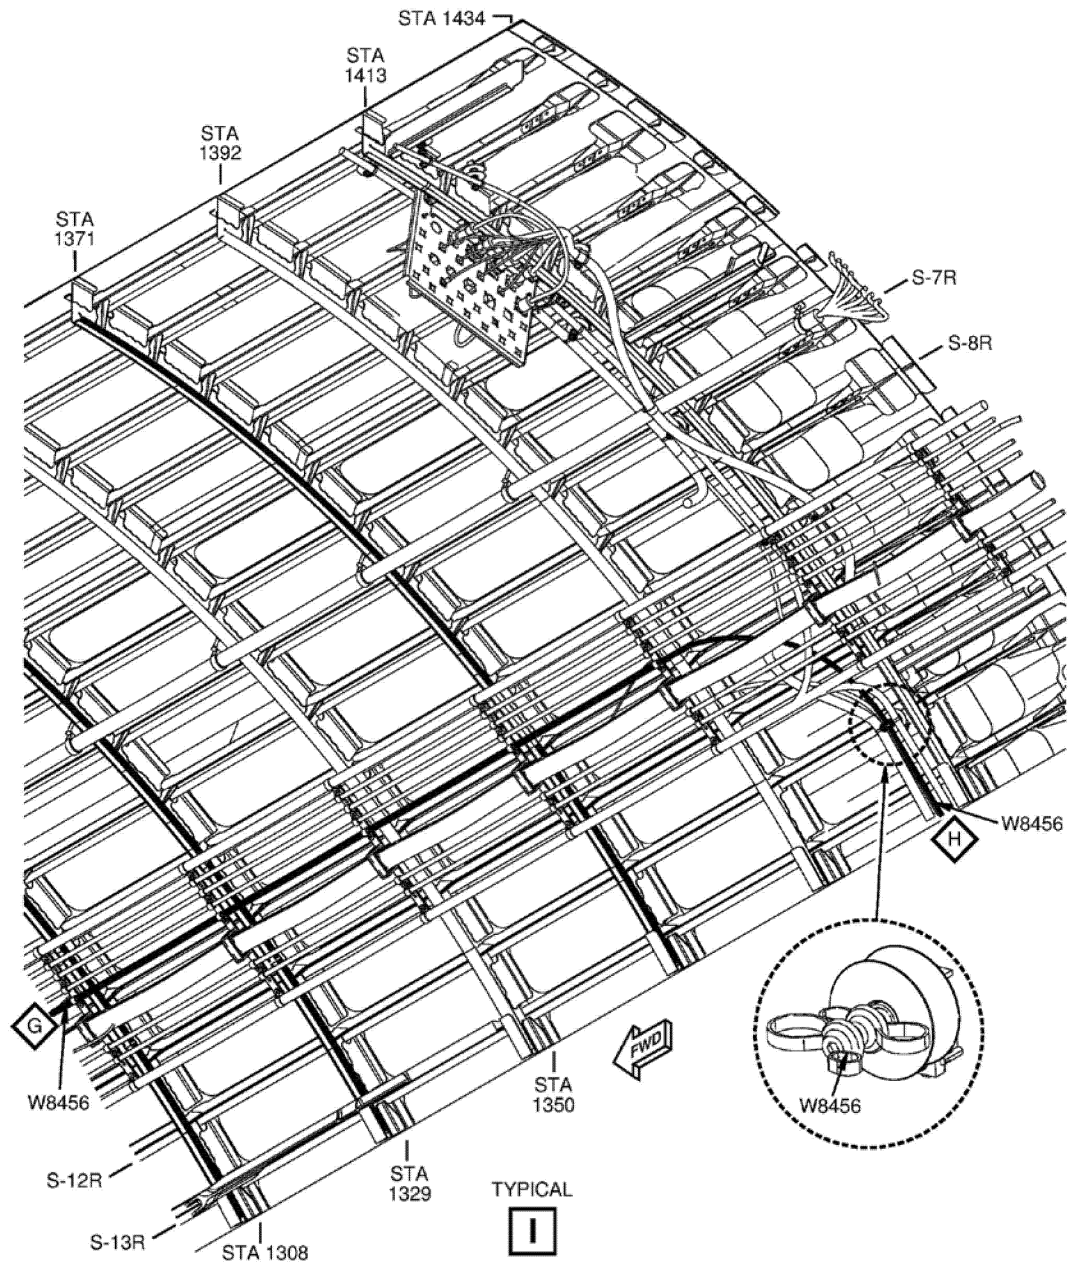
appropriate source of service information in this AD because it is not an FAA-approved document. However, we acknowledge that for certain airplanes, Figure 22, Sheet 9, of Boeing Special Attention Service Bulletin 777-28-0061, Revision 2, dated May 4, 2015, includes an editorial error, which shows incorrect wire routing. Boeing Service Bulletin Information Notice 777-28-0061, IN 03, dated November 16, 2015, allows for a modification of Group 2 airplanes that meets the requirements of the AD without an additional burden to operators. We have included a corrected figure in paragraph (h) of this AD to address this issue.

(1) Where Boeing Special Attention Service Bulletin 777–28–0061, Revision 2, dated May 4, 2015, specifies to use Figure 22, Sheet 9, for the wiring installation of the right engine fuel spar valve, this AD requires using figure 1 to paragraph (h) of this AD.
