[Docket No. FAA-2016-9254; Directorate Identifier 2015-CE-030-AD; Amendment 39-18948; AD 2017-14-04]

Airworthiness Directives; Piper Aircraft, Inc. Airplanes

2017–14–04 Piper Aircraft, Inc.:
Amendment 39–18948; Docket No. FAA–2016–9254; Directorate Identifier 2015–CE–030–AD.

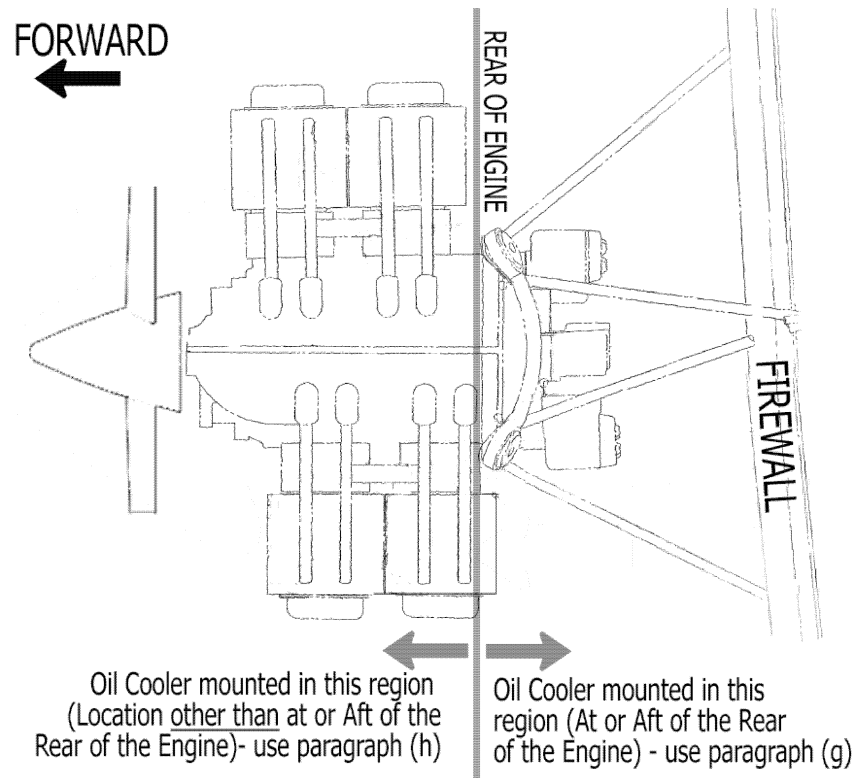
Figure 1 to paragraphs (g) and (h) of this AD: Oil cooler

For any oil cooler hose assemblies that do not meet TSO–C53a, Type D requirements: Within the next 100 hours time-in-service (TIS) after February 5, 1996 (the effective date retained from AD 95–26–13), and repetitively thereafter at intervals not to exceed 100 hours TIS, inspect the fire sleeve of each oil cooler hose assembly for soaked oil, a brownish or whitish color, and any evidence of brittleness or deterioration as a result of heat or oil seepage. See figure 1 to paragraphs (g) and (h) of this AD for additional information.

after February 5, 1996 (the effective date retained from AD 95-26-13), and repetitively thereafter at intervals not to exceed 100 hours TIS, inspect the fire sleeve of each oil cooler hose assembly for soaked oil, a brownish or whitish color, and any evidence of brittleness or deterioration as a result of heat or oil seepage. See figure 1 to paragraphs (g) and (h) of this AD for additional information.

(1) If any of the conditions described in paragraph (g) or (h)(1) of this AD are found on an oil cooler hose assembly during the inspection required in paragraph (g) or (h)(1) of this AD, as applicable, before further flight, replace the oil cooler hose assembly with a serviceable new or used TSO-C53a Type D oil cooler hose assembly or TSO-C53a Type C oil cooler hose assembly. If a used TSO-C53a Type C oil cooler hose assembly is installed, it must have documented hours TIS.

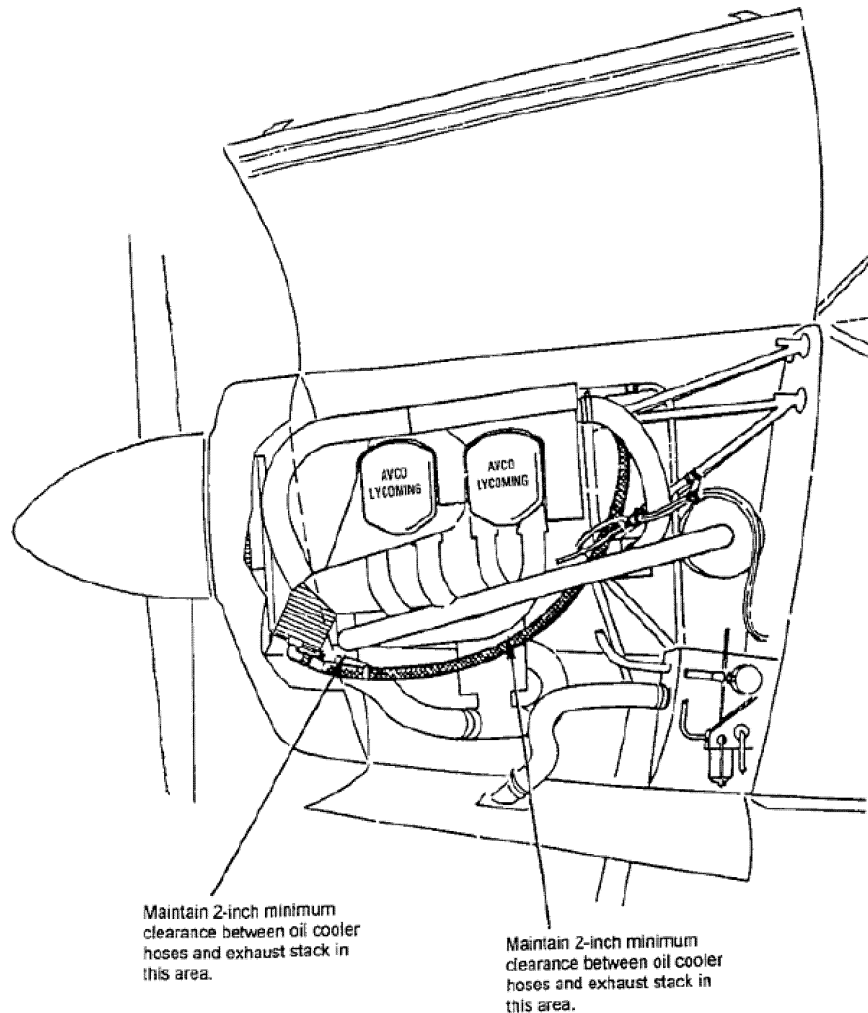
Figure 2 to paragraph (h)(2) of this AD: Acceptable clearances

(h) of this AD for additional information. If the conditions listed in paragraphs (h)(2)(i) through (iii) of this AD are not met, before further flight, make any necessary adjustments. See figure 2 to paragraph (h)(2) of this AD for additional information.

(i) The oil cooler hose assemblies pass underneath and behind the electrical ground cable and in front of the lower of the two engine mounts.

(ii) The oil cooler hose assemblies are secured to the engine mount strut and a clearance of at least 2 inches exists between the oil cooler hose assemblies and the exhaust stack.

(iii) Oil cooler hose assemblies with a minimum outer diameter of 0.75 inch are installed with a bend radius of at least 6.5 inches.
