## DEPARTMENT OF TRANSPORTATION

### Federal Railroad Administration

#### Addressing Electrode-Induced Rail Pitting From Pressure Electric Welding

**ACTION:** Notice of draft Safety Advisory; request for comment.

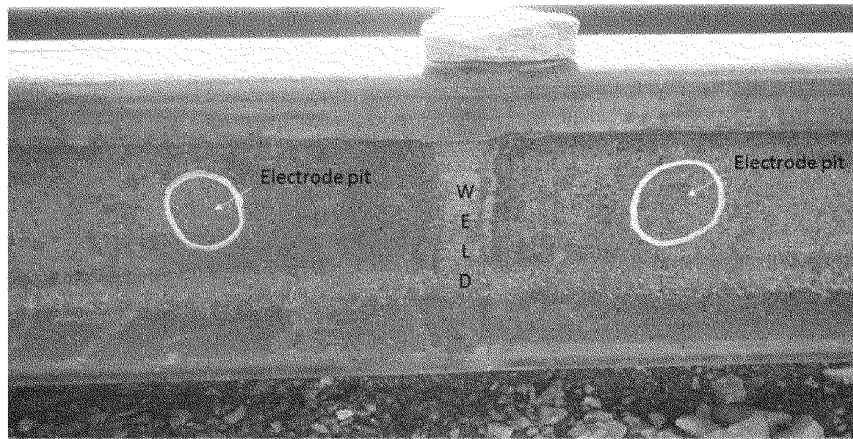
as stress raisers (also referred to as stress concentrations). Fatigue cracks often develop at locations of stress concentration. Once a fatigue crack initiates, the localized stress encourages the growth of the crack, which may potentially lead to rail failure. FRA believes electrode pitting may be a contributing factor, if not the root cause, in some accidents involving rail web cracking.

Figure 1 below shows a photograph of a rail with electrode pits in the web. The location of these electrode pits, when they occur, is typically four to eight inches on either side of the weld. Electrode-induced pitting from pressure electric welding may also occur in the head and base of the rail. At this time, it is unclear whether traditional ultrasonic rail testing can consistently detect electrode-induced pitting.

Figure 1: Electrode-Induced Pits in a Rail

1. Prevent electrode-induced rail pitting from occurring by:
  - a. Reviewing proper pre- and post-weld procedures to avoid the development of electrode pitting;

a. Inspecting the rail upon completion of welding, and reviewing the documentation in the weld report to help identify if pitting occurred;

a. Removing the section of rail containing electrode-induced pitting and re-welding the rail; or

b. Developing and applying possible alternative methods to remove electrode-induced pitting, such as drilling, if electrode-induced pitting is found and the section of rail cannot be readily removed or re-welded.

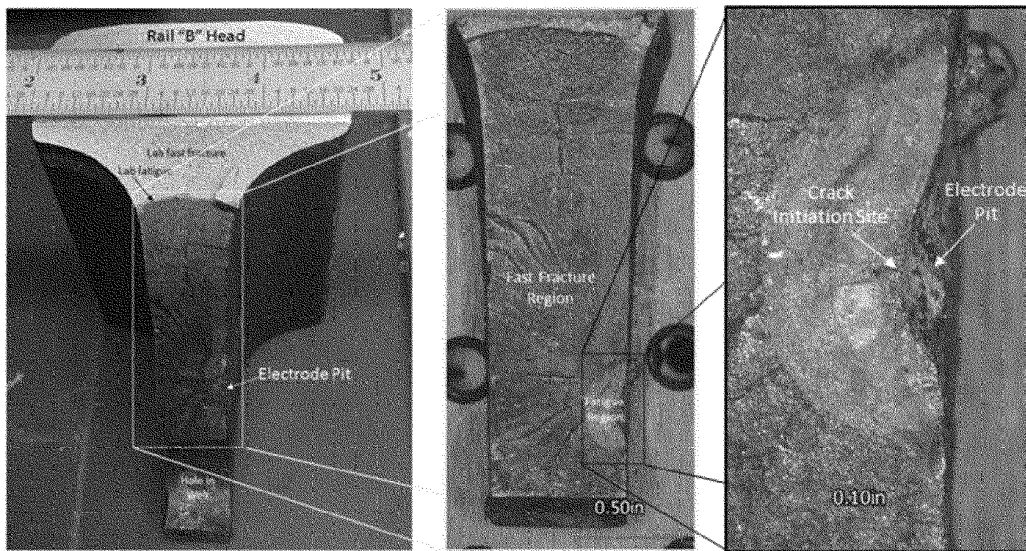
Specifically, Benét's metallurgical analyses concluded the cracking in the rail web originated from the pitting created by inadequate electrode-to-rail contact during the pressure electric welding process. The fractographic and metallographic examinations revealed evidence of fatigue cracking originating from the pitting and fast fracture once the fatigue crack reached a critical length. Figure 2 below shows three photographs of the fracture surface of a crack found in one of the rails Benét examined. These photographs support

the metallurgical evidence indicative of three stages of fatigue fracture: (1) Crack initiation or formation originating from the pitting; (2) crack propagation or growth by metal fatigue; and (3) final rupture or fast fracture. Figure 3 below shows photographs of the microstructure near the electrode pits in each examined rail, providing further evidence the cracking originated from the pitting created by improper electrode contact during welding.

Figure 2: Photographs of Crack Fracture Surface in Examined Rail

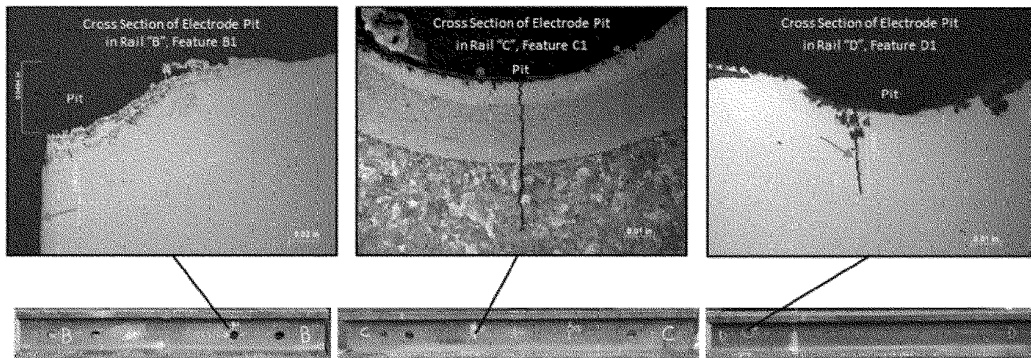
Figure 3: Photographs of Rail Cross Sections
