[Docket No. FAA-2017-0288; Product Identifier 2017-CE-007-AD]

Airworthiness Directives; Textron Aviation Inc. Airplanes

ACTION: Supplemental notice of proposed rulemaking (SNPRM); reopening of comment period.

Textron Aviation Inc.: Docket No. FAA–2017–0288; Product Identifier 2017–CE–007–AD.

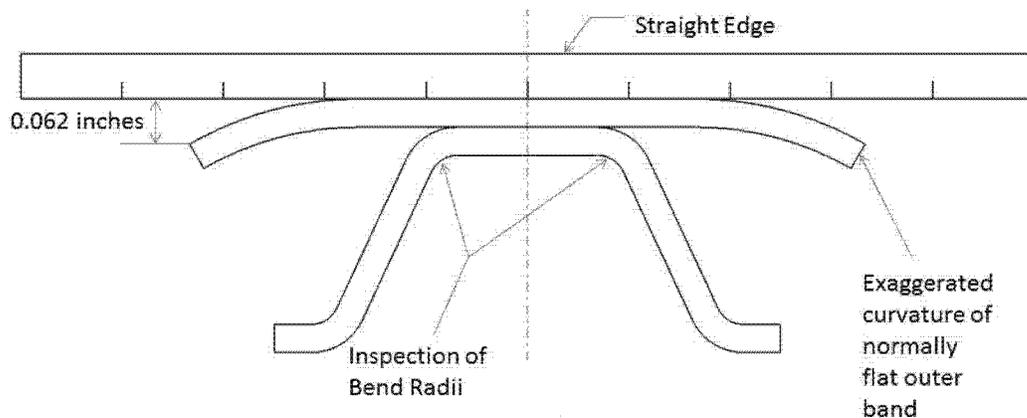
Figure 1 to paragraphs (k)(1)(iii) and (v) of this AD: Cross section of v-band coupling

(iii) Visually inspect the flatness of the outer band using a straight edge. Lay the straight edge across the width of the outer band. The gap must be less than 0.062 inches. See figure 1 to paragraphs (k)(1)(iii) and (v) of this AD. If the gap exceeds 0.062 inches between the outer band and the straight edge, do not re-install the v-band coupling. Before further flight, you must install a new v-band coupling and restart the hours TIS for the repetitive replacement of the v-band coupling.

(v) Visually inspect the bend radii of the coupling v-retainer coupling segments for cracks. Inspect the radii throughout the length of the segment. See figure 1 to paragraphs (k)(1)(iii) and (v) of this AD. If any cracks are found, do not re-install the v-band coupling. Before further flight, you must install a new v-band coupling and restart the hours TIS for the repetitive replacement of the v-band coupling.
