DEPARTMENT OF TRANSPORTATION**Federal Aviation Administration****14 CFR Part 39**

[Docket No. FAA-2018-0479; Product Identifier 2016-NE-23-AD]

Airworthiness Directives; Honeywell International Inc. Turboprop and Turboshaft Engines

ACTION: Notice of proposed rulemaking (NPRM).

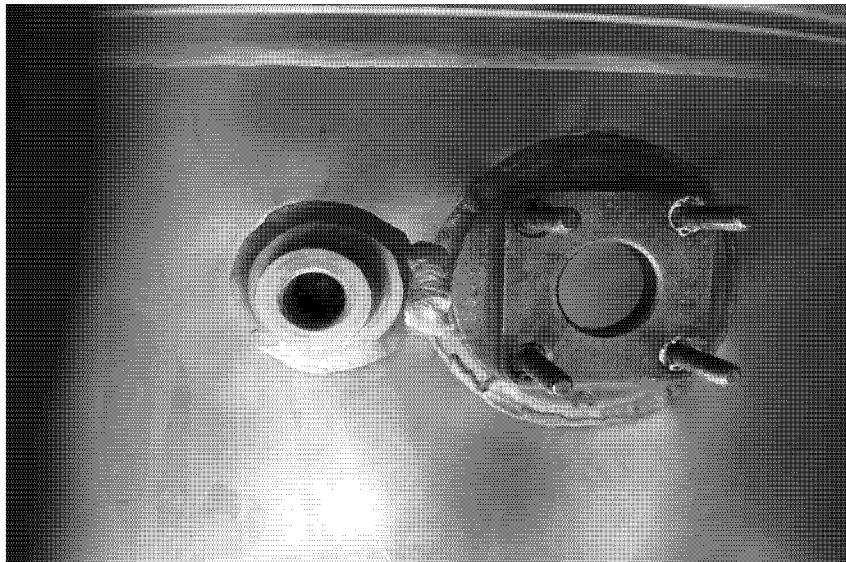
Figure 1 to Paragraph (h) of this AD. Combustion Chamber Case Assembly Without the One-Piece Bleed Pad with P3 Boss

(2) Figures 1 and 2 to paragraph (h) of this AD illustrate the appearance of combustion chamber case assembly, P/N 893973–5, without and with, respectively, the one-piece bleed pad with the P3 boss.

(2) For TPE331–3U, –3UW, –5, –5A, –5AB, –5B, –6, and –6A engine models with combustion chamber case assemblies, P/Ns 869728–1, 869728–3, or 893973–5, installed, and without the one-piece bleed pad with P3 boss; and for TPE331–1, –2, and –2UA engine models modified by National Flight Services, Inc., supplemental type certificate (STC) SE383CH, remove the combustion chamber case assembly from service at the next removal of the combustion chamber case assembly from the engine, not to exceed 3,700 hours TIS since last hot section inspection.

After the effective date of this AD, do not install a combustion chamber case assembly, P/N 869728-1, 869728-3, or 893973-5, in TPE331-3U, -3UW, -5, -5A, -5AB, -5B, -6, and -6A engine models or in TPE331-1, -2, and -2UA engine models modified by National Flight Services, Inc., STC SE383CH, unless the combustion chamber case assembly has a one-piece bleed pad with P3 boss.
