**DEPARTMENT OF TRANSPORTATION****Federal Railroad Administration**

[Docket No. FRA-2017-0074, Notice No. 2; Safety Advisory 2018-01]

**Addressing Electrode-Induced Rail Pitting From Pressure Electric Welding**

**ACTION:** Notice of Safety Advisory.

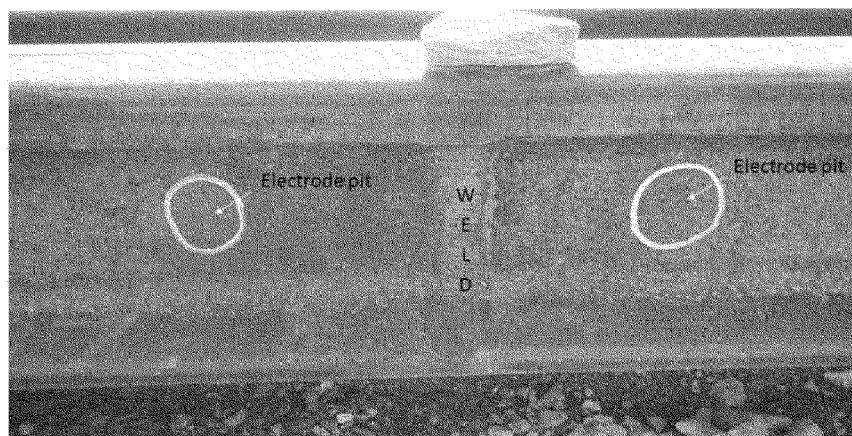
Pressure electric welding is the process of using a hydraulically-operated welding head that clamps around two opposing rail ends, pressing an electrode on each rail, then hydraulically pulling the rail ends together while arcing current through the electrodes into the rails, causing them to essentially melt together to form a continuous rail. Stray arcing during this process results in the formation of electrode burns or pits on the web, head, or base of the rail. Fractures in the rail may originate from the electrode pits because they behave as stress raisers (also referred to as stress concentrations). Fatigue cracks may develop at locations of stress concentration. Once a fatigue crack initiates, the localized stress encourages the growth of the crack, which may potentially lead to rail failure. FRA believes electrode pitting may be a contributing factor, if not the root cause, in some accidents involving rail web cracking.

Figure 1 below shows a photograph of a rail with electrode pits in the web. The location of these electrode pits, when they occur, is typically four to eight inches on either side of the weld. Electrode-induced pitting from pressure electric welding may also occur in the head and base of the rail. It is unclear whether traditional ultrasonic rail

Figure 1: Electrode-Induced Pits in a Rail

FRA recognizes that the industry already has practices and procedures in place to avoid electrode pitting during the pressure electric welding process. Therefore, FRA is issuing Safety Advisory 2018-01 to remind railroads,

railroad employees, railroad contractors, and welding companies and their employees of the importance of complying with those procedures to prevent electrode pitting and, ultimately, to prevent rail failures. (FRA has posted a copy of this notice on its public website, [www.fra.dot.gov](http://www.fra.dot.gov), where you may view the figures below in their full resolution.)

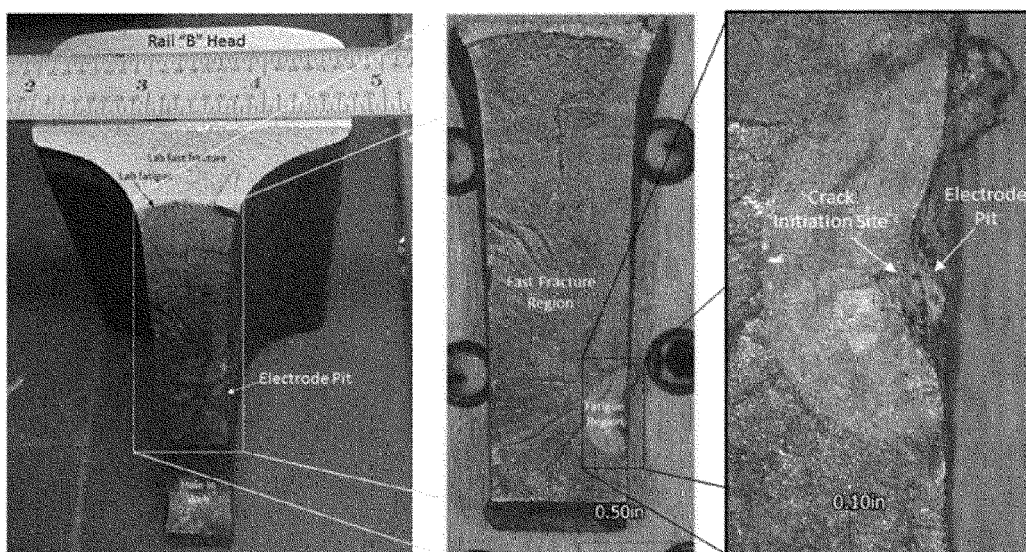
Specifically, Benét's metallurgical analyses concluded the cracking in the rail web originated from the pitting created by inadequate electrode-to-rail contact during the pressure electric welding process. The fractographic and metallographic examinations revealed evidence of fatigue cracking originating from the pitting and fast fracture once the fatigue crack reached a critical length. Figure 2 below shows three photographs of the fracture surface of a crack found in one of the rails Benét examined. These photographs support the metallurgical evidence indicative of three stages of fatigue fracture: (1) Crack initiation or formation originating from the pitting; (2) crack propagation or growth by metal fatigue; and (3) final rupture or fast fracture. Figure 3 below shows photographs of the microstructure near the electrode pits in each examined rail, providing further evidence the cracking originated from the pitting created by improper electrode contact during welding.

Figure 2: Photographs of Crack Fracture Surface in Examined Rail

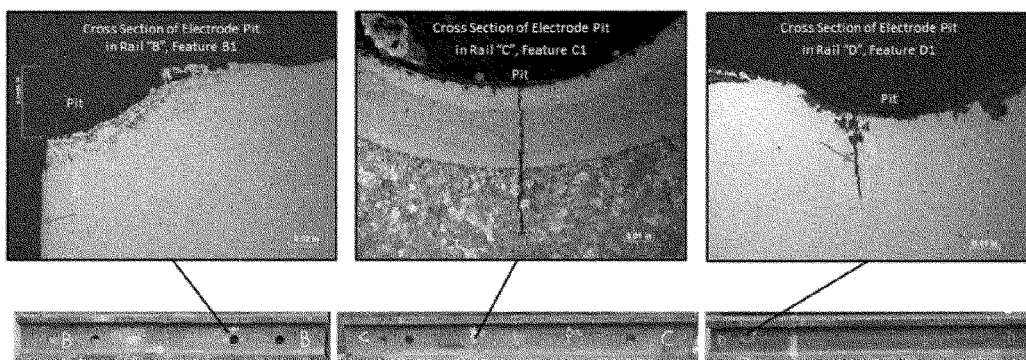
chromium, which were still within AREMA tolerances. Testing of the chemistry and the mechanical properties revealed all three rails were made from standard quality steel containing no other defects except the electrode-induced pitting.

Figure 3: Photographs of Rail Cross Sections
