[Docket No. FAA-2019-0715; Product Identifier 2019-NM-151-AD; Amendment 39-19760; AD 2019-20-07]

Airworthiness Directives; The Boeing Company Airplanes

2019–20–07 The Boeing Company:
Amendment 39–19760; Docket No. FAA–2019–0715; Product Identifier 2019–NM–151–AD.

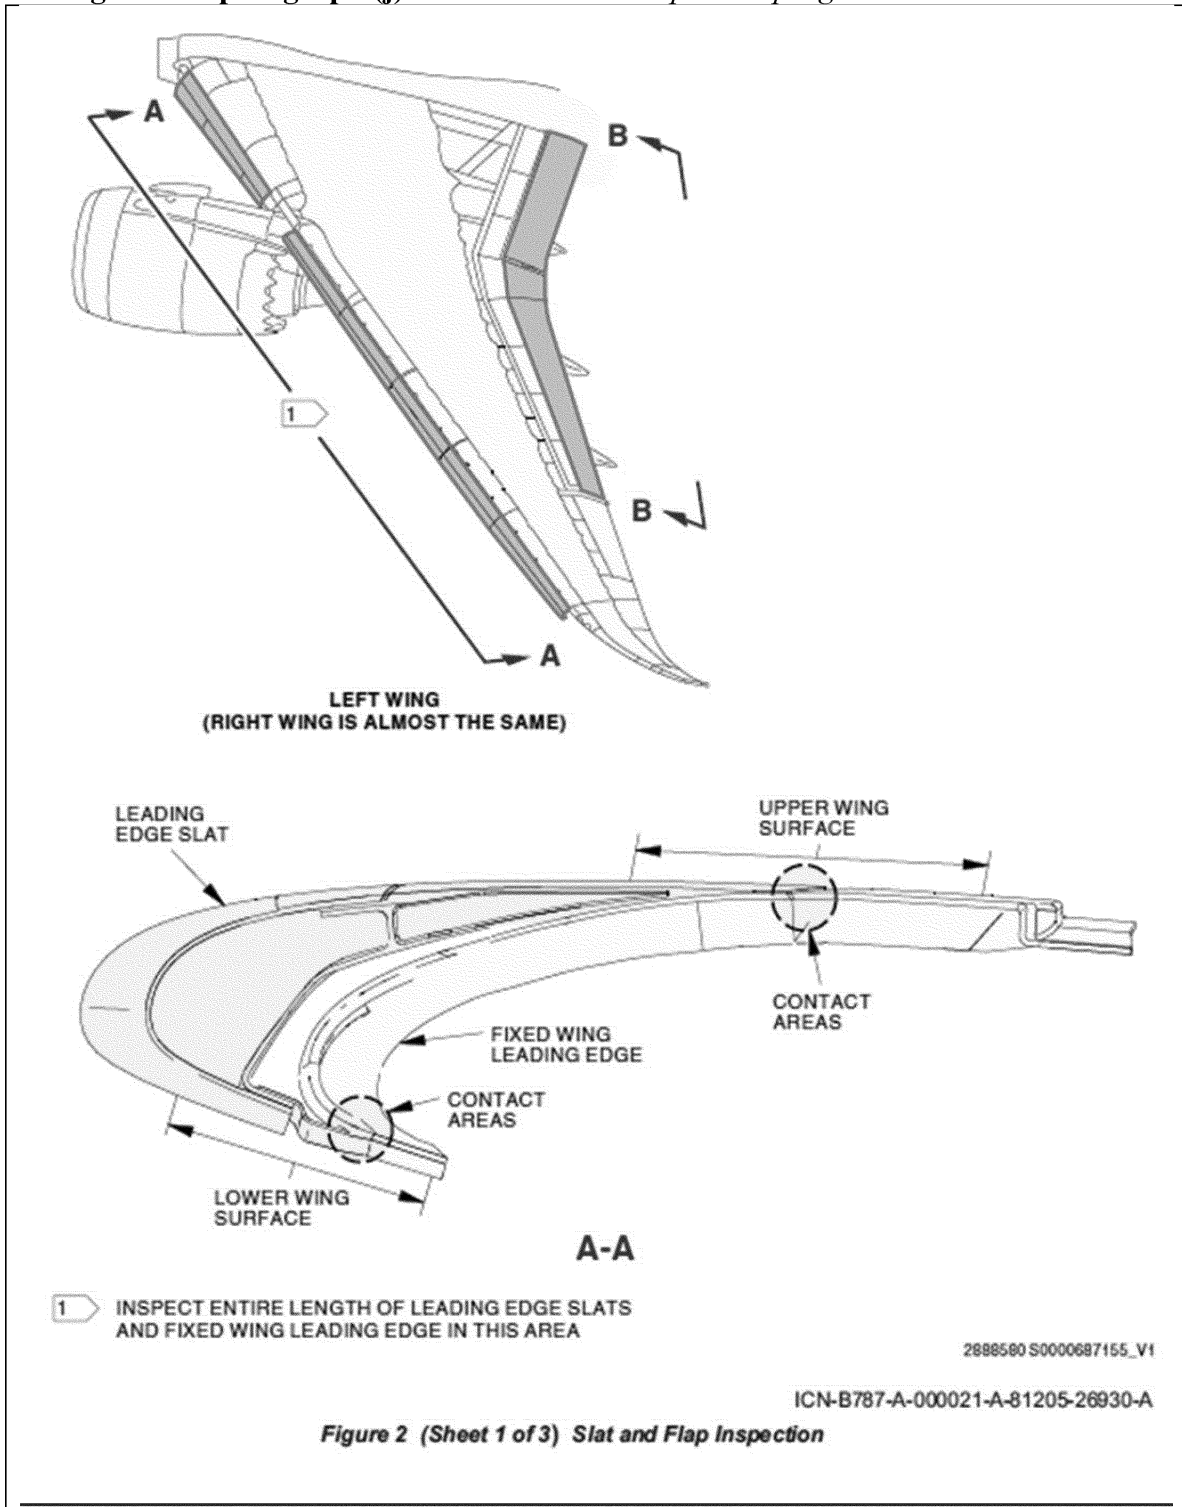
Figure 2 (Sheet 1 of 3) Slat and Flap Inspection

After any landing in icing conditions, do this inspection with the slats/flaps (flaps 25 detent) fully extended (Figure 2):

- (a) Examine these areas for contaminants (ice, snow, slush):

- 1) Slats/flaps surfaces
- 2) Leading edge contact surfaces

- 3) Slat actuation areas, including exposed areas of the slat track cavity, and slat cove
- 4) Flap tracks, hinges, seals

- (b) Remove the contamination that you find.
