Federal Register

[Docket No. FAA-2020-0098; Product Identifier 2020-NM-011-AD; Amendment 39-19844; AD 2020-03-20]

Airworthiness Directives; The Boeing Company Airplanes

2020-03-20 The Boeing Company:

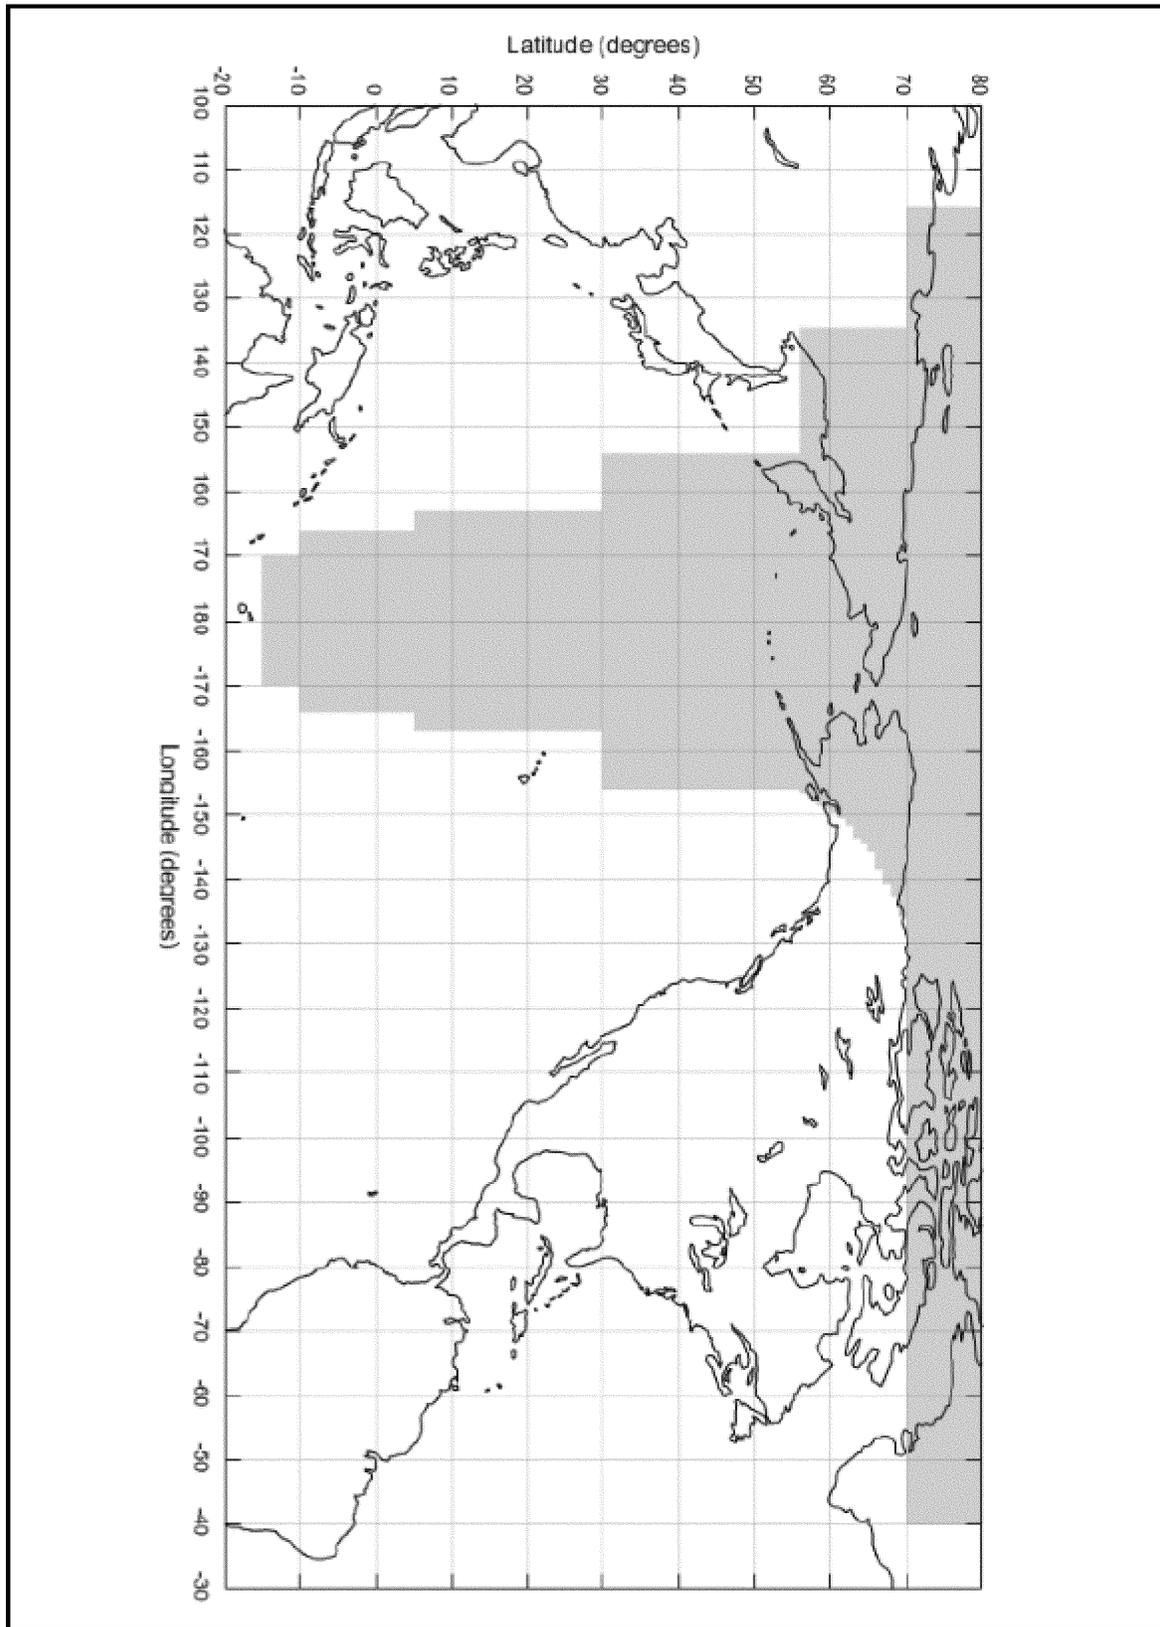
Figure 2 to paragraph (g) – AFM – Limitations or Certificate Limitations continued

Operations that require less than 0.3 RNP (For example, 0.1, 0.11, 0.15, etc.) in the region identified below are prohibited with GLU-2100 OPS software number COL4D-0087-0002, COL4E-0087-0001, COL48-0087-0700, or COL49-0087-0701 installed.

Region bounded by the following coordinates:

Latitude Range (degrees)	Longitude Range (degrees)
80 N to 70 N	40 E to 40 W
70 N to 69 N	134.5 E to 134.38 W
69 N to 68 N	134.5 E to 137.28 W
68 N to 67 N	134.5 E to 139.50 W
67 N to 66 N	134.5 E to 141.58 W
66 N to 65 N	134.5 E to 144.23 W
65 N to 64 N	134.5 E to 145.48 W
64 N to 63 N	134.5 E to 146.44 W
63 N to 62 N	134.5 E to 148.33 W
62 N to 61 N	134.5 E to 149.50 W
61 N to 60 N	134.5 E to 150.35 W
60 N to 59 N	134.5 E to 151.00 W
59 N to 58 N	134.5 E to 151.40 W
58 N to 57 N	134.5 E to 152.62 W
57 N to 56 N	134.5 E to 153.42 W
56 N to 30 N	154 E to 154 W
30 N to 5 N	163 E to 163 W
5 N to 10 S	166 E to 166 W
10 S to 15 S	170 E to 170 W

Exception: Anchorage (PANC) approach procedures that allow less than RNP 0.3 are authorized provided the instructions outlined in the Electronics – Global Landing Unit Section of Normal Procedures Chapter are followed.
